**NYC Department of Education
Building Condition Assessment Survey 2023 - 2024**

Architectural Inspection

K453

Asset: PRE-K CENTER @ 8501 5TH AVENUE - BROOKLYN, 8501 5 AVENUE, New York, 11209

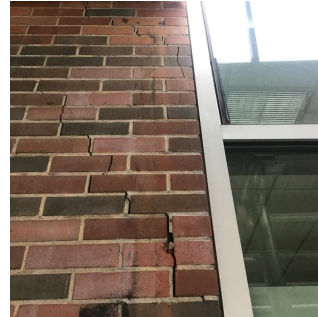
Question	Response
EXTERIOR	Inspected
AREAWAY	Not Required
AWNINGS AND CANOPIES	Does not Exist
CHIMNEY	Not Required
COPING	Not Required
CORNICE	Does not Exist
DOORS	Inspected
DOORS AND FRAMES	Inspected
Condition	2 - Between Good and Fair
Deficiency	No deficiencies recorded
DOOR HARDWARE	Inspected
Condition	2 - Between Good and Fair
Deficiency	No deficiencies recorded
LINTELS	Inspected
Condition	2 - Between Good and Fair
Deficiency	No deficiencies recorded
TRANSOM/SIDE LIGHT	Inspected
Condition	2 - Between Good and Fair
Deficiency	No deficiencies recorded
EXTERIOR WALLS	Inspected
Material Type(s)	Concrete, Masonry
Replacement Quantity	1,000
Replacement Uom	S.F.
Instance on Facade A	Inspected
Instance Condition	4 - Between Fair and Poor
Instance Quantity	1,000
Instance Quantity Uom	S.F.
Deficiency	BRICK: MAJOR / THRU CRACKS
Roof Plan reference

Deficiency Quantity	20
Quantity Uom	S.F.

REMOVE AND REBUILD
PRIORITY 4
LEVEL 2

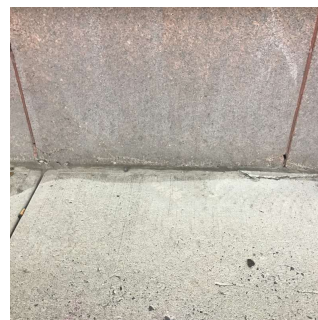
STONE: CHIPPED/SPALLED/BROKEN PIECES - MINOR

10
S.F.
REPAIR
PRIORITY 3
LEVEL 2

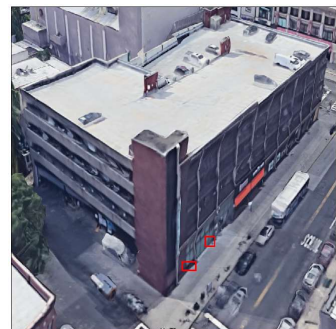
Question	Response
EXTERIOR	
EXTERIOR WALLS	
Violations	Facade A No violations recorded.
Deficiency	STONE: DETERIORATED JOINTS
Roof Plan reference	 
Elevation

Deficiency Quantity	10
Quantity Uom	L.F.
Potential Action	REPOINT
Urgency of Action	PRIORITY 3
Purpose of Action	LEVEL 2
Deficiency Photo1	 
Violations	Facade A No violations recorded.
EXTERIOR SOFFITS	Not Required
LOADING DOCK	Does not Exist
LOUVER	Inspected
Condition	2 - Between Good and Fair
Deficiency	No deficiencies recorded
PARAPETS	Not Required
PLAZA DECK	Does not Exist
ROOF	Inspected
Roofing	Not Required

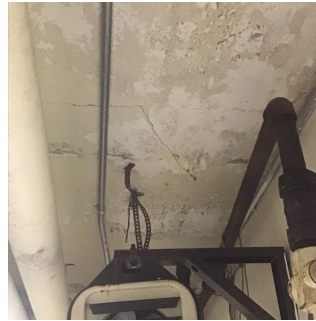
Room C07

FLOOR STRUCTURE	Inspected
Condition	3 - Fair
Deficiency	CONCRETE: CRACKS/SPALLED/REINFORCEMENT EXPOSED
Deficiency Location/Instance	Basement - Room C07, Electrical Room
Deficiency Quantity	30
Quantity Uom	S.F.
Potential Action	REPAIR
Urgency of Action	PRIORITY 3
Purpose of Action	LEVEL 5

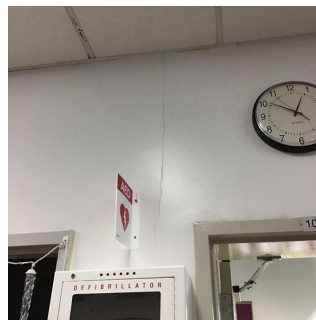
Corridor near Room 104

GYPSUM BOARD: DETERIORATED

REPLACE
