NYC Department of Education
Building Condition Assessment Survey 2023 - 2024

Architectural Inspection

K456

Asset: BOYS & GIRLS AF - BROOKLYN, 1700 FULTON STREET, New York, 11213

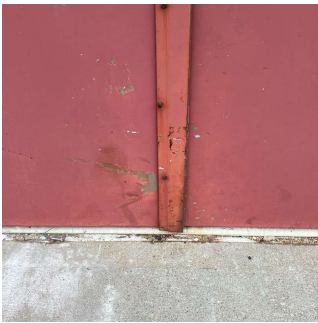
Deficiency METAL: DETERIORATED DOOR AND FRAME - MAJOR DETERIORATION

Violations	Facade A (Doors do not close properly) No violations recorded.
DOOR HARDWARE	Inspected
Condition	3 - Fair
Deficiency	No deficiencies recorded
LINTELS	Inspected
Condition	2 - Between Good and Fair
Deficiency	No deficiencies recorded
TRANSOM/SIDE LIGHT	Does not Exist
EXTERIOR WALLS	Inspected
Material Type(s)	Masonry
Replacement Quantity	1,000
Replacement Uom	S.F.
Instance on All Facades	Inspected
Instance Condition	2 - Between Good and Fair
Instance Quantity	1,000
Instance Quantity Uom	S.F.
Deficiency	No deficiencies recorded
EXTERIOR SOFFITS	Inspected
Condition	2 - Between Good and Fair
Deficiency	No deficiencies recorded
LOUVER	Inspected
Condition	2 - Between Good and Fair
Deficiency	No deficiencies recorded
PARAPETS	Does not Exist
PLAZA DECK	Does not Exist
ROOF	Inspected
Roofing	Inspected
Replacement Quantity	700
Replacement Uom	S.F.
ROOF HATCH/SMOKE HATCH	Does not Exist

2
EACH
REPLACE
PRIORITY 4
LEVEL 2

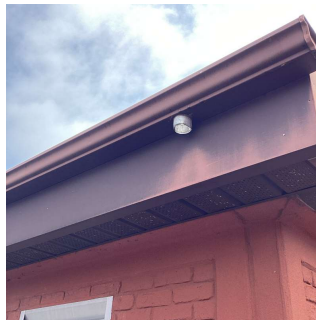
Roof 1
No violations recorded.

LEADERS, GUTTERS, DOWNSPOUTS, SCUPPERS	Inspected
Condition	3 - Fair
Deficiency	DAMAGED/MISSING

10
L.F.
REPLACE
PRIORITY 4
LEVEL 2

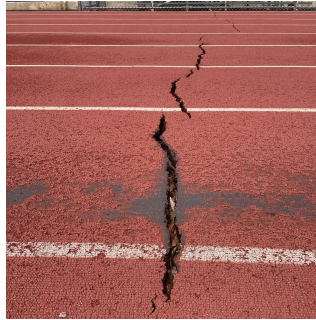
Synthetic Turf Field exists?	Yes
Year of Installation	2014
Replacement Quantity	152,000
Replacement Uom	S.F.
Instance on Running Track	Inspected
Instance Condition	5 - Poor
Instance Quantity	15,000
Instance Quantity Uom	S.F.
Deficiency	ATHLETIC WEARING SURFACE: DAMAGED/DETERIORATED
Deficiency Location/Instance	Running Track - Various Locations

100

REPLACE

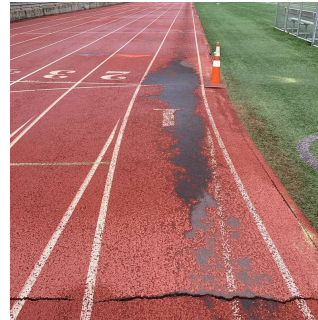
ATHLETIC WEARING SURFACE: DAMAGED/DETERIORATED

Running Track

5,000

REPLACE

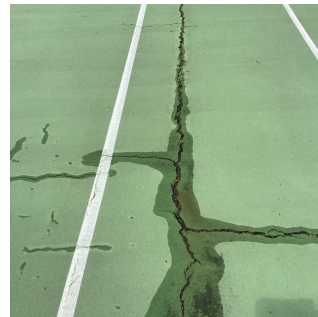
East Tennis Court

ASPHALT: DAMAGED/DETERIORATED

Tennis Courts

600

REPLACE

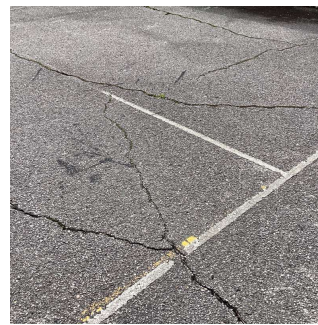
ASPHALT: DAMAGED/DETERIORATED

Handball Court

500

REPLACE

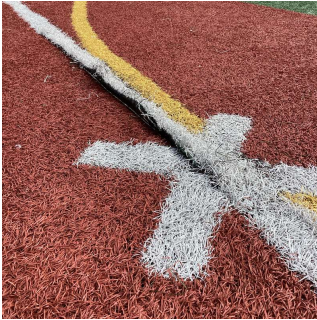
Priority Condition Exist Last Year?	Priority Category	Condition Description	Component Affected	Location Description	Person(s) Notified	Person(s) Title	PhotoImage
No	Tripping Hazard	Damaged synthetic field is a potential tripping hazard.	ATHLETIC FIELDS PLAYING SURFACE	Football Field - West 40 yard line	Craig Ebanks	Fireman	 
Yes	Tripping Hazard	Severely damaged asphalt with wide cracks is a potential tripping hazard.	SITE PAVING Student Use Asphalt	Near Storage Building, All 4 Corners of Field	Craig Ebanks	Fireman	 
Yes	Tripping Hazard	Severely damaged and sinking areas of asphalt are a potential tripping hazard.	SITE PAVING Student Non-Use Asphalt	Parking Lot - Atlantic Avenue Side, Adjacent to Tennis Court	Craig Ebanks	Fireman	 
Yes	Tripping Hazard	Severely damaged sidewalks on Atlantic Avenue and severely heaving sidewalks on Schenectady Avenue are a potential tripping hazard.	SITE PAVING DOT Sidewalk Concrete	Utica Avenue, Atlantic Avenue, Schenectady Avenue	Craig Ebanks	Fireman

ARTIFICIAL TURF: DAMAGED/WORN OUT

Football Field - 40 yard line west

Violations	Football/Soccer Field - West 40-yard line No violations recorded.
FIXED EQUIPMENT	Inspected
Basketball Backboard	Does not Exist
Basketball Hoops	Does not Exist
Basketball Posts	Does not Exist
Football Goal Posts	Inspected
Condition	2 - Between Good and Fair
Deficiency	No deficiencies recorded
Tennis Net Posts	Inspected
Condition	5 - Poor
Deficiency	DAMAGED/MISSING
Deficiency Location/Instance	Tennis Court near Utica Avenue
Deficiency Quantity	2
Quantity Uom	EACH
Potential Action	REPLACE
Urgency of Action	PRIORITY 3
Purpose of Action	LEVEL 2
Deficiency Photo1

20

REPLACE

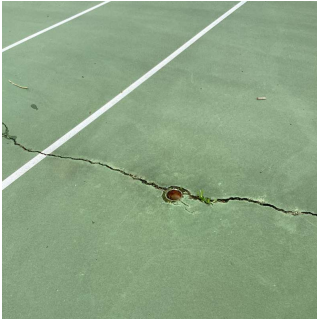
Violations	Tennis Court near Utica Avenue No violations recorded.
SEATING	Inspected
Benches	Inspected
Concrete	Does not Exist
Metal/Wood/Plastic	Inspected
Condition	2 - Between Good and Fair
Deficiency	No deficiencies recorded
Bleachers	Inspected
Concrete	Does not Exist
Metal/Wood/Plastic	Inspected

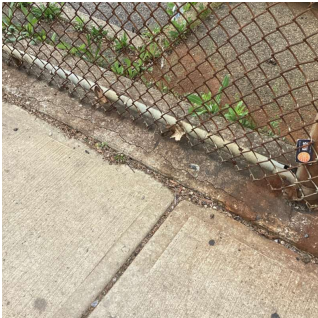
Question	Response
ATHLETIC FIELDS	Inspected
SEATING	Inspected
Bleachers	
Metal/Wood/Plastic	
Condition	2 - Between Good and Fair
Deficiency	No deficiencies recorded
SITE	Inspected
CONTAINERIZATION	Does not Exist
Drainage System for Asphalt	Inspected
Catch Basins/Manhole - Surrounded by asphalt	Inspected
Condition	2 - Between Good and Fair
Deficiency	No deficiencies recorded
Culverts - Asphalt Covering	Does not Exist
Drainage System for Concrete	Does not Exist
Drainage System for Soil	Does not Exist
DRINKING FOUNTAINS	Inspected
Condition	5 - Poor
Deficiency	INOPERABLE
Deficiency Location/Instance	Near Scoreboard, Near Large Bleachers
Deficiency Quantity	2
Quantity Uom	EACH
Potential Action	MAINTENANCE
Urgency of Action	PRIORITY 3
Purpose of Action	LEVEL 2
Deficiency Photo1	No photo recorded
Violations	No violations recorded.
FENCES	Inspected
Condition	4 - Between Fair and Poor
Deficiency	CONCRETE CURB: DAMAGED/DETERIORATED

Deficiency Location/Instance	Atlantic Avenue
Deficiency Quantity	35
Quantity Uom	S.F.
Potential Action	REPLACE
Urgency of Action	PRIORITY 4
Purpose of Action	LEVEL 4
Deficiency Photo1

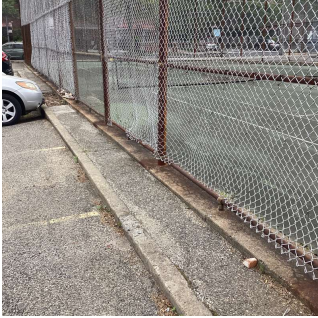
Violations	Atlantic Avenue 35671792M
Deficiency	CHAIN LINK: DAMAGED/DETERIORATED
Deficiency Location/Instance	Tennis Court at Schenectady Avenue, Atlantic Avenue, Schenectady Avenue
Deficiency Quantity	450

Question	Response
SITE	Inspected
FENCES	
Quantity Uom	S.F.
Potential Action	REPLACE
Urgency of Action	PRIORITY 3
Purpose of Action	LEVEL 2
Deficiency Photo1

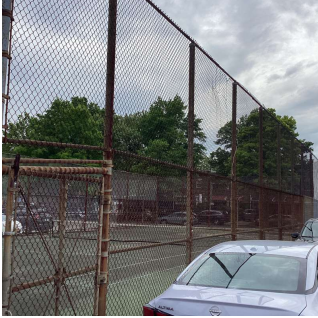
Violations	Tennis Court at Schenectady Avenue No violations recorded.
Deficiency	CHAIN LINK: RUST - MAJOR
Deficiency Location/Instance	Tennis Court at Schenectady Avenue, Atlantic Avenue, Schenectady Avenue
Deficiency Quantity	2,250
Quantity Uom	S.F.
Potential Action	REPLACE
Urgency of Action	PRIORITY 3
Purpose of Action	LEVEL 2
Deficiency Photo1

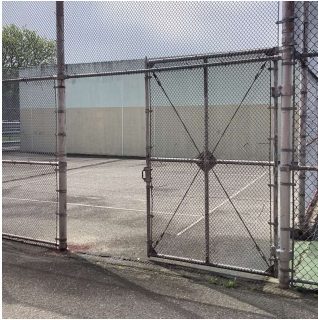
Violations	Tennis Court at Schenectady Avenue No violations recorded.
Deficiency	CHAIN LINK: MISSING SECTIONS
Deficiency Location/Instance	Handball Court
Deficiency Quantity	100
Quantity Uom	S.F.
Potential Action	REPLACE
Urgency of Action	PRIORITY 3
Purpose of Action	LEVEL 2

Violations	Handball Court No violations recorded.
Deficiency	CONCRETE CURB: DAMAGED/DETERIORATED
Deficiency Location/Instance	Near Tennis Court, Utica Avenue, Schenectady Avenue
Deficiency Quantity	60
Quantity Uom	S.F.
Potential Action	REPLACE
Urgency of Action	PRIORITY 3
Purpose of Action	LEVEL 2
Deficiency Photo1

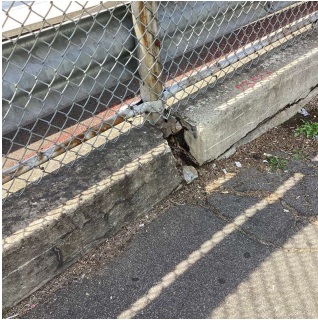
Violations	Utica Avenue No violations recorded.
IRRIGATION SYSTEM	Does not Exist
PAVING	Inspected
Student Non-Use	Inspected
Gravel Exists?	No
Asphalt	Inspected
Condition	4 - Between Fair and Poor
Deficiency	LOCALIZED SINK AREA
Deficiency Location/Instance	Parking Lot on Atlantic Avenue Side, Parking Lot on Tennis Court Side
Deficiency Quantity	300
Quantity Uom	S.F.
Potential Action	REPAIR
Urgency of Action	PRIORITY 5
Purpose of Action	LEVEL 6

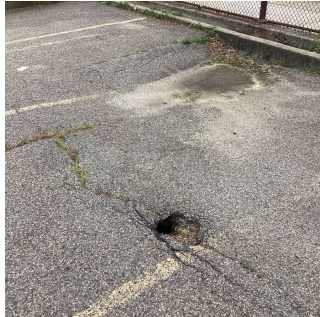
Violations	Parking Lot on Atlantic Avenue Side No violations recorded.
Deficiency	CRACKS - MAJOR
Deficiency Location/Instance	Under Bleachers, Parking Lot
Deficiency Quantity	3,160
Quantity Uom	S.F.
Potential Action	REPLACE
Urgency of Action	PRIORITY 3
Purpose of Action	LEVEL 2
Deficiency Photo1

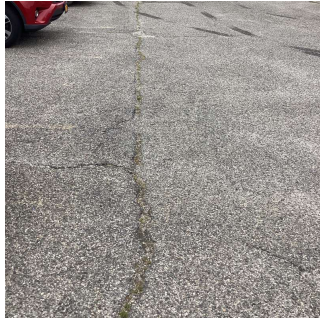
Violations	Parking Lot No violations recorded.
Concrete	Does not Exist
Pavers	Does not Exist
Student Use	Inspected
Gravel Exists?	No
Asphalt	Inspected
Condition	4 - Between Fair and Poor
Deficiency	CRACKS - MAJOR
Deficiency Location/Instance	Football Field, Near Bleachers
Deficiency Quantity	150
Quantity Uom	S.F.
Potential Action	REPLACE
Urgency of Action	PRIORITY 3
Purpose of Action	LEVEL 2

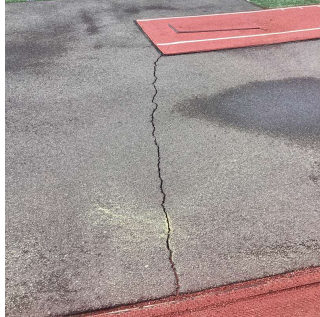
Violations	Football Field No violations recorded.
Deficiency	CRACKS - MAJOR
Deficiency Location/Instance	Near Storage Building, All 4 Corners of Field
Deficiency Quantity	1,000
Quantity Uom	S.F.
Potential Action	REPLACE
Urgency of Action	PRIORITY 5
Purpose of Action	LEVEL 6
Deficiency Photo1

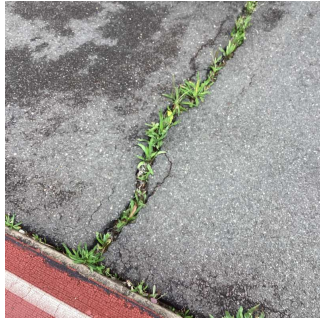
Violations	Near Storage Building No violations recorded.
Concrete	Inspected
Condition	2 - Between Good and Fair
Deficiency	LOCALIZED SINK AREA
Deficiency Location/Instance	South Side of Field
Deficiency Quantity	25
Quantity Uom	S.F.
Potential Action	REPAIR
Urgency of Action	PRIORITY 3
Purpose of Action	LEVEL 2

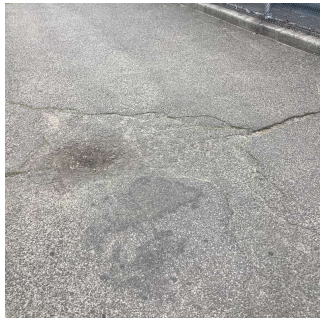
Question	Response
SITE	
PAVING	
Student Use	
Concrete	Inspected
Deficiency Photo1	 
	South Side of Field
Violations	No violations recorded.
Pavers	Does not Exist
Site Sidewalks & Walkways	Inspected
Asphalt	Inspected
Condition	4 - Between Fair and Poor
Deficiency	CRACKS - MAJOR
Deficiency Location/Instance	Near Parking Lot, Utica Avenue
Deficiency Quantity	275
Quantity Uom	S.F.
Potential Action	REPLACE
Urgency of Action	PRIORITY 3
Purpose of Action	LEVEL 2
Deficiency Photo1

Utica Avenue
Violations	No violations recorded.
Deficiency	HEAVING
Deficiency Location/Instance	Walkway Between Parking Lot and Schenectady Avenue Tennis Court
Deficiency Quantity	250
Quantity Uom	S.F.
Potential Action	REPLACE
Urgency of Action	PRIORITY 5
Purpose of Action	LEVEL 6

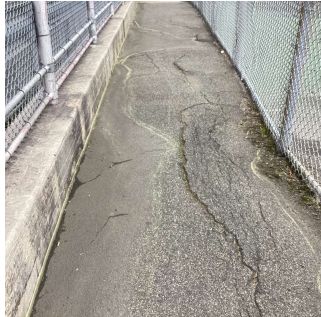
Yes	Tripping Hazard	Severely heaving asphalt walkway is a potential tripping hazard.	SITE PAVING Site Sidewalks & Walkways Asphalt	Walkway Between Parking Lot and Schenectady Avenue Tennis Court	Craig Ebanks	Custodian	 
Yes	Tripping Hazard	Worn-out playing surface with cracks and sink holes is a potential tripping hazard.	ATHLETIC FIELDS PLAYING SURFACE	Midpoint of the North side of the Running track by the field entrance.	Craig Ebanks	Fireman

Walkway Between Parking Lot and Schenectady Avenue Tennis Court
Violations	No violations recorded.
Concrete	Does not Exist
Pavers	Does not Exist
DOT Sidewalk	Inspected
Asphalt	Does not Exist
Concrete	Inspected
Condition	5 - Poor
Deficiency	DAMAGED CURBS
Deficiency Location/Instance	Utica Avenue, Atlantic Avenue
Deficiency Quantity	145
Quantity Uom	L.F.
Potential Action	REPLACE
Urgency of Action	PRIORITY 3
Purpose of Action	LEVEL 2
Deficiency Photo1

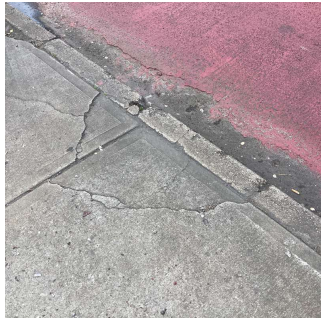
Utica Avenue
Violations	No violations recorded.
Deficiency	DAMAGED/DETERIORATED/MISSING SECTIONS
Deficiency Location/Instance	Utica Avenue, Atlantic Avenue, Schenectady Avenue
Deficiency Quantity	1,575
Quantity Uom	S.F.
Potential Action	REPLACE
Urgency of Action	PRIORITY 5
Purpose of Action	LEVEL 6

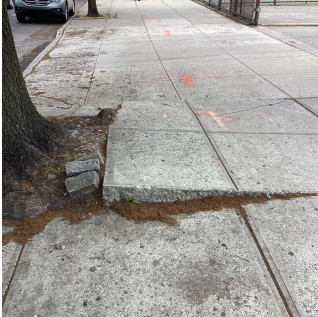
Violations	Schenectady Avenue No violations recorded.
Deficiency	HEAVING
Deficiency Location/Instance	Utica Avenue, Schenectady Avenue
Deficiency Quantity	450
Quantity Uom	S.F.
Potential Action	REPLACE
Urgency of Action	PRIORITY 3
Purpose of Action	LEVEL 2
Deficiency Photo1

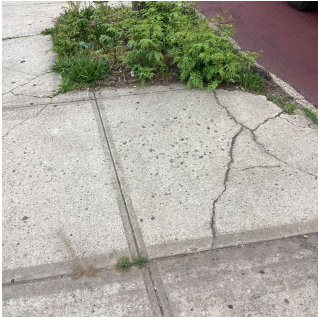
Violations	Utica Avenue No violations recorded.
Deficiency	DAMAGED/DETERIORATED/MISSING SECTIONS
Deficiency Location/Instance	Utica Avenue, Atlantic Avenue, Schenectady Avenue
Deficiency Quantity	3,375
Quantity Uom	S.F.
Potential Action	REPLACE
Urgency of Action	PRIORITY 3
Purpose of Action	LEVEL 2
Deficiency Photo1

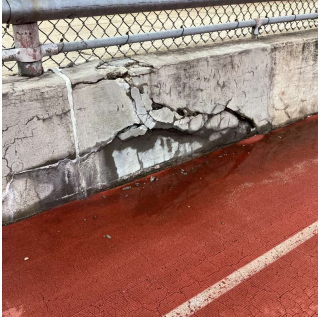
Question	Response
SITE	
PAVING	Inspected
DOT Sidewalk	
Concrete	Inspected
Violations	No violations recorded.
Pavers	Does not Exist
PLAYGROUNDS	Does not Exist
RETAINING WALLS	Inspected
Are there any Retaining Walls 6' OR higher facing public street/sidewalk?	No
Condition	3 - Fair
Deficiency	CAST IN PLACE CONCRETE: CRACKS/SPALLING - MAJOR
Deficiency Location/Instance	Atlantic Avenue Side
Deficiency Quantity	120
Quantity Uom	S.F.
Potential Action	REPLACE
Urgency of Action	PRIORITY 4
Purpose of Action	LEVEL 4
Deficiency Photo1

Violations	Atlantic Avenue Side 35671792M
Deficiency	CAST IN PLACE CONCRETE: CRACKS/SPALLING - MAJOR
Deficiency Location/Instance	Handball Court
Deficiency Quantity	20
Quantity Uom	S.F.
Potential Action	REPLACE
Urgency of Action	PRIORITY 3
Purpose of Action	LEVEL 2
Deficiency Photo1

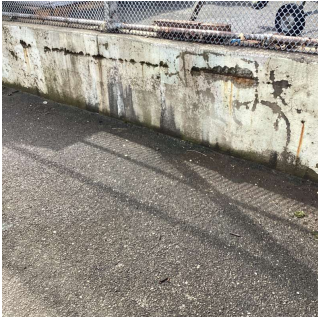
Violations	Handball Court No violations recorded.
SEATING	Does not Exist
SITE WALLS (NOT RETAINING WALLS)	Inspected
