**NYC Department of Education**  
**Building Condition Assessment Survey 2023 - 2024**

Architectural Inspection

**K457**

**Asset: BOYS HS AF (OLD) - BROOKLYN, 708 MAPLE STREET, New York, 11216**

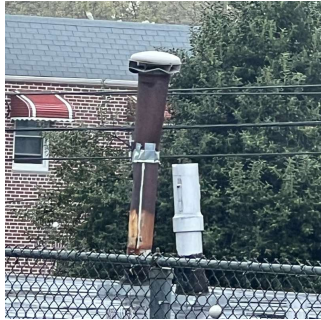
Question	Response
<b>Architectural</b>	
<b>EXTERIOR</b>	Inspected
<b>AREAWAY</b>	Does not Exist
<b>AWNINGS AND CANOPIES</b>	Does not Exist
<b>CHIMNEY</b>	Inspected
Material Type(s)	Metal
Condition	3 - Fair
Deficiency	METAL: DENTS, MAJOR RUSTING
Roof Plan reference	
Deficiency Quantity	20
Quantity Uom	S.F.
Potential Action	REPLACE-UPGRADE
Urgency of Action	PRIORITY 4
Purpose of Action	LEVEL 2

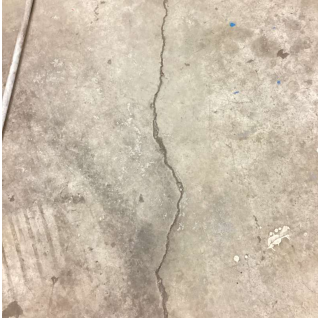
Question	Response
<b>EXTERIOR</b>	Inspected
<b>WINDOWS</b>	Does not Exist
<b>INTERIOR</b>	Inspected
<b>STRUCTURAL</b>	Inspected
<b>COLUMNS/BEAMS/BEARING WALLS</b>	Inspected
Condition	2 - Between Good and Fair
Deficiency	No deficiencies recorded
<b>FLOOR STRUCTURE</b>	Inspected
Condition	3 - Fair
Deficiency	CONCRETE SLAB ON GRADE: THRU CRACKS
Deficiency Location/Instance	Locker Room #2, Office
Deficiency Quantity	100
Quantity Uom	S.F.
Potential Action	REPAIR
Urgency of Action	PRIORITY 3
Purpose of Action	LEVEL 5
Deficiency Photo1

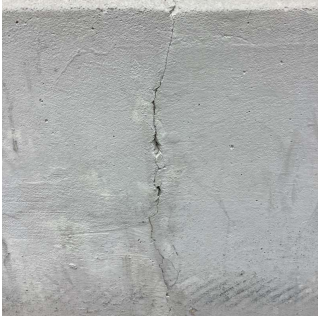
Violations	Office No violations recorded.
<b>FOUNDATION WALLS</b>	Inspected
Material Type(s)	Concrete, Masonry
Condition	3 - Fair
Deficiency	CONCRETE: CRACKED/SPALLED/REINFORCEMENT EXPOSED
Deficiency Location/Instance	Facade C
Deficiency Quantity	20
Quantity Uom	S.F.
Potential Action	REPAIR
Urgency of Action	PRIORITY 4
Purpose of Action	LEVEL 5
Deficiency Photo1

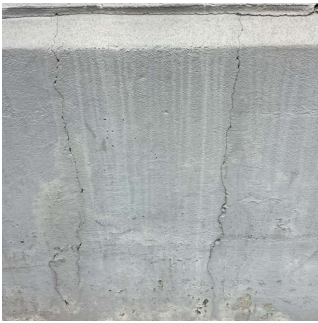
Deficiency	CONCRETE: CRACKED/SPALLED/REINFORCEMENT EXPOSED
Deficiency Location/Instance	Facade C
Deficiency Quantity	40
Quantity Uom	S.F.
Potential Action	REPAIR
Urgency of Action	PRIORITY 3
Purpose of Action	LEVEL 5
Deficiency Photo1

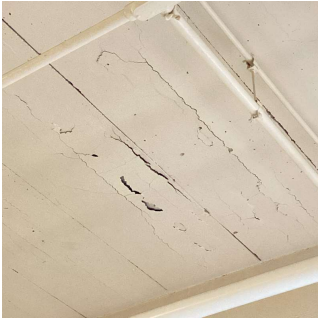
No	Potential Falling Debris	Cracking concrete roof slab is a potential falling debris hazard.	INTERIOR   STRUCTURAL   ROOF STRUCTURE	Locker Room #2	Monty Sutton	Fieldman

Deficiency	CONCRETE: CRACKED/SPALLED/REINFORCEMENT EXPOSED
Deficiency Location/Instance	Locker Room #2
Deficiency Quantity	10
Quantity Uom	S.F.
Potential Action	REPAIR
Urgency of Action	PRIORITY 5
Purpose of Action	LEVEL 6
Deficiency Photo1

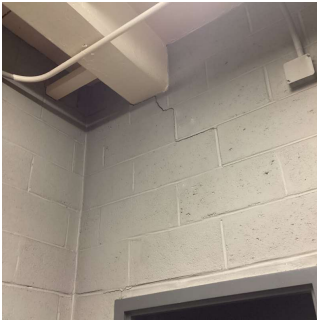
Question	Response
<b>INTERIOR</b>	
<b>STRUCTURAL</b>	
<b>ROOF STRUCTURE</b>	
Purpose of Action	LEVEL 5
Deficiency Photo1	 
Violations	Roof 1 - Facade B No violations recorded.
<b>VAULTS-BUNKERS</b>	Does not Exist
<b>CLASSROOMS/CORRIDORS/ADMIN SPACES</b>	Inspected
<b>Ceiling</b>	Does not Exist
<b>Door(s)</b>	Inspected
Condition	5 - Poor
Deficiency	METAL: DETERIORATED DOOR
Deficiency Location/Instance	Coach Office, Coach Office Inside Locker Room 1
Deficiency Quantity	2
Quantity Uom	EACH
Potential Action	MAINTENANCE
Urgency of Action	PRIORITY 3
Purpose of Action	LEVEL 2
Deficiency Photo1	 
Violations	Coach Office Inside Locker Room 1 No violations recorded.
<b>Floor Finish</b>	Inspected
Condition	2 - Between Good and Fair
Deficiency	No deficiencies recorded
<b>Walls</b>	Inspected
Condition	2 - Between Good and Fair
Deficiency	MASONRY: CRACKS/SPALLING
Deficiency Location/Instance	Coach Office Inside Locker Room 1
Deficiency Quantity	10

Coach Office Inside Locker Room 1
Violations	No violations recorded.
<b>INTERIOR DOOR HARDWARE</b>	
Condition	Inspected
	2 - Between Good and Fair
Deficiency	No deficiencies recorded
<b>LOCKER ROOM</b>	
	Inspected
Instance on 1st Floor - Room 1 (6 Lockers)	Inspected
Alternative use	No
Instance on 1st Floor - Room 2 (65 Lockers)	Inspected
Alternative use	No
Instance on 1st Floor - Room 3 (72 Lockers)	Inspected
Alternative use	No
Instance on 1st Floor - Room 4 (80 Lockers)	Inspected
Alternative use	No
<b>Ceiling</b>	
Instance on 1st Floor - Room 1 (6 Lockers)	Does not Exist
Instance on 1st Floor - Room 2 (65 Lockers)	Does not Exist
Instance on 1st Floor - Room 3 (72 Lockers)	Does not Exist
Instance on 1st Floor - Room 4 (80 Lockers)	Does not Exist
<b>Door(s)</b>	
Instance on 1st Floor - Room 1 (6 Lockers)	Does not Exist

Quantity Uom	S.F.
Potential Action	REPLACE
Urgency of Action	PRIORITY 3
Purpose of Action	LEVEL 2

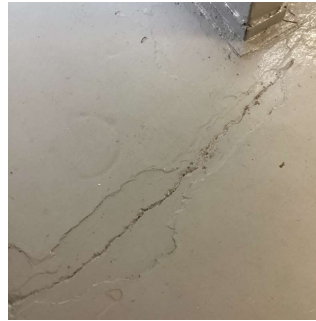
Near Entrance

Instance on 1st Floor - Room 2 (65 Lockers)	Not Required
Instance on 1st Floor - Room 3 (72 Lockers)	Not Required
Instance on 1st Floor - Room 4 (80 Lockers)	Not Required
<b>Floor Finish</b>	
Instance on 1st Floor - Room 2 (65 Lockers)	Inspected
Condition	3 - Fair
Deficiency	CONCRETE: CRACKS
Deficiency Location/Instance	Near Entrance, Center, Rear
Deficiency Quantity	60
Quantity Uom	S.F.
Potential Action	REPLACE
Urgency of Action	PRIORITY 3
Purpose of Action	LEVEL 2

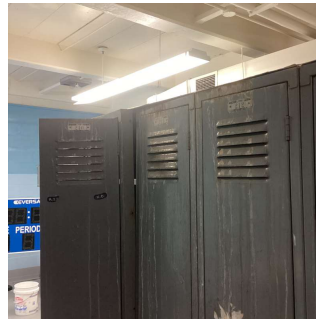
Locker 209

Instance on 1st Floor - Room 3 (72 Lockers)	Inspected
Condition	5 - Poor
Deficiency	DAMAGED UNITS
Deficiency Location/Instance	Lockers 190, 209, 210, 211, 212, 238, 239, 240
Deficiency Quantity	8
Quantity Uom	EACH
Potential Action	REPLACE
Urgency of Action	PRIORITY 3
Purpose of Action	LEVEL 2
Deficiency Photo1

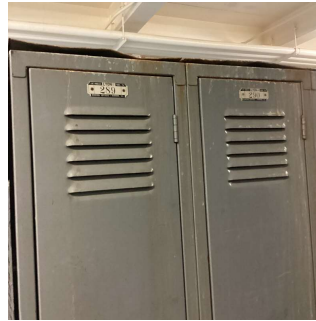
Locker 289

Instance on 1st Floor - Room 4 (80 Lockers)	Inspected
Condition	2 - Between Good and Fair
Deficiency	DAMAGED UNITS
Deficiency Location/Instance	Lockers 289, 290
Deficiency Quantity	2
Quantity Uom	EACH
Potential Action	REPLACE
Urgency of Action	PRIORITY 3
Purpose of Action	LEVEL 2

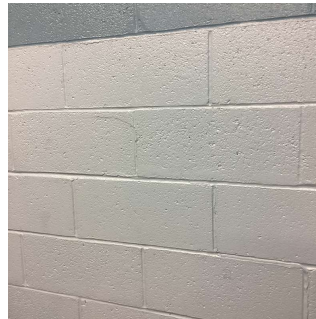
Instance on 1st Floor - Room 3 (72 Lockers)	Inspected
Condition	2 - Between Good and Fair
Deficiency	MASONRY: CRACKS/SPALLING
Deficiency Location/Instance	Right Side
Deficiency Quantity	10
Quantity Uom	S.F.
Potential Action	REPLACE
Urgency of Action	PRIORITY 3
Purpose of Action	LEVEL 2
Deficiency Photo1

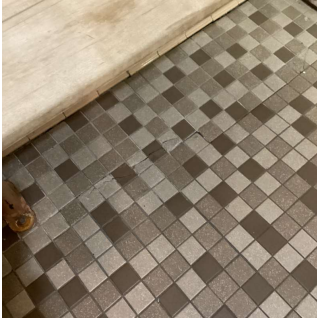
Question	Response
<b>INTERIOR</b>	
<b>SHOWER ROOM</b>	
<b>Floor Finish</b>	
Instance on 1st Floor - Room 2	Inspected
Condition	3 - Fair
Deficiency	CERAMIC TILE: BROKEN/MISSING TILES
Deficiency Location/Instance	Near Entrance
Deficiency Quantity	10
Quantity Uom	S.F.
Potential Action	REPLACE
Urgency of Action	PRIORITY 3
Purpose of Action	LEVEL 2
Deficiency Photo1

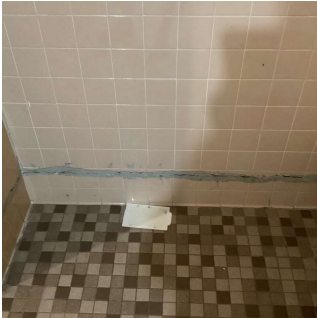
Violations	Near Entrance No violations recorded.
<b>Walls</b>	
Instance on 1st Floor - Room 2	Inspected
Condition	3 - Fair
Deficiency	CERAMIC TILE: BROKEN/ MISSING
Deficiency Location/Instance	Perimeter
Deficiency Quantity	30
Quantity Uom	S.F.
Potential Action	REPLACE
Urgency of Action	PRIORITY 3
Purpose of Action	LEVEL 2
Deficiency Photo1

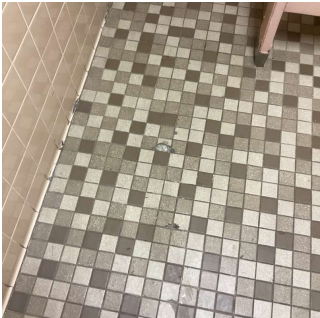
Ladies Restroom
Violations	No violations recorded.
<b>TOILET ROOMS - STUDENTS</b>	
	Inspected
<b>Ceiling</b>	Does not Exist
<b>Door(s)</b>	Does not Exist
<b>Floor Finish</b>	Inspected
Condition	2 - Between Good and Fair
Deficiency	CERAMIC TILE: BROKEN/MISSING TILES
Deficiency Location/Instance	Inside Locker Room 1
Deficiency Quantity	10
Quantity Uom	S.F.
Potential Action	REPLACE
Urgency of Action	PRIORITY 3
Purpose of Action	LEVEL 2
Deficiency Photo1

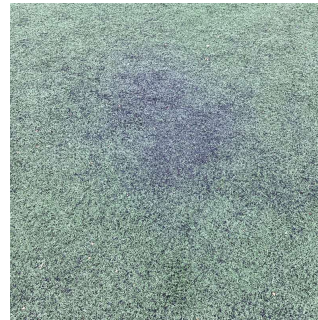
Question	Response
<b>INTERIOR</b>	
<b>TOILET ROOMS - STUDENTS</b>	
<b>Stalls</b>	
Purpose of Action	LEVEL 2
Deficiency Photo1	 
Violations	Inside Locker Room 1 No violations recorded.
<b>Walls</b>	
Condition	Inspected 2 - Between Good and Fair
Deficiency	CERAMIC TILE: BROKEN/ MISSING
Deficiency Location/Instance	Inside Locker Room 4
Deficiency Quantity	20
Quantity Uom	S.F.
Potential Action	REPLACE
Urgency of Action	PRIORITY 3
Purpose of Action	LEVEL 2
Deficiency Photo1	 
Violations	Inside Locker Room 4 No violations recorded.
<b>ATHLETIC FIELDS</b>	
<b>PLAYING SURFACE</b>	
Synthetic Turf Field exists?	Inspected Yes
Year of Installation	2005
Replacement Quantity	215,000
Replacement Uom	S.F.
Instance on Baseball Field	Inspected
Instance Condition	4 - Between Fair and Poor
Instance Quantity	87,000
Instance Quantity Uom	S.F.
Deficiency	ARTIFICIAL TURF: DAMAGED/WORN OUT
Deficiency Location/Instance	Baseball Field

1,000  
 S.F.  
 REPLACE  
 PRIORITY 4  
 LEVEL 2

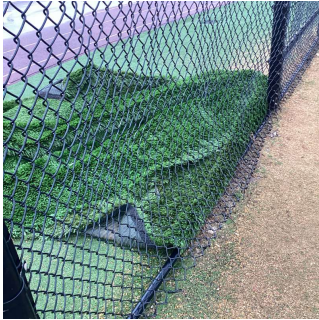
<b>Culverts - Asphalt Covering</b>	Does not Exist
<b>Drainage System for Concrete</b>	Does not Exist
<b>Drainage System for Soil</b>	Does not Exist
<b>DRINKING FOUNTAINS</b>	Inspected
Condition	1 - Good
Deficiency	No deficiencies recorded
<b>FENCES</b>	Inspected
Condition	3 - Fair
Deficiency	CHAIN LINK: DAMAGED/DETERIORATED
Deficiency Location/Instance	Near Baseball Field
Deficiency Quantity	200
Quantity Uom	S.F.
Potential Action	REPLACE
Urgency of Action	PRIORITY 3
Purpose of Action	LEVEL 2

Violations	Near Baseball Field No violations recorded.
<b>IRRIGATION SYSTEM</b>	Does not Exist
<b>PAVING</b>	Inspected
<b>Student Non-Use</b>	Inspected
Gravel Exists?	No
<b>Asphalt</b>	Inspected
Condition	2 - Between Good and Fair
Deficiency	No deficiencies recorded
<b>Concrete</b>	Does not Exist
<b>Pavers</b>	Does not Exist
<b>Student Use</b>	Inspected
Gravel Exists?	No
<b>Asphalt</b>	Inspected
Condition	3 - Fair
Deficiency	CRACKS - MAJOR
Deficiency Location/Instance	Near Track, Basement Field
Deficiency Quantity	350
Quantity Uom	S.F.
Potential Action	REPLACE
Urgency of Action	PRIORITY 3
Purpose of Action	LEVEL 2
Deficiency Photo1

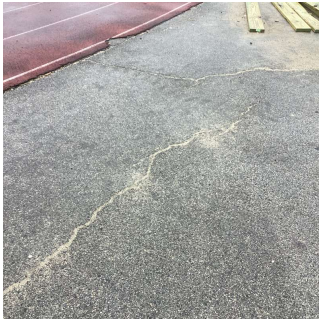
Violations	Near Track No violations recorded.
<b>Concrete</b>	Inspected
Condition	2 - Between Good and Fair
Deficiency	No deficiencies recorded
<b>Pavers</b>	Does not Exist
<b>Site Sidewalks &amp; Walkways</b>	Inspected

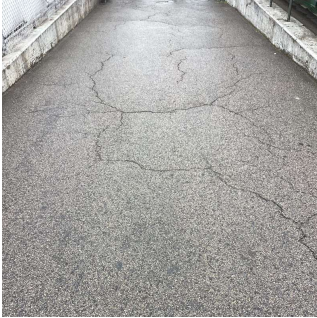
Question	Response
<b>SITE</b>	
<b>PAVING</b>	
<b>Site Sidewalks &amp; Walkways</b>	
<b>Asphalt</b>	Inspected
Condition	4 - Between Fair and Poor
Deficiency	CRACKS - MAJOR
Deficiency Location/Instance	Near Entrance, Near Field house
Deficiency Quantity	600
Quantity Uom	S.F.
Potential Action	REPLACE
Urgency of Action	PRIORITY 3
Purpose of Action	LEVEL 2
Deficiency Photo1

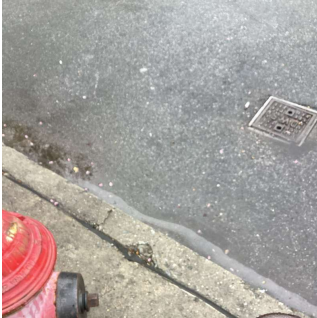
Near Entrance, Near Field house
Violations	No violations recorded.
<b>Concrete</b>	Inspected
Condition	2 - Between Good and Fair
Deficiency	No deficiencies recorded
<b>Pavers</b>	Does not Exist
<b>DOT Sidewalk</b>	Inspected
<b>Asphalt</b>	Does not Exist
<b>Concrete</b>	Inspected
Condition	4 - Between Fair and Poor
Deficiency	DAMAGED CURBS
Deficiency Location/Instance	Maple Street, Troy Avenue, Rutland Road, Schenectady Avenue
Deficiency Quantity	100
Quantity Uom	L.F.
Potential Action	REPLACE
Urgency of Action	PRIORITY 3
Purpose of Action	LEVEL 2
Deficiency Photo1

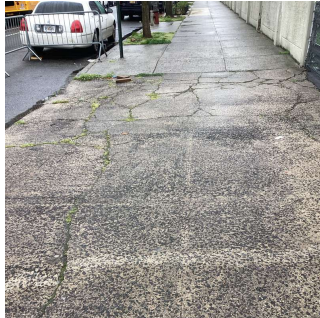
Question	Response
<b>SITE</b>	
<b>PAVING</b>	
<b>DOT Sidewalk</b>	
<b>Concrete</b>	
Deficiency Location/Instance	Maple Street, Troy Avenue, Rutland Road, Schenectady Avenue
Deficiency Quantity	500
Quantity Uom	S.F.
Potential Action	REPLACE
Urgency of Action	PRIORITY 3
Purpose of Action	LEVEL 2
Deficiency Photo1

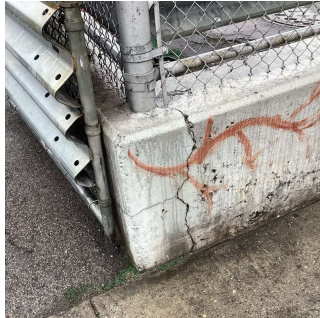
Violations	Maple Street No violations recorded.
<b>Pavers</b>	Does not Exist
<b>PLAYGROUNDS</b>	Does not Exist
<b>RETAINING WALLS</b>	Inspected
Are there any Retaining Walls 6' OR higher facing public street/sidewalk?	No
Condition	3 - Fair
Deficiency	CAST IN PLACE CONCRETE: CRACKS/SPALLING - MAJOR
Deficiency Location/Instance	Rutland Road, Troy Avenue
Deficiency Quantity	230
Quantity Uom	S.F.
Potential Action	REPLACE
Urgency of Action	PRIORITY 3
Purpose of Action	LEVEL 2
Deficiency Photo1

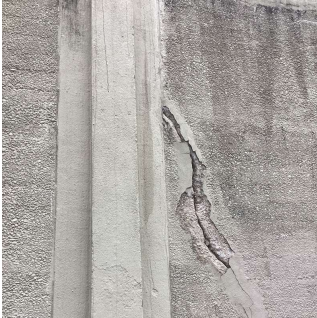
Condition	5 - Poor
Deficiency	CAST IN PLACE CONCRETE: CRACKS/SPALLING - MAJOR
Deficiency Location/Instance	Maple Street, Troy Avenue, Rutland Road, Schenectady Avenue

Question	Response
<b>SITE</b>	
<b>SITE WALLS (NOT RETAINING WALLS)</b>	
Deficiency Quantity	3,000
Quantity Uom	S.F.
Potential Action	REPLACE
Urgency of Action	PRIORITY 4
Purpose of Action	LEVEL 4
Deficiency Photo1

Violations	Maple Street 35655400Y, 35675030Y
<b>STAIRS/RAMPS: EXTERIOR</b>	Inspected
<b>Railings</b>	Does not Exist
<b>Site Cheek/flank Walls</b>	Inspected
Condition	2 - Between Good and Fair
Deficiency	No deficiencies recorded
<b>Stairs/ramps</b>	Inspected
Condition	2 - Between Good and Fair
Deficiency	No deficiencies recorded
<b>ARTWORK</b>	Does not Exist
