**NYC Department of Education**  
**Building Condition Assessment Survey 2023 - 2024**

Architectural Inspection

**K458**

**Asset:**        **BOYS HS (OLD) - K, 832 MARCY AVENUE, New York, 11216**

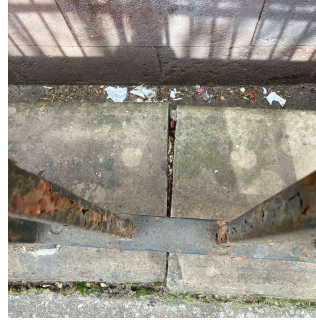
AW1

**AREAWAY WALLS: CRACKS AND SPALLING**

REPLACE

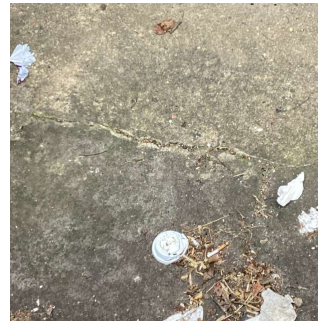
AW1  
No violations recorded.

**AREAWAY SLAB: CRACKS AND SPALLING**

40  
S.F.  
REPLACE  
PRIORITY 4  
LEVEL 2

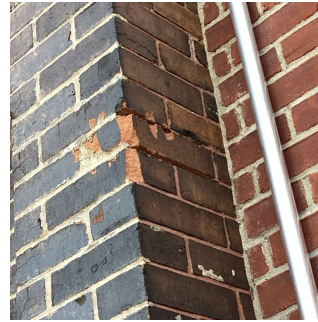
CHI

BRICK: DETERIORATED JOINTS

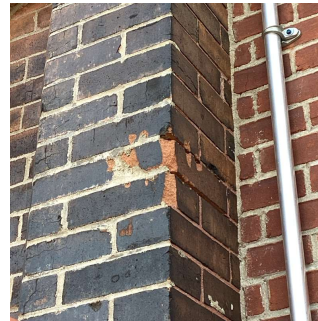
CHI

**BRICK: MINOR CRACKS AND SPALLING**

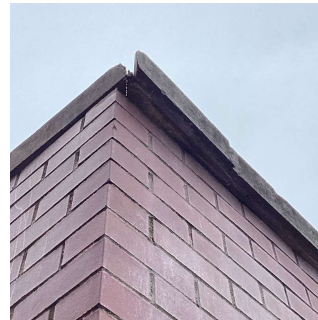
Plaza Deck - BH3  
No violations recorded.

CAST STONE: CRACKED/BROKEN PIECES

10  
L.F.  
REPLACE-IN-KIND  
PRIORITY 5  
LEVEL 6

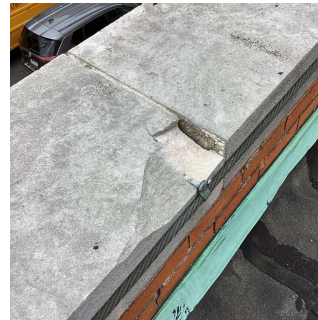
Roof 9

**CAST STONE: CRACKED/BROKEN PIECES**

REPLACE-IN-KIND

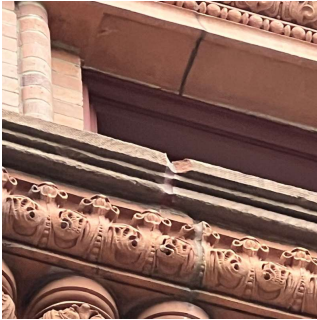
Question	Response
<b>EXTERIOR</b>	
<b>CORNICE</b>	
Deficiency Photo1

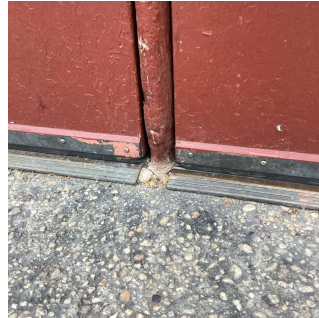
Violations	Facade G No violations recorded.
Deficiency	WOOD: DETERIORATED DOOR AND FRAME - MAJOR DETERIORATION

Deficiency Quantity	4
Quantity Uom	EACH
Potential Action	REPLACE
Urgency of Action	PRIORITY 4
Purpose of Action	LEVEL 2
Deficiency Photo1

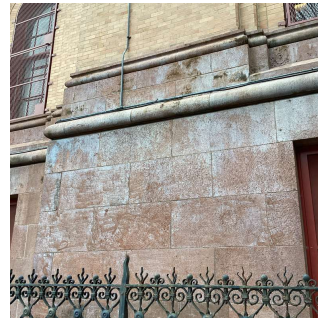
Facade F

Violations	Facade L No violations recorded.
<b>DOOR HARDWARE</b>	Inspected
Condition	3 - Fair
Deficiency	No deficiencies recorded
<b>LINTELS</b>	Inspected
Condition	2 - Between Good and Fair
Deficiency	No deficiencies recorded
<b>TRANSOM/SIDE LIGHT</b>	Inspected
Condition	2 - Between Good and Fair
Deficiency	No deficiencies recorded
<b>EXTERIOR WALLS</b>	Inspected
Material Type(s)	Concrete, Masonry
Replacement Quantity	39,000
Replacement Uom	S.F.
Instance on All Facades	Inspected
Instance Condition	4 - Between Fair and Poor
Instance Quantity	39,000
Instance Quantity Uom	S.F.
Deficiency	STONE: EFFLORESCENCE

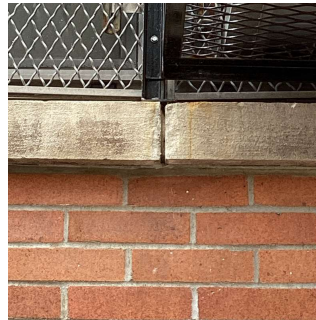
Facade G

**BRICK: MASONRY SILLS - DETERIORATED JOINTS**

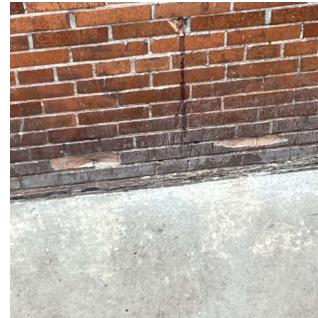
Facade G

**BRICK: MAJOR / THRU CRACKS**

PRIORITY 4  
LEVEL 2

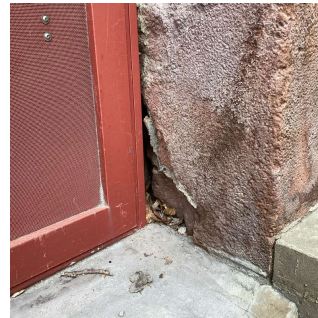
Facade E

**STONE: CHIPPED/SPALLED/BROKEN PIECES - MAJOR**

REPLACE

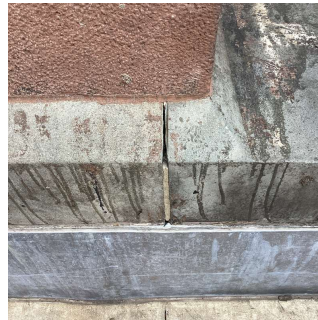
Facade G

**STONE: DETERIORATED JOINTS**

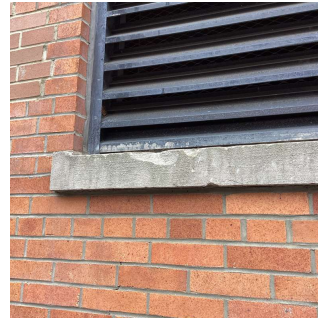
Facade J

**BRICK: DETERIORATED MASONRY SILLS - MAJOR**

REMOVE AND REPLACE

PRIORITY 4  
LEVEL 2

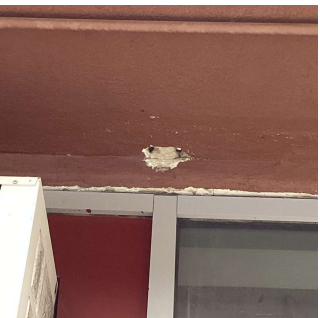
Question	Response
<b>EXTERIOR</b>	
<b>EXTERIOR WALLS</b>	Inspected
	Facade A - Room 402 (Facade A - Room 402A, Facade F - Stair F/2, Facade K - Room 413B, Facade L - Room 310, Facades A & L - Room 500 similar)
Violations	No violations recorded.
<b>EXTERIOR SOFFITS</b>	Inspected
Condition	3 - Fair
Deficiency	<b>STUCCO/PLASTER: MAJOR CRACKS/SPALLING</b>
Roof Plan reference

Deficiency Quantity	10
Quantity Uom	S.F.
Potential Action	REPLACE
Urgency of Action	PRIORITY 4
Purpose of Action	LEVEL 2
Deficiency Photo1

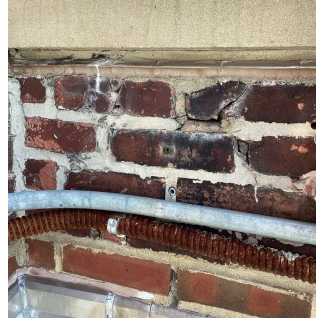
Roof 7

**BRICK: MAJOR DETERIORATION/CRACKS**

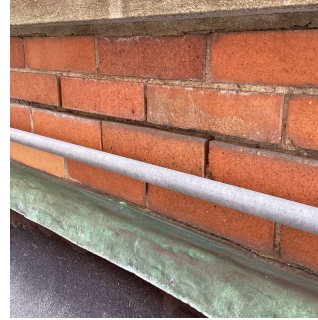
Roof 9

**BRICK: DETERIORATED JOINTS**

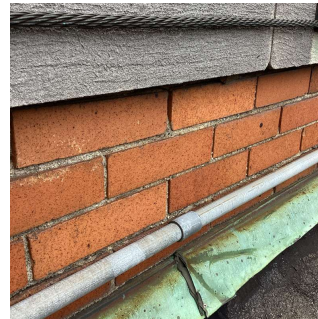
Roof 9

**BRICK: DETERIORATED JOINTS**

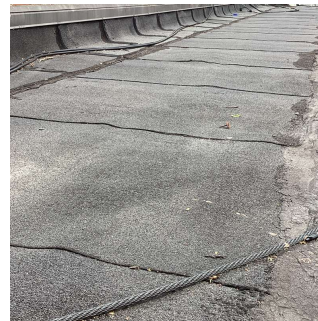
Roof 9
Violations	No violations recorded.
Deficiency	MODIFIED BITUMEN: ROOFING: DELAMINATION

REPLACE ROOFING WITHOUT MAJOR EQUIPMENT REMOVAL

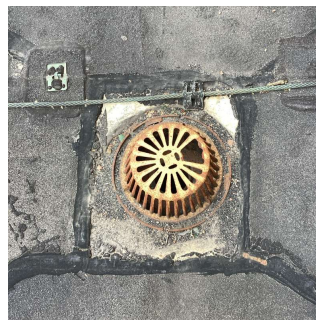
Roof 9

DETERIORATED

1  
EACH  
REPLACE  
PRIORITY 4  
LEVEL 2

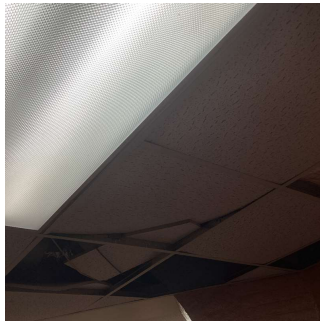
Question	Response
<b>INTERIOR</b>	
<b>CAFETERIA</b>	
<b>Walls</b>	
Deficiency Photo1	 
	Left Side Column
Violations	No violations recorded.
<b>Window Curtains/Shades/Blinds</b>	
Instance on Basement	Does not Exist
<b>CLASSROOMS/CORRIDORS/ADMIN SPACES</b>	
<b>Ceiling</b>	Inspected
Condition	2 - Between Good and Fair
Deficiency	ACOUSTIC TILES: DAMAGED/MISSING
Deficiency Location/Instance	Room B-3
Deficiency Quantity	20
Quantity Uom	S.F.
Potential Action	REPLACE
Urgency of Action	PRIORITY 3
Purpose of Action	LEVEL 2
Deficiency Photo1

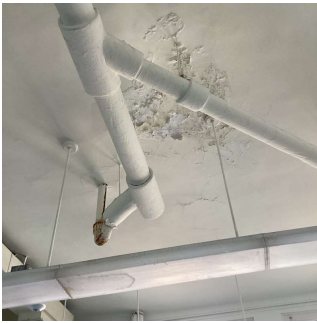
Question	Response
<b>INTERIOR</b>	
<b>CLASSROOMS/CORRIDORS/ADMIN SPACES</b>	
<b>Ceiling</b>	
Deficiency Photo1

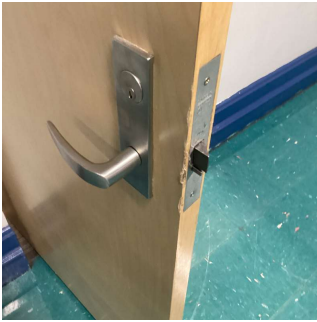
Room 421
Violations	No violations recorded.
<b>Door(s)</b>	Inspected
Condition	3 - Fair
Deficiency	WOOD: DETERIORATED DOOR
Deficiency Location/Instance	Room 102, Vestibule Doors (2 Doors)
Deficiency Quantity	3
Quantity Uom	EACH
Potential Action	MAINTENANCE
Urgency of Action	PRIORITY 3
Purpose of Action	LEVEL 2
Deficiency Photo1

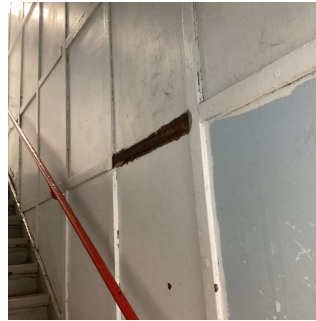
Condition	Inspected
Deficiency	3 - Fair
Deficiency	METAL FRAME: DAMAGED/DETERIORATED
Deficiency Location/Instance	Stair G/2
Deficiency Quantity	10
Quantity Uom	L.F.
Potential Action	REPLACE
Urgency of Action	PRIORITY 3
Purpose of Action	LEVEL 2

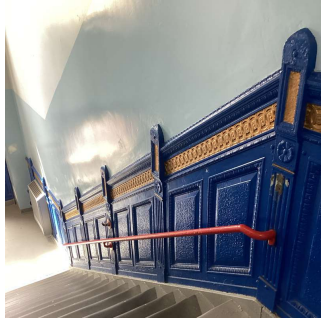
Question	Response
<b>INTERIOR</b>	
<b>STAIRS/RAMPS: INTERIOR</b>	
<b>Railings</b>	Inspected
Condition	4 - Between Fair and Poor
Deficiency	METAL: MISSING
Deficiency Location/Instance	Stair C/3
Deficiency Quantity	20
Quantity Uom	L.F.
Potential Action	REPLACE
Urgency of Action	PRIORITY 5
Purpose of Action	LEVEL 6
Deficiency Photo1

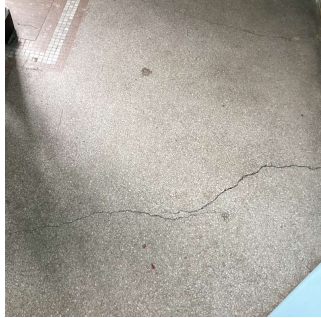
Violations	Stair C/3 No violations recorded.
<b>Stairs and Landings</b>	Inspected
Condition	3 - Fair
Deficiency	TERRAZZO: CRACKS
Deficiency Location/Instance	Stairs E/2, F/2
Deficiency Quantity	50
Quantity Uom	S.F.
Potential Action	REPLACE
Urgency of Action	PRIORITY 3
Purpose of Action	LEVEL 2
Deficiency Photo1

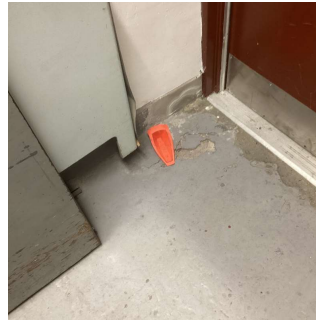
Stair M/Cellar

Violations	Stair E/2 No violations recorded.
Deficiency	CONCRETE: CRACKS/SPALLING - MAJOR
Deficiency Location/Instance	Stair M/Cellar, Stairs A/4,3,2
Deficiency Quantity	60
Quantity Uom	S.F.
Potential Action	REPLACE
Urgency of Action	PRIORITY 3
Purpose of Action	LEVEL 2
