**NYC Department of Education
Building Condition Assessment Survey 2023 - 2024**

Architectural Inspection

K462

Asset: 3K CENTER @ 4822 NEW UTRECHT AVENUE - BROOKLYN, 4822 NEW UTRECHT AVENUE, 11219

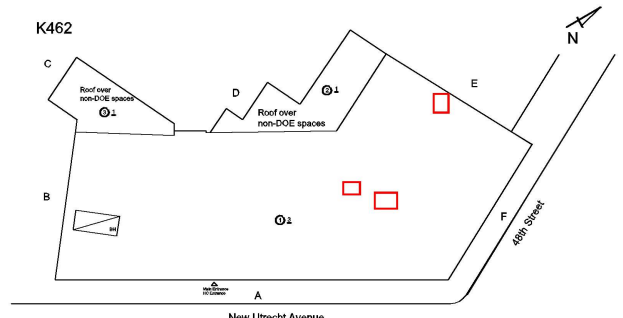
Source of Installation	Custodial Staff
Deficiency	SINGLE PLY, FULLY ADHERED ROOF: ROOFING: MAJOR ACTIVE ROOF LEAKS IN INSTRUCTIONAL SPACE
Roof Plan reference

Question	Response
EXTERIOR	
ROOF	Inspected
Roofing	
ROOFING	
Deficiency Photo1	 
Violations	Roof 1 - Corridor near Room 316 (Roof 1 - Corridor near Room 314, Stairwell E/3 similar) No violations recorded.
ROOFING DRAINS	Inspected
Condition	4 - Between Fair and Poor
Deficiency	DETERIORATED
Roof Plan reference	 
Deficiency Quantity	2
Quantity Uom	EACH
Potential Action	REPLACE
Urgency of Action	PRIORITY 4
Purpose of Action	LEVEL 2
Deficiency Photo1	 
Violations	Roof 1 No violations recorded.
Specialties	Inspected
BULKHEAD/PENTHOUSE	Inspected
Condition	3 - Fair
Deficiency	BULKHEAD/PENTHOUSE WALLS/INTERIOR: CMU CRACKS/SPALLING

Deficiency Quantity	300
Quantity Uom	S.F.
Potential Action	REPLACE ROOFING WITHOUT MAJOR EQUIPMENT REMOVAL
Urgency of Action	PRIORITY 5
Purpose of Action	LEVEL 2

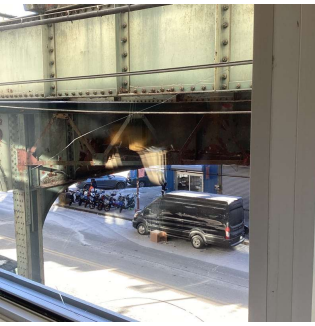
Question	Response
EXTERIOR	
WINDOWS	
WINDOWS	
Instance Quantity Uom	S.F.
Are these windows insulated	Yes
Installation Year	2016
Source of Installation	Custodial Staff
Deficiency	ALUMINUM - OTHER: AIR/WATER INFILTRATION, DETERIORATED JOINTS WITH DAMAGED CAULKING
Roof Plan reference	 
Elevation	 
Deficiency Quantity	150
Quantity Uom	L.F.
Potential Action	MAINTENANCE
Urgency of Action	PRIORITY 3
Purpose of Action	LEVEL 2
Deficiency Photo1	 
Violations	Facade A - Room 219 (Facade A - Room 219A similar) No violations recorded.
Deficiency	ALUMINUM - OTHER: BROKEN PANE

Violations	<p>Facade A - Room 209 (Facade A - Rooms 211, 309, 309A similar) No violations recorded.</p>
INTERIOR	Inspected
POOLS	Does not Exist
STRUCTURAL	Inspected
COLUMNS/BEAMS/BEARING WALLS	Inspected
Condition	2 - Between Good and Fair
Deficiency	No deficiencies recorded
FLOOR STRUCTURE	Inspected
Condition	2 - Between Good and Fair
Deficiency	No deficiencies recorded
FOUNDATION WALLS	Inspected
Material Type(s)	Concrete
Condition	2 - Between Good and Fair

Deficiency Quantity	150
Quantity Uom	S.F.
Potential Action	MAINTENANCE
Urgency of Action	PRIORITY 3
Purpose of Action	LEVEL 2
Deficiency Photo1

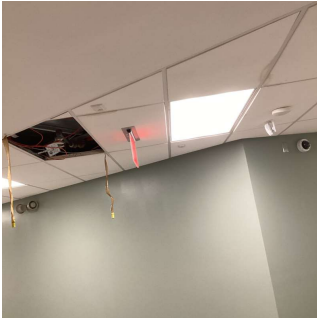
Violations	Corridor near room 314, 316 No violations recorded.
Door(s)	Inspected
Condition	1 - Good
Deficiency	No deficiencies recorded
Floor Finish	Inspected
Condition	1 - Good
Deficiency	No deficiencies recorded
Walls	Inspected
Condition	1 - Good
Deficiency	No deficiencies recorded
Specialties	Does not Exist

Question	Response
INTERIOR	
STRUCTURAL	
FOUNDATION WALLS	Inspected
Deficiency	No deficiencies recorded
ROOF STRUCTURE	Inspected
Condition	2 - Between Good and Fair
Deficiency	No deficiencies recorded
VAULTS-BUNKERS	Does not Exist
AUDITORIUM	Does not Exist
CAFETERIA	Does not Exist
CLASSROOMS/CORRIDORS/ADMIN SPACES	Inspected
Ceiling	Inspected
Condition	2 - Between Good and Fair
Deficiency	ACOUSTIC TILES: DAMAGED/MISSING - ACTIVE LEAK
Deficiency Location/Instance	Corridor near room 314, 316
Deficiency Quantity	20
Quantity Uom	S.F.
Potential Action	REPLACE
Urgency of Action	PRIORITY 5
Purpose of Action	LEVEL 2
Deficiency Photo1
