NYC Department of Education
Building Condition Assessment Survey 2023 - 2024

Architectural Inspection

K469

Asset: 3K CENTER @ 1070 FLATBUSH AVENUE - BROOKLYN, 1070 FLATBUSH AVENUE, 11226

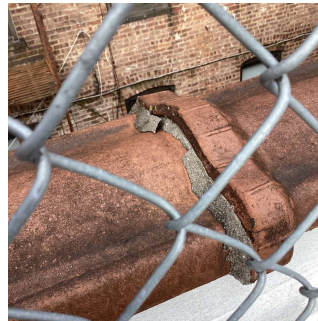
Facade C

Question	Response
Architectural	
EXTERIOR	Inspected
AREAWAY	Does not Exist
AWNINGS AND CANOPIES	Does not Exist
CHIMNEY	Inspected
Material Type(s)	Masonry
Condition	2 - Between Good and Fair
Deficiency	No deficiencies recorded
COPING	Inspected
Condition	3 - Fair
Deficiency	TERRA COTTA: DETERIORATED TRANSVERSE JOINTS

10
L.F.
MAINTENANCE
PRIORITY 3
LEVEL 2

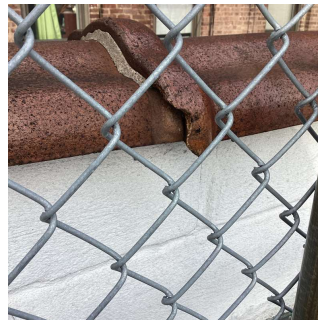
Facade C

TERRA COTTA: CRACKED/BROKEN PIECES

10
L.F.
REPLACE-IN-KIND
PRIORITY 4
LEVEL 2

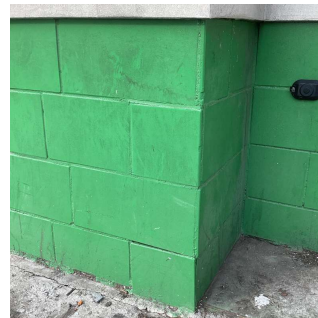
Facade A

CONCRETE MASONRY UNIT: DETERIORATED JOINTS

REPOINT

PRIORITY 3

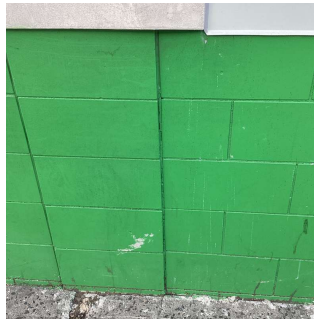
Facade A

CONCRETE MASONRY UNIT: DETERIORATED CONTROL/EXPANSION JOINTS

MAINTENANCE

PRIORITY 3

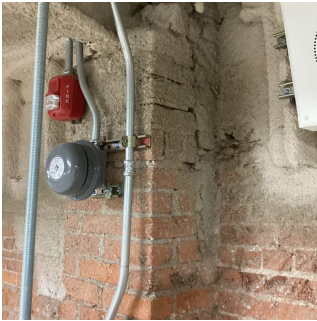
Question	Response
INTERIOR	
STRUCTURAL	
COLUMNS/BEAMS/BEARING WALLS	
Deficiency	STEEL COLUMNS/BEAMS: DETERIORATED MASONRY FIREPROOFING
Deficiency Location/Instance	Basement - West side
Deficiency Quantity	20
Quantity Uom	S.F.
Potential Action	REPLACE
Urgency of Action	PRIORITY 4
Purpose of Action	LEVEL 5
Deficiency Photo1

Basement - West side
Violations	No violations recorded.
FLOOR STRUCTURE	
Condition	Inspected
	3 - Fair
Deficiency	CONCRETE SLAB ON GRADE: THRU CRACKS
Deficiency Location/Instance	Basement - Electrical Room C01A, Near Stair A
Deficiency Quantity	50
Quantity Uom	S.F.
Potential Action	REPAIR
Urgency of Action	PRIORITY 3
Purpose of Action	LEVEL 5
Deficiency Photo1

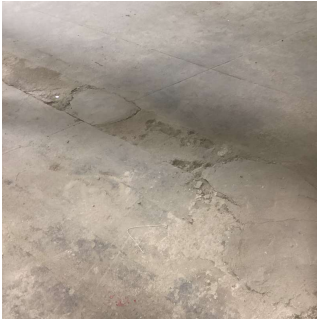
Basement - Near Stair A
Violations	No violations recorded.
Deficiency	CONCRETE SLAB ON GRADE: THRU CRACKS
Deficiency Location/Instance	Basement - Near Stair B
Deficiency Quantity	50
Quantity Uom	S.F.
Potential Action	REPLACE
Urgency of Action	PRIORITY 4

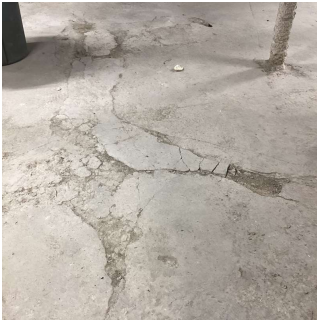
Basement - Near Stair B
Violations	No violations recorded.
FOUNDATION WALLS	
Material Type(s)	Inspected Masonry
Condition	3 - Fair
Deficiency	BRICK: CRACKED/SPALLED
Deficiency Location/Instance	Basement - East side
Deficiency Quantity	20
Quantity Uom	S.F.
Potential Action	RESTITCH
Urgency of Action	PRIORITY 3
Purpose of Action	LEVEL 5
Deficiency Photo1

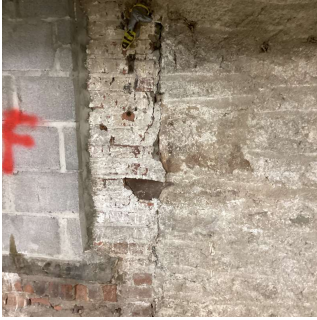
Basement - East side
Violations	No violations recorded.
Deficiency	BRICK: CRACKED/SPALLED
Deficiency Location/Instance	Basement - West side
Deficiency Quantity	10
Quantity Uom	S.F.
Potential Action	RESTITCH
Urgency of Action	PRIORITY 4
Purpose of Action	LEVEL 5

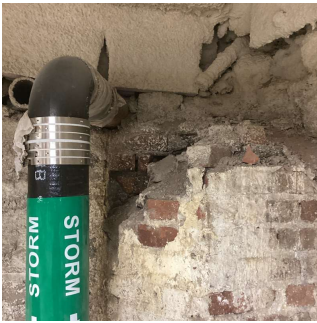
Violations	Basement - West side No violations recorded.
ROOF STRUCTURE	Inspected
Condition	2 - Between Good and Fair
Deficiency	No deficiencies recorded
VAULTS-BUNKERS	Inspected
Foundation Walls	Inaccessible
Slab Structure	Inaccessible
Vault/Ash Hoist Doors and Framing	Inspected
Condition	3 - Fair
Deficiency	NOT IN USE / DETERIORATED
Deficiency Location/Instance	Facade A
Deficiency Quantity	4
Quantity Uom	EACH
Potential Action	REMOVE AND SEAL
Urgency of Action	PRIORITY 3
Purpose of Action	LEVEL 2
Deficiency Photo1

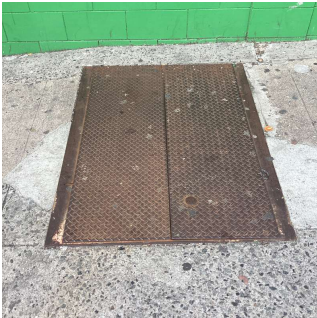
Violations	Facade A No violations recorded.
AUDITORIUM	Does not Exist
CAFETERIA	Does not Exist
CLASSROOMS/CORRIDORS/ADMIN SPACES	Inspected
Ceiling	Inspected
Condition	1 - Good
Deficiency	No deficiencies recorded
Door(s)	Inspected
Condition	1 - Good
Deficiency	No deficiencies recorded

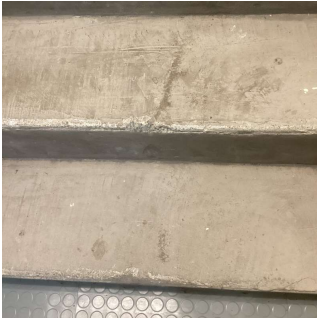
Question	Response
INTERIOR	
STAIRS/RAMPS: INTERIOR	
Stairs and Landings	
Deficiency	CONCRETE: WORN-OUT TREAD/NOSINGS
Deficiency Location/Instance	Cortelyou Road Exit
Deficiency Quantity	20
Quantity Uom	S.F.
Potential Action	REPLACE
Urgency of Action	PRIORITY 3
Purpose of Action	LEVEL 2
Deficiency Photo1

Violations	Cortelyou Road Exit No violations recorded.
Walls	Does not Exist
TOILET ROOMS - STAFF	
Ceiling	Inspected
Condition	1 - Good
Deficiency	No deficiencies recorded
Door(s)	Inspected
Condition	1 - Good
Deficiency	No deficiencies recorded
Floor Finish	Inspected
Condition	1 - Good
Deficiency	No deficiencies recorded
Stalls	Does not Exist
Walls	Inspected
Condition	1 - Good
Deficiency	No deficiencies recorded
TOILET ROOMS - STUDENTS	
Ceiling	Inspected
Condition	1 - Good
Deficiency	No deficiencies recorded
Door(s)	Inspected
Condition	1 - Good
Deficiency	No deficiencies recorded
Floor Finish	Inspected
Condition	1 - Good

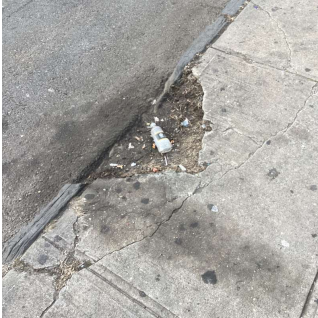
Question	Response
LIFE SAFETY	Inspected
F.D. HOLDING AREA	Does not Exist
STEEL STAIRS	Does not Exist
SITE	Inspected
CONTAINERIZATION	Does not Exist
Drainage System for Asphalt	Does not Exist
Drainage System for Concrete	Does not Exist
Drainage System for Soil	Does not Exist
DRINKING FOUNTAINS	Does not Exist
FENCES	Does not Exist
IRRIGATION SYSTEM	Does not Exist
PAVING	Inspected
Student Non-Use	Does not Exist
Student Use	Does not Exist
Site Sidewalks & Walkways	Inspected
Asphalt	Does not Exist
Concrete	Inspected
Condition	2 - Between Good and Fair
Deficiency	No deficiencies recorded
Pavers	Does not Exist
DOT Sidewalk	Inspected
Asphalt	Does not Exist
Concrete	Inspected
Condition	4 - Between Fair and Poor
Deficiency	DAMAGED/DETERIORATED/MISSING SECTIONS
Deficiency Location/Instance	Cortelyou Road
Deficiency Quantity	25
Quantity Uom	S.F.
Potential Action	REPLACE
Urgency of Action	PRIORITY 5
Purpose of Action	LEVEL 6
Deficiency Photo1

Cortelyou Road
Violations	No violations recorded.
Deficiency	DAMAGED CURBS
Deficiency Location/Instance	Flatbush Avenue, Cortelyou Road
Deficiency Quantity	100
Quantity Uom	L.F.
Potential Action	REPLACE
Urgency of Action	PRIORITY 3

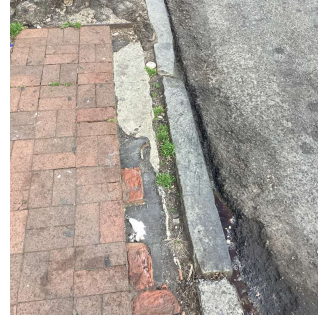
Yes	Tripping Hazard	Broken DOT sidewalk creates a potential hazardous condition.	SITE PAVING DOT Sidewalk Concrete	Flatbush Avenue	Enjoy Vega	Custodian

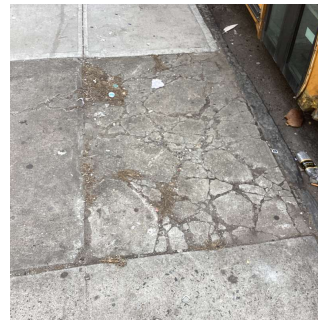
DAMAGED/DETERIORATED/MISSING SECTIONS

Flatbush Avenue, Cortelyou Road

REPLACE

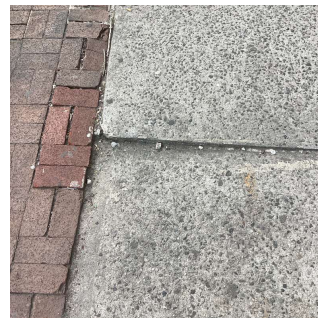
HEAVING

Flatbush Avenue

REPLACE

Question	Response
SITE	
PAVING	
DOT Sidewalk	
Concrete	Inspected
	Flatbush Avenue
Violations	No violations recorded.
Pavers	Inspected
Condition	3 - Fair
Deficiency	DAMAGED/MISSING
Deficiency Location/Instance	Flatbush Avenue
Deficiency Quantity	100
Quantity Uom	S.F.
Potential Action	REPLACE
Urgency of Action	PRIORITY 5
Purpose of Action	LEVEL 6
Deficiency Photo1	 
Violations	Flatbush Avenue No violations recorded.
Deficiency	DAMAGED/MISSING
Deficiency Location/Instance	Flatbush Avenue
Deficiency Quantity	300
Quantity Uom	S.F.
Potential Action	REPLACE
Urgency of Action	PRIORITY 3
Purpose of Action	LEVEL 2
Deficiency Photo1	 
Violations	Flatbush Avenue No violations recorded.
PLAYGROUNDS	Does not Exist
PLAYING SURFACE	Does not Exist
RETAINING WALLS	Does not Exist
SEATING	Does not Exist
SITE WALLS (NOT RETAINING WALLS)	Does not Exist
