NYC Department of Education
Building Condition Assessment Survey 2023 - 2024

Architectural Inspection

K477

Asset: P.S. 172 GYM ANNEX - BROOKLYN, 825 4TH AVENUE, 11232

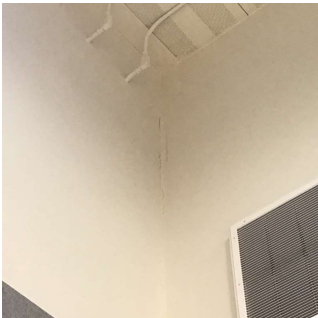
Question	Response
INTERIOR	
GYMNASIUM	
Ceiling	
Instance on 1st Floor	Inspected
Condition	1 - Good
Deficiency	No deficiencies recorded
Door(s)	
Instance on 1st Floor	Inspected
Condition	1 - Good
Deficiency	No deficiencies recorded
Fixed Equipment	
Instance on 1st Floor	Inspected
Condition	1 - Good
Deficiency	No deficiencies recorded
Floor Finish	
Instance on 1st Floor	Inspected
Condition	1 - Good
Deficiency	No deficiencies recorded
Seating	
Instance on 1st Floor	Does not Exist
Sliding-folding Partition	
Instance on 1st Floor	Does not Exist
Stage	
Instance on 1st Floor	Does not Exist
Walls	
Instance on 1st Floor	Inspected
Condition	2 - Between Good and Fair
Deficiency	GYPSUM BOARD: DETERIORATED
Deficiency Location/Instance	Near Office, Near Main Entrance
Deficiency Quantity	20
Quantity Uom	S.F.
Potential Action	REPLACE
Urgency of Action	PRIORITY 3
Purpose of Action	LEVEL 2
Deficiency Photo1
