**NYC Department of Education**  
**Building Condition Assessment Survey 2023 - 2024**

Architectural Inspection

**Asset: BUSHWICK AF - BROOKLYN, 400 IRVING AVENUE, New York, 11237**

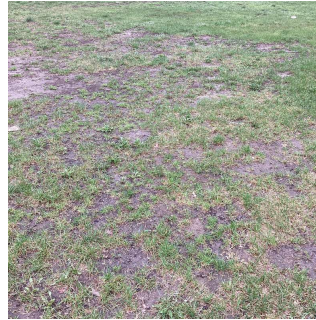
Question	Response
<b>Architectural</b>	
<b>EXTERIOR</b>	Does not Exist
<b>INTERIOR</b>	Does not Exist
<b>ATHLETIC FIELDS</b>	Inspected
<b>PLAYING SURFACE</b>	Inspected
Synthetic Turf Field exists?	No
Replacement Quantity	52,000
Replacement Uom	S.F.
Instance on Softball Field	Inspected
Instance Condition	5 - Poor
Instance Quantity	45,000
Instance Quantity Uom	S.F.
Deficiency	NATURAL TURF: MISSING AREAS
Deficiency Location/Instance	Softball Field

8,000

PRIORITY 4

REPLACE

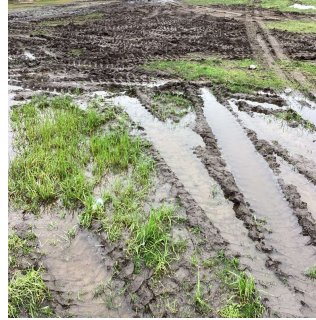
NATURAL TURF: DAMAGED/WORN OUT

Softball Field

4,000

PRIORITY 5

REPLACE

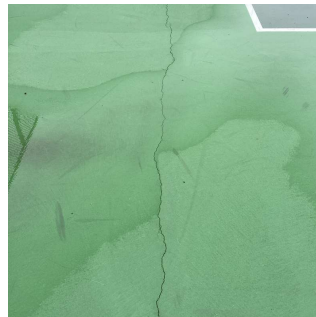
Instance on Tennis Court	Inspected
Instance Condition	3 - Fair
Instance Quantity	7,000
Instance Quantity Uom	S.F.

Deficiency ATHLETIC WEARING SURFACE: DAMAGED/DETERIORATED

Tennis Court

400

PRIORITY 4

REPLACE

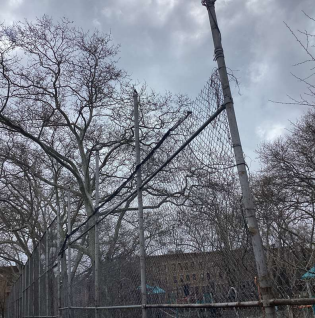
Deficiency Location/Instance	Putnam Avenue
Deficiency Quantity	60
Quantity Uom	S.F.
Potential Action	REPLACE
Urgency of Action	PRIORITY 3
Purpose of Action	LEVEL 2
Deficiency Photo1	 
Violations	Putnam Avenue No violations recorded.
Deficiency	CHAIN LINK: MISSING SECTIONS
Deficiency Location/Instance	Baseball Field
Deficiency Quantity	250
Quantity Uom	S.F.
Potential Action	REPLACE
Urgency of Action	PRIORITY 3
Purpose of Action	LEVEL 2

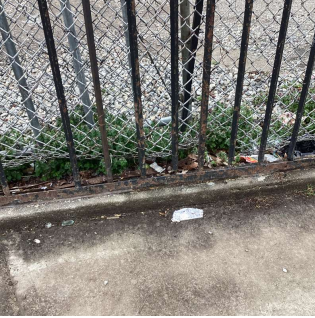
Violations	Baseball Field No violations recorded.
Deficiency	<b>CHAIN LINK: DAMAGED/DETERIORATED</b>
Deficiency Location/Instance	Putnam Avenue
Deficiency Quantity	500
Quantity Uom	S.F.
Potential Action	REPLACE
Urgency of Action	PRIORITY 3
Purpose of Action	LEVEL 2
Deficiency Photo1

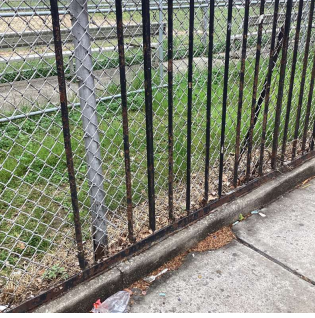
Violations	Putnam Avenue No violations recorded.
Deficiency	<b>WROUGHT IRON: RUST - MAJOR</b>
Deficiency Location/Instance	Putnam Avenue
Deficiency Quantity	1,600
Quantity Uom	S.F.
Potential Action	REPLACE
Urgency of Action	PRIORITY 3
Purpose of Action	LEVEL 2
Deficiency Photo1

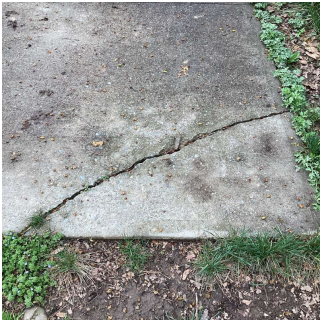
Question	Response
<b>SITE</b>	
<b>IRRIGATION SYSTEM</b>	Does not Exist
<b>PAVING</b>	Inspected
<b>Student Non-Use</b>	Inspected
Gravel Exists?	Yes
<b>Asphalt</b>	Does not Exist
<b>Concrete</b>	Does not Exist
<b>Pavers</b>	Does not Exist
<b>Student Use</b>	Inspected
Gravel Exists?	No
<b>Asphalt</b>	Does not Exist
<b>Concrete</b>	Inspected
Condition	2 - Between Good and Fair
Deficiency	CRACKS - MAJOR
Deficiency Location/Instance	Baseball Field
Deficiency Quantity	25
Quantity Uom	S.F.
Potential Action	REPLACE
Urgency of Action	PRIORITY 3
Purpose of Action	LEVEL 2
Deficiency Photo1
