NYC Department of Education
Building Condition Assessment Survey 2023 - 2024

Architectural Inspection

Asset: **I.S. 187 - BROOKLYN, 1171 65 STREET, New York, 11219**

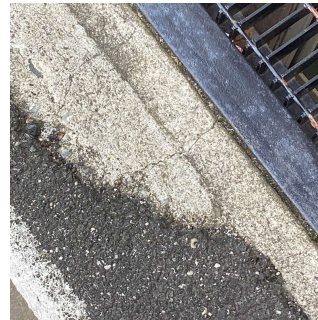
| Question | Response |
|---|---|
| Deficiency | AREAWAY WALLS: CRACKS AND SPALLING |

10
 S.F.
 REPAIR
 PRIORITY 3
 LEVEL 2

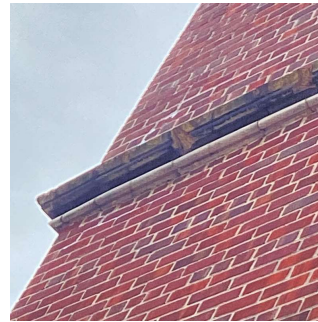
CH
No violations recorded.

STONE/TERRA COTTA BAND: MAJOR DETERIORATION

10
S.F.
REPLACE
PRIORITY 4
LEVEL 2

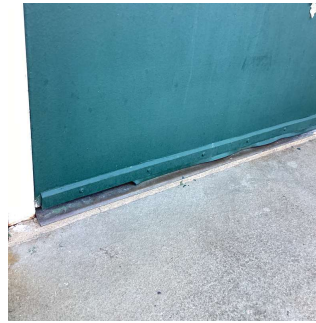
Facade A - Main Entrance

METAL CLAD: DETERIORATED DOOR - MINOR DETERIORATION

MAINTENANCE
 PRIORITY 3
 LEVEL 2

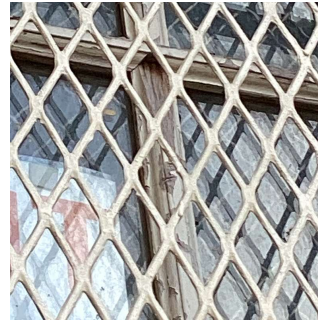
Facade E - Exit 4

WOOD: EXCESSIVELY WEATHERED

REPLACE

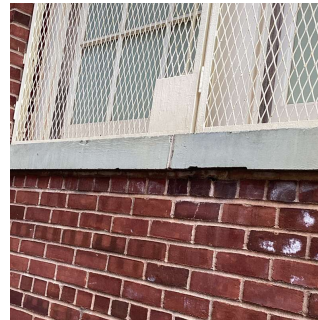
Facade D

BRICK: DETERIORATED MASONRY SILLS - MINOR

REPAIR

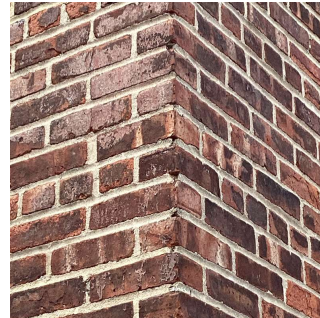
Facade H

BRICK: DETERIORATED JOINTS

PRIORITY 3
LEVEL 2

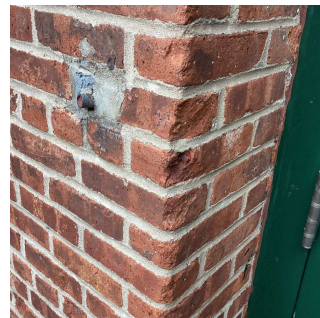
Facade G - Near Exit 8

BRICK: MINOR CRACKS AND SPALLING

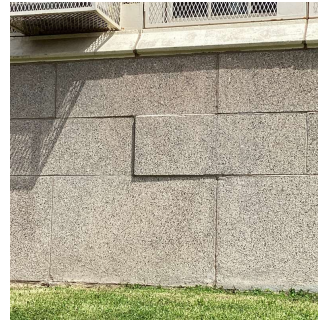
Facade A (Bulging only)

BRICK: WATER INFILTRATION IN INSTRUCTIONAL SPACE

PRIORITY 4
LEVEL 2

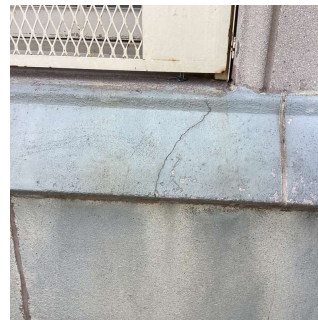
Facade B

STONE: CHIPPED/SPALLED/BROKEN PIECES - MINOR

REPAIR

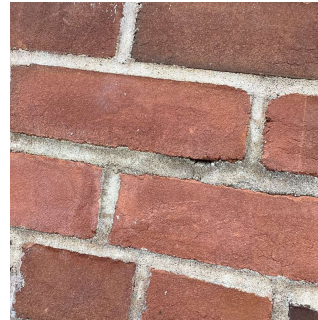
Roof 1 - Facade A

| Question | Response |
|---|--|
| Deficiency | BRICK: DETERIORATED JOINTS |

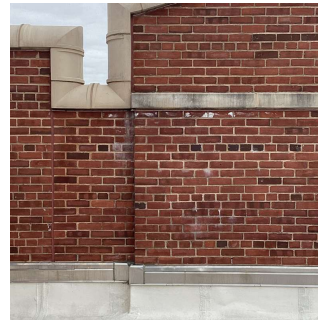
Roof 1 - Facade C
No violations recorded.

100
S.F.
MAINTENANCE
PRIORITY 1
LEVEL 1

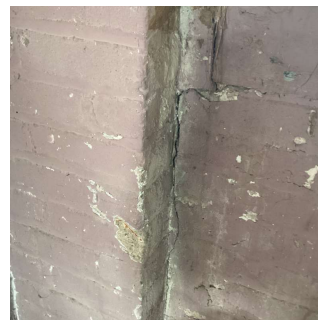
Roof 1 - PH

| Deficiency | BULKHEAD/PENTHOUSE WALLS/INTERIOR: BRICK CRACKS/SPALLING |

10
S.F.
REPLACE
PRIORITY 3
LEVEL 2

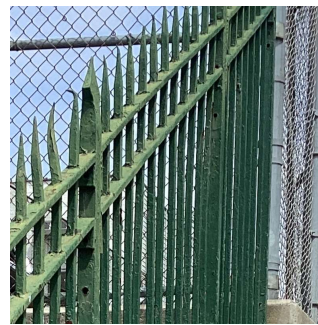
Facade B

| Deficiency | MISSING RAILING |

10
L.F.
REPLACE
PRIORITY 5
LEVEL 6

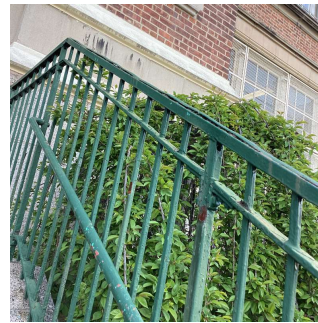
Facade A - Main Entrance

RUST - MAJOR

20
L.F.
REPLACE
PRIORITY 4
LEVEL 2

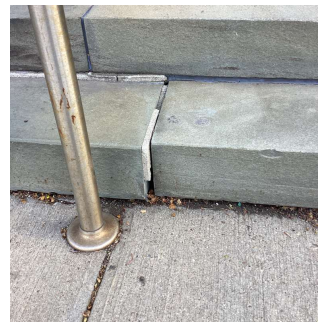
Facade A - Main Entrance

STONE: DETERIORATED JOINTS

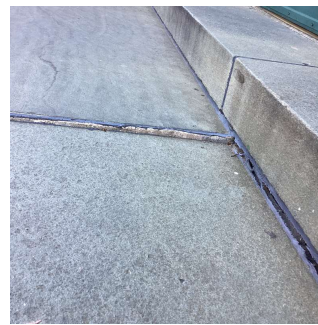
Facade A - Main Entrance
No violations recorded.

STONE: DETERIORATED SUBSTRATE

20
S.F.
REPLACE SUBSTRATE AND RESET
PRIORITY 4
LEVEL 2

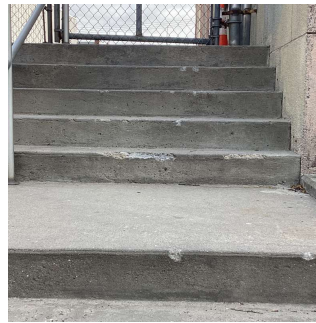
Corner of Facade A and Facade B

CONCRETE: WORN-OUT TREAD/RISER/NOSING

40
S.F.
REPLACE
PRIORITY 4
LEVEL 2

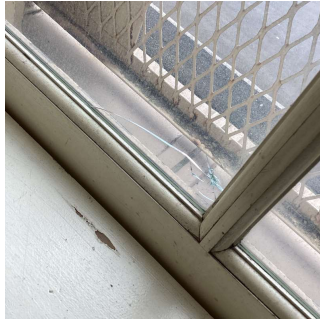
| Question | Response |
|---|--|
| Violations | Facade E - Corridor near the Cafeteria No violations recorded. |

WOOD: BROKEN PANE

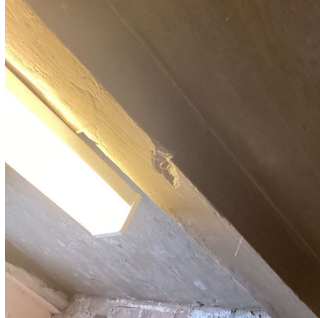
| Question | Response |
|---|--|
| | Roof 1 - BH2 |

| Question | Response |
|---|--|
| Deficiency | STEEL COLUMNS/BEAMS: DETERIORATED CONCRETE FIREPROOFING |
| Deficiency Location/Instance | Roof 1 - PH, BH2, BH3 |

| Question | Response |
|---|--|
| Potential Action | REPLACE |

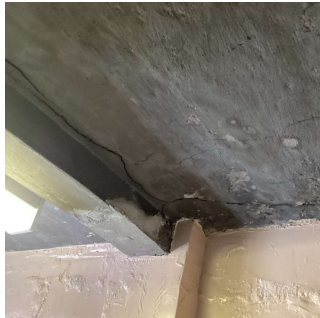
| Question | Response |
|---|--|
| | Roof 1 - BH1 |

| Question | Response |
|---|--|
| Deficiency | CONCRETE: CRACKED/SPALLED/REINFORCEMENT EXPOSED |
| Deficiency Location/Instance | Roof 1 - PH, BH1, Roof 2 - Auditorium PH |

| Question | Response |
|---|--|
| Potential Action | REPAIR |
