NYC Department of Education
Building Condition Assessment Survey 2023 - 2024

Architectural Inspection

K491

Asset: PRE-K CENTER @ 2165 71ST STREET - BROOKLYN, 2165 71ST STREET, New York, 11204

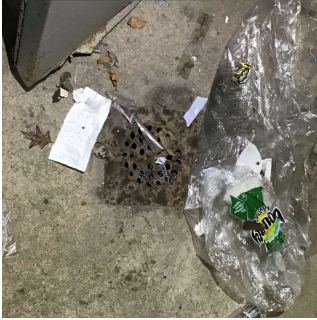
AW3
Violations	No violations recorded.
AWNINGS AND CANOPIES	
Condition	Inspected
Deficiency	2 - Between Good and Fair
	No deficiencies recorded
CHIMNEY	
Material Type(s)	Inspected
Condition	Masonry
Deficiency	3 - Fair
Roof Plan reference	BRICK: DETERIORATED JOINTS

Question	Response
Architectural	
EXTERIOR	Inspected
AREAWAY	Inspected
Instance on AW1-AW3	Inspected
Instance Condition	3 - Fair
Instance Quantity	3
Instance Quantity Uom	EACH
Deficiency	AREAWAY DRAINS: DETERIORATED
Roof Plan reference

Deficiency Quantity	1
Quantity Uom	EACH
Potential Action	REPLACE
Urgency of Action	PRIORITY 4
Purpose of Action	LEVEL 2

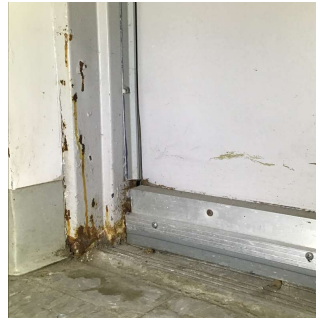
Facade D

METAL: DETERIORATED DOOR AND FRAME - MINOR DETERIORATION

1
EACH
MAINTENANCE
PRIORITY 3

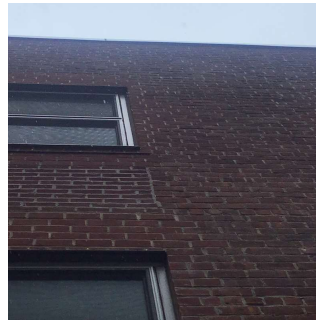
Facade D

BRICK: DETERIORATED JOINTS

REPOINT

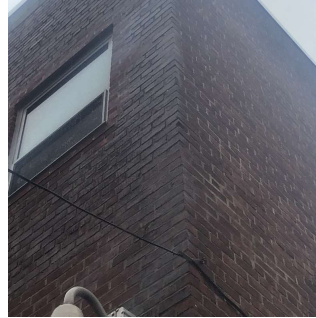
Facade B

BRICK: CRACKS/DISPLACED/SPALLED BRICK AT BUILDING CORNERS

REMOVE AND REBUILD
PRIORITY 4
LEVEL 2

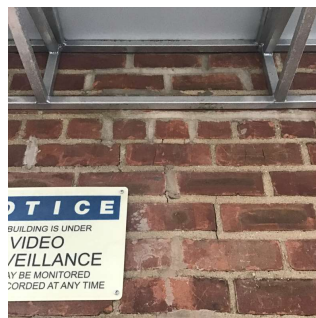
BRICK: MINOR CRACKS AND SPALLING

40
S.F.
RESTITCH
PRIORITY 3
LEVEL 2

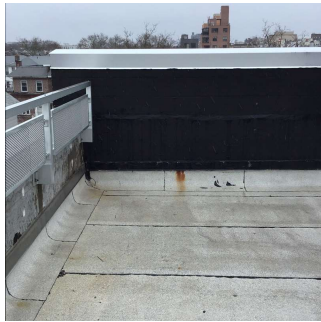
Question	Response
EXTERIOR	
EXTERIOR WALLS	Inspected
	Facade B
Violations	No violations recorded.
EXTERIOR SOFFITS	Does not Exist
LOADING DOCK	Does not Exist
LOUVER	Inspected
Condition	2 - Between Good and Fair
Deficiency	No deficiencies recorded
PARAPETS	Inspected
Material Type(s)	Concrete, Masonry
Replacement Quantity	1,000
Replacement Uom	C.F.
Instance on Roof 1	Inspected
Instance Condition	3 - Fair
Instance Quantity	1,000
Instance Quantity Uom	C.F.
Deficiency	CONCRETE MASONRY UNITS: DETERIORATED JOINTS
Roof Plan reference

Deficiency Quantity	60
Quantity Uom	S.F.
Potential Action	REPOINT
Urgency of Action	PRIORITY 3
Purpose of Action	LEVEL 2
Deficiency Photo1

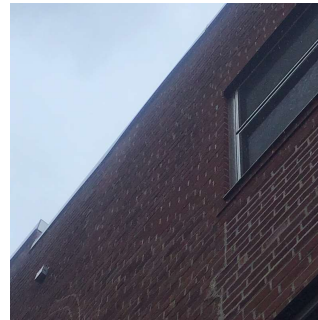
Facade D
 No violations recorded.

Violations	Roof 1 Facade C No violations recorded.
Deficiency	BRICK: DETERIORATED JOINTS

150
 S.F.
 REPOINT
 PRIORITY 3
 LEVEL 2

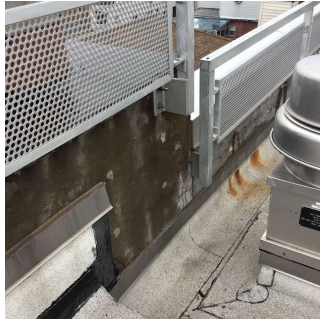
CONCRETE: MINOR CRACKS, SPALLING

30
 S.F.
 REPAIR
 PRIORITY 3
 LEVEL 2

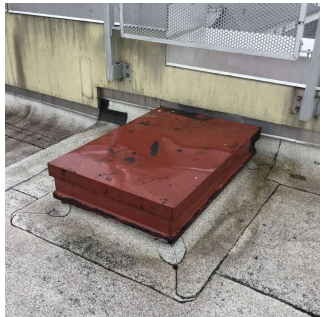
Violations	Roof 1 No violations recorded.
PLAZA DECK	Does not Exist
ROOF	Inspected
Roofing	Inspected
Replacement Quantity	4,000
Replacement Uom	S.F.
ROOF HATCH/SMOKE HATCH	Inspected
Condition	5 - Poor
Deficiency	DETERIORATED
Roof Plan reference

Deficiency Quantity	1
Quantity Uom	EACH
Potential Action	REPLACE
Urgency of Action	PRIORITY 4
Purpose of Action	LEVEL 2
Deficiency Photo1

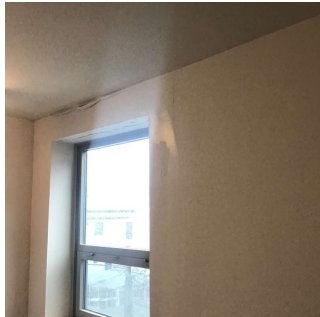
Roof 1
Instance Quantity	4,000
Instance Quantity Uom	S.F.
Does the roof have major mechanical equipment sitting on Dunnage Steel less than 18" above the Roofing?	No
Does this roof instance have a Sustainable Roof System?	Yes
Sustainable Roof Type	White Roof
Sustainable Roof Location (Roof Number)	Roof 1
Do solar panels exist on these roofs?	No
Is/Are the roof(s) suitable for Solar Panel installation?	No
Installation Year	2015
Source of Installation	Custodial Staff
Deficiency	MODIFIED BITUMEN: ROOFING: MAJOR ACTIVE ROOF LEAKS IN INSTRUCTIONAL SPACE
Roof Plan reference

Roof 1 - Stair B/2 shown, Room 206, Corridor near Room 206 similar
Violations	No violations recorded.
Deficiency	MODIFIED BITUMEN: ROOFING: MAJOR ACTIVE ROOF LEAKS IN NON-INSTRUCTIONAL SPACE
Roof Plan reference

Deficiency Quantity	300
Quantity Uom	S.F.
Potential Action	REPLACE ROOFING WITHOUT MAJOR EQUIPMENT REMOVAL

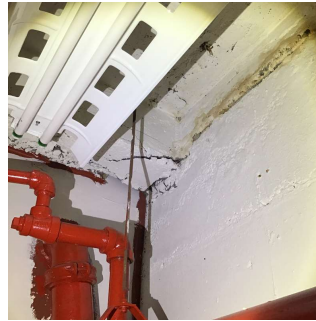
Sprinkler Room

Condition	3 - Fair
Deficiency	STEEL COLUMNS/BEAMS: DETERIORATED CONCRETE FIREPROOFING
Deficiency Location/Instance	Sub Basement
Deficiency Quantity	15
Quantity Uom	S.F.
Potential Action	REPLACE
Urgency of Action	PRIORITY 4
Purpose of Action	LEVEL 5

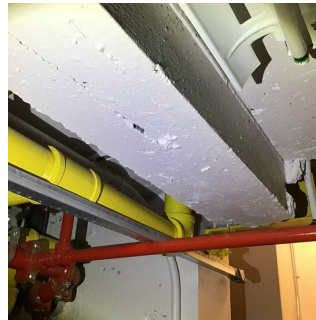
Water Meter Room

STEEL COLUMNS/BEAMS: DETERIORATED CONCRETE FIREPROOFING

REPLACE

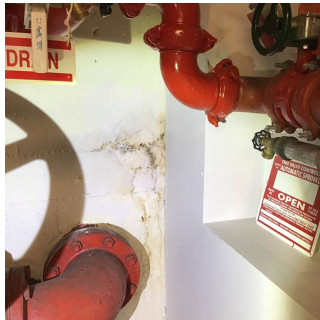
Question	Response
INTERIOR	
STRUCTURAL	
FLOOR STRUCTURE	Inspected
Deficiency Photo1	 
	Water Meter Room
Violations	No violations recorded.
FOUNDATION WALLS	
Material Type(s)	Inspected Concrete
Condition	2 - Between Good and Fair
Deficiency	CONCRETE: CRACKED/SPALLED/REINFORCEMENT EXPOSED
Deficiency Location/Instance	Sub Basement
Deficiency Quantity	20
Quantity Uom	S.F.
Potential Action	REPAIR
Urgency of Action	PRIORITY 3
Purpose of Action	LEVEL 5
Deficiency Photo1

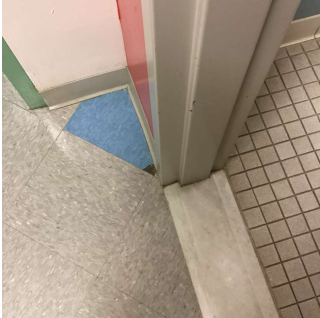
Question	Response
INTERIOR	
CLASSROOMS/CORRIDORS/ADMIN SPACES	
Floor Finish	
Condition	2 - Between Good and Fair
Deficiency	VINYL TILES: BROKEN/DETERIORATED/MISSING TILES
Deficiency Location/Instance	Corridor near Room B05
Deficiency Quantity	10
Quantity Uom	S.F.
Potential Action	REPLACE
Urgency of Action	PRIORITY 3
Purpose of Action	LEVEL 2
Deficiency Photo1

Violations	Corridor near Room B05 No violations recorded.
Deficiency	VINYL TILES: DETERIORATED SUBSTRATE
Deficiency Location/Instance	Corridor near Stair B/1, by Rooms 106, 105
Deficiency Quantity	40
Quantity Uom	S.F.
Potential Action	REPLACE
Urgency of Action	PRIORITY 3
Purpose of Action	LEVEL 2
Deficiency Photo1

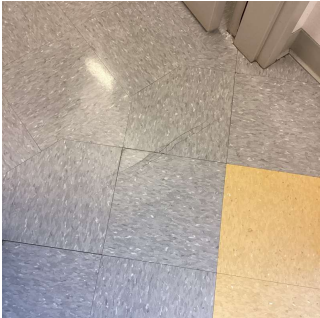
Violations	Corridor near Stair B/1 No violations recorded.
Walls	Inspected
Condition	2 - Between Good and Fair
Deficiency	GYPSUM BOARD: DETERIORATED - ACTIVE LEAK
Deficiency Location/Instance	Room 206
Deficiency Quantity	20
Quantity Uom	S.F.

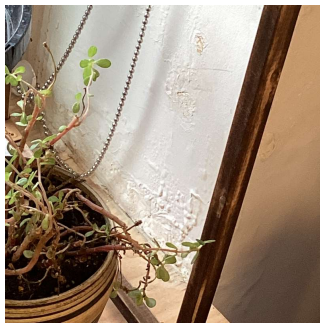
Principal Name	Danielle Bennett
Organization	District 20 Pre-K Center - Brooklyn
Did you meet with this Principal?	No
Did this Principal provide feedback?	Yes
Summary of Principal's Feedback	Site Coordinator Jenna Martin provided the following comment on behalf of the principal: active leaks into Room 206 need to be repaired.

Violations	Room 206 No violations recorded.
Specialties	Does not Exist
GYMNASIUM	Does not Exist
INTERIOR DOOR HARDWARE	Inspected
Condition	2 - Between Good and Fair
Deficiency	No deficiencies recorded
INTERIOR GUARDS	Inspected
Condition	2 - Between Good and Fair
Deficiency	No deficiencies recorded
KITCHEN	Inspected
Instance on Basement	Inspected
Ceiling	
Instance on Basement	Inspected
Condition	2 - Between Good and Fair
Deficiency	No deficiencies recorded
Door(s)	
Instance on Basement	Inspected
Condition	2 - Between Good and Fair
Deficiency	No deficiencies recorded
Floor Finish	
Instance on Basement	Inspected
Condition	2 - Between Good and Fair
Deficiency	No deficiencies recorded
Walls	
Instance on Basement	Inspected
Condition	2 - Between Good and Fair
Deficiency	No deficiencies recorded
LIBRARY	Does not Exist
LOCKER ROOM	Does not Exist

Potential Action	REPLACE
Urgency of Action	PRIORITY 5
Purpose of Action	LEVEL 2

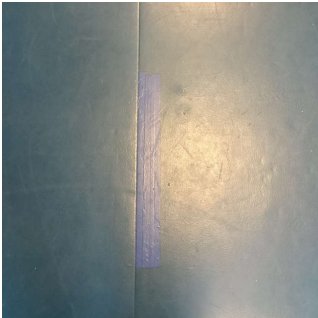
Question	Response
INTERIOR	
MULTI-PURPOSE ROOM	
Door(s)	
Condition	2 - Between Good and Fair
Deficiency	No deficiencies recorded
Fixed Equipment	
Instance on Room B10	Does not Exist
Floor Finish	
Instance on Room B10	Inspected
Condition	2 - Between Good and Fair
Deficiency	VINYL TILES: BROKEN/DETERIORATED/MISSING TILES
Deficiency Location/Instance	Near Windows
Deficiency Quantity	10
Quantity Uom	S.F.
Potential Action	REPLACE
Urgency of Action	PRIORITY 3
Purpose of Action	LEVEL 2
Deficiency Photo1

Violations	Near Windows No violations recorded.
Sliding-folding Partition	
Instance on Room B10	Does not Exist
Stage	
Instance on Room B10	Does not Exist
Walls	
Instance on Room B10	Inspected
Condition	2 - Between Good and Fair
Deficiency	WALL PADDING: DETERIORATED
Deficiency Location/Instance	Near Windows
Deficiency Quantity	20
Quantity Uom	S.F.
Potential Action	REPLACE
Urgency of Action	PRIORITY 3
Purpose of Action	LEVEL 2

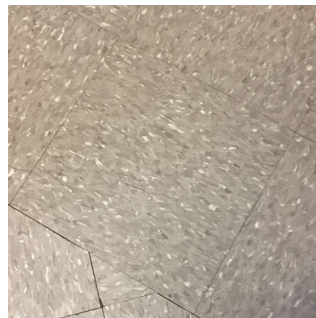
VINYL TILES: BROKEN/DETERIORATED/MISSING TILES

Stairs and Landings	Inspected
	Stair A/2
Violations	No violations recorded.

REPLACE

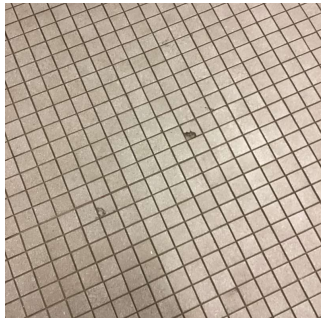
Floor Finish	Inspected
Condition	5 - Poor
Deficiency	CERAMIC TILE: BROKEN/MISSING TILES
Deficiency Location/Instance	Room B05
Deficiency Quantity	10
Quantity Uom	S.F.
Potential Action	REPLACE
Urgency of Action	PRIORITY 3
Purpose of Action	LEVEL 2
Deficiency Photo1

Question	Response
INTERIOR	
TOILET ROOMS - STAFF	
Floor Finish	Inspected
	Room B05
Violations	No violations recorded.
Stalls	Does not Exist
Walls	Inspected
Condition	2 - Between Good and Fair
Deficiency	No deficiencies recorded
TOILET ROOMS - STUDENTS	
Ceiling	Inspected
Condition	2 - Between Good and Fair
Deficiency	No deficiencies recorded
Door(s)	Inspected
Condition	2 - Between Good and Fair
Deficiency	No deficiencies recorded
Floor Finish	Inspected
Condition	2 - Between Good and Fair
Deficiency	No deficiencies recorded
Stalls	Does not Exist
Walls	Inspected
Condition	2 - Between Good and Fair
Deficiency	No deficiencies recorded
LIFE SAFETY	
F.D. HOLDING AREA	Does not Exist
STEEL STAIRS	Does not Exist
SITE	
CONTAINERIZATION	Does not Exist
Drainage System for Asphalt	Does not Exist
Drainage System for Concrete	Does not Exist
Drainage System for Soil	Does not Exist
DRINKING FOUNTAINS	
FENCES	Inspected
Condition	2 - Between Good and Fair

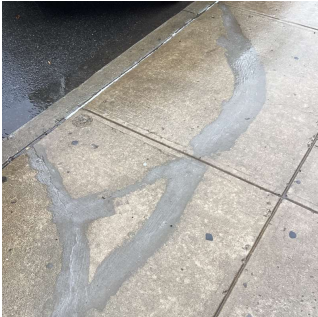
Question	Response
SITE	
FENCES	Inspected
Deficiency Photo1	 
Violations	71st Street No violations recorded.
IRRIGATION SYSTEM	Does not Exist
PAVING	Inspected
Student Non-Use	Does not Exist
Student Use	Does not Exist
Site Sidewalks & Walkways	Inspected
Asphalt	Does not Exist
Concrete	Inspected
Condition	2 - Between Good and Fair
Deficiency	CRACKS - MAJOR
Deficiency Location/Instance	Near Playing Surface
Deficiency Quantity	25
Quantity Uom	S.F.
Potential Action	REPLACE
Urgency of Action	PRIORITY 3
Purpose of Action	LEVEL 2
Deficiency Photo1	 
Violations	Near Playing Surface No violations recorded.
Pavers	Inspected
Condition	2 - Between Good and Fair
Deficiency	No deficiencies recorded
DOT Sidewalk	Inspected
Asphalt	Does not Exist
Concrete	Inspected
Condition	3 - Fair
Deficiency	DAMAGED/DETERIORATED/MISSING SECTIONS
Deficiency Location/Instance	71st Street
Deficiency Quantity	150

Question	Response
SITE	
PAVING	
DOT Sidewalk	
Concrete	
Quantity Uom	S.F.
Potential Action	REPLACE
Urgency of Action	PRIORITY 3
Purpose of Action	LEVEL 2
Deficiency Photo1

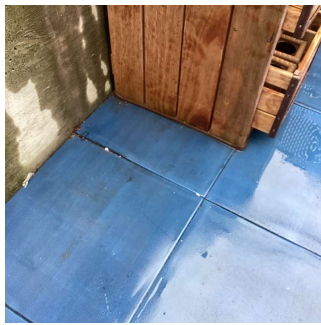
71st Street
Violations	No violations recorded.
Pavers	Does not Exist
PLAYGROUNDS	Inspected
Instance on Rear of Building	Inspected
Benches	
Instance on Rear of Building	Does not Exist
Fence	
Instance on Rear of Building	Inspected
Condition	2 - Between Good and Fair
Deficiency	No deficiencies recorded
Pavement	
Instance on Rear of Building	Does not Exist
Play Equipment	
Instance on Rear of Building	Inspected
Condition	2 - Between Good and Fair
Deficiency	No deficiencies recorded
Safety Surfacing	
Instance on Rear of Building	Inspected
Condition	2 - Between Good and Fair
Deficiency	DETERIORATED/MISSING
Deficiency Location/Instance	Near Main Entrance, By Exit
Deficiency Quantity	20
Quantity Uom	S.F.
Potential Action	REPLACE
Urgency of Action	PRIORITY 3

Violations	Near Main Entrance No violations recorded.
Unpaved Area	
Instance on Rear of Building	Does not Exist
PLAYING SURFACE	Inspected
Playing Field	Inspected
Instance on Along 71st Street	Inspected
Instance Condition	2 - Between Good and Fair
Deficiency	No deficiencies recorded
Running Track	Does not Exist
RETAINING WALLS	Inspected
Are there any Retaining Walls 6' OR higher facing public street/sidewalk?	No
Condition	2 - Between Good and Fair
Deficiency	CAST IN PLACE CONCRETE: CRACKS/SPALLING - MAJOR
Deficiency Location/Instance	Playground
Deficiency Quantity	20
Quantity Uom	S.F.
Potential Action	REPLACE
Urgency of Action	PRIORITY 3
Purpose of Action	LEVEL 2
Deficiency Photo1

Purpose of Action	LEVEL 2

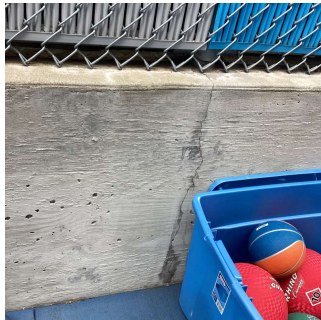
Violations	Playground No violations recorded.
SEATING	Does not Exist
SITE WALLS (NOT RETAINING WALLS)	Does not Exist
STAIRS/RAMPS: EXTERIOR	Does not Exist
ARTWORK	Does not Exist
