NYC Department of Education
Building Condition Assessment Survey 2023 - 2024

Architectural Inspection

K496

Asset: SHEEPSHEAD BAY AF - BROOKLYN, 3000 AVENUE X, New York, 11235

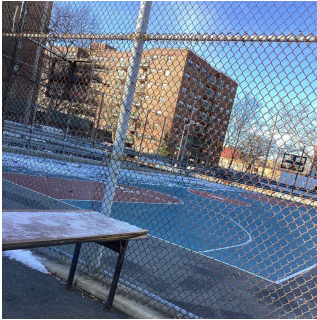
Question	Response
SITE	
Drainage System for Concrete	
Catch Basins/Manhole - Surrounded by concrete	
Deficiency Photo1	 
Violations	Bleachers Area No violations recorded.
Culverts - Concrete Covering	Does not Exist
Drainage System for Soil	Does not Exist
DRINKING FOUNTAINS	Inspected
Condition	2 - Between Good and Fair
Deficiency	No deficiencies recorded
FENCES	Inspected
Condition	4 - Between Fair and Poor
Deficiency	CHAIN LINK: DAMAGED/DETERIORATED
Deficiency Location/Instance	Batchelder Street
Deficiency Quantity	100
Quantity Uom	S.F.
Potential Action	REPLACE
Urgency of Action	PRIORITY 3
Purpose of Action	LEVEL 2
Deficiency Photo1	 
Violations	Batchelder Street No violations recorded.
Deficiency	CHAIN LINK: RUST - MAJOR
Deficiency Location/Instance	Bleachers Area
Deficiency Quantity	800
Quantity Uom	S.F.
Potential Action	REPLACE
Urgency of Action	PRIORITY 3
Purpose of Action	LEVEL 2

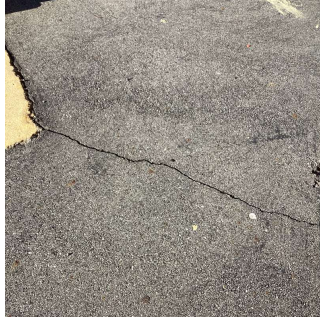
Violations	Bleachers Area No violations recorded.
IRRIGATION SYSTEM	Does not Exist
PAVING	Inspected
Student Non-Use	Inspected
Gravel Exists?	Yes
Asphalt	Inspected
Condition	3 - Fair
Deficiency	CRACKS - MAJOR
Deficiency Location/Instance	Under Bleachers
Deficiency Quantity	60
Quantity Uom	S.F.
Potential Action	REPLACE
Urgency of Action	PRIORITY 3
Purpose of Action	LEVEL 2
Deficiency Photo1	 
Violations	Under Bleachers No violations recorded.
Concrete	Does not Exist
Pavers	Does not Exist
Student Use	Inspected
Gravel Exists?	No
Asphalt	Inspected
Condition	3 - Fair
Deficiency	CRACKS - MAJOR
Deficiency Location/Instance	Near Score Board, Drinking Fountain, Perimeter around Track
Deficiency Quantity	100
Quantity Uom	S.F.
Potential Action	REPLACE
Urgency of Action	PRIORITY 3

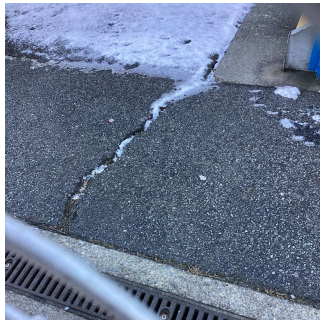
Near Score Board
Violations	No violations recorded.
Concrete	Inspected
Condition	2 - Between Good and Fair
Deficiency	No deficiencies recorded
Pavers	Does not Exist
Site Sidewalks & Walkways	Inspected
Asphalt	Inspected
Condition	3 - Fair
Deficiency	CRACKS - MAJOR
Deficiency Location/Instance	Bleachers Area
Deficiency Quantity	80
Quantity Uom	S.F.
Potential Action	REPLACE
Urgency of Action	PRIORITY 3
Purpose of Action	LEVEL 2
Deficiency Photo1

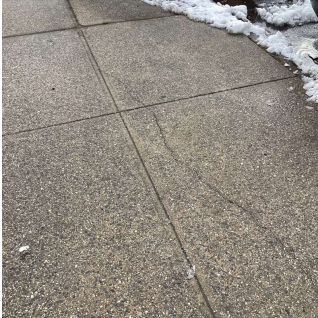
Bleachers Area
Violations	No violations recorded.
Concrete	Does not Exist
Pavers	Does not Exist
DOT Sidewalk	Inspected
Asphalt	Does not Exist
Concrete	Inspected
Condition	4 - Between Fair and Poor
Deficiency	DAMAGED/DETERIORATED/MISSING SECTIONS
Deficiency Location/Instance	Coyle Street, Batchelder Street

Question	Response
SITE	
PAVING	
DOT Sidewalk	
Concrete	
Deficiency Quantity	500
Quantity Uom	S.F.
Potential Action	REPLACE
Urgency of Action	PRIORITY 3
Purpose of Action	LEVEL 2
Deficiency Photo1
