NYC Department of Education
Building Condition Assessment Survey 2023 - 2024

Architectural Inspection

Asset: CANARSIE HS - K, 1600 ROCKAWAY PKWY, New York, 11236

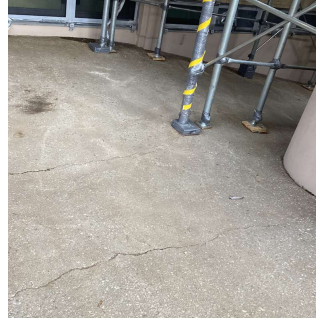
AW4

AREAWAY SLAB: CRACKS AND SPALLING

REPAIR

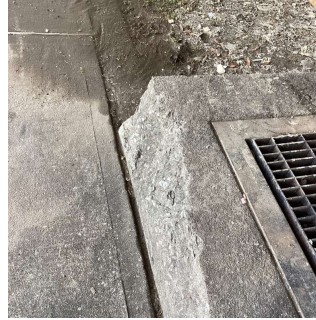
AW6

AREAWAY WALLS: CRACKS AND SPALLING

REPAIR

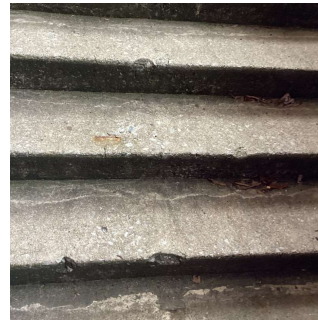
AW9
No violations recorded.

AREAWAY STAIRS: DETERIORATED TREADS/RISERS/NOSINGS

150
S.F.
REPLACE
PRIORITY 4
LEVEL 2

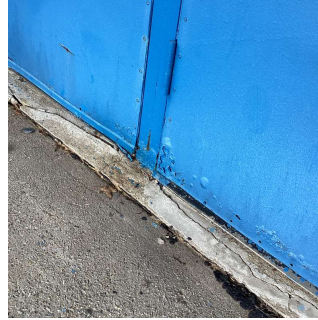
Facade D

METAL CLAD: DETERIORATED DOOR AND FRAME - MAJOR DETERIORATION

REPLACE
PRIORITY 4
LEVEL 2

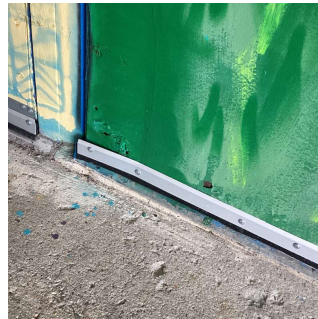
Facade N

METAL CLAD: DETERIORATED DOOR - MAJOR DETERIORATION

20
EACH
REPLACE
PRIORITY 4
LEVEL 2

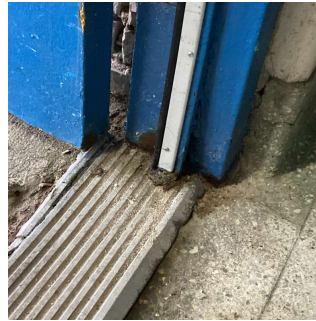
Facade I - Exit 11

METAL CLAD: DETERIORATED DOOR AND FRAME - MINOR DETERIORATION

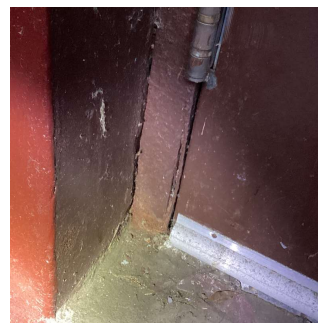
Near AW10

METAL: DETERIORATED DOOR AND FRAME - MINOR DETERIORATION

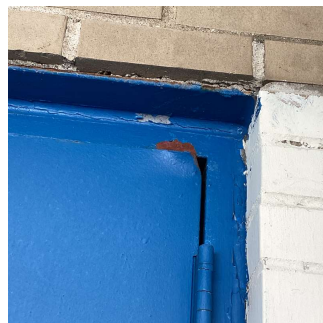
METAL: DETERIORATED DOOR - MINOR DETERIORATION

Violations	<p>Facade J - Men Toilet Room Entrance</p> <p>No violations recorded.</p>
DOOR HARDWARE	Inspected
Condition	3 - Fair
Deficiency	No deficiencies recorded
LINTELS	Inspected
Condition	2 - Between Good and Fair
Deficiency	No deficiencies recorded
TRANSOM/SIDE LIGHT	Inspected
Condition	2 - Between Good and Fair
Deficiency	No deficiencies recorded
EXTERIOR WALLS	Inspected
Material Type(s)	Masonry
Replacement Quantity	40,000
Replacement Uom	S.F.
Instance on All Facades	Under Construction
Instance Quantity	40,000
Instance Quantity Uom	S.F.
EXTERIOR SOFFITS	Inspected
Condition	2 - Between Good and Fair
Deficiency	CONCRETE: MINOR CRACKS/SPALLING

Deficiency Quantity	2
Quantity Uom	EACH
Potential Action	MAINTENANCE
Urgency of Action	PRIORITY 3
Purpose of Action	LEVEL 2
Deficiency Photo1

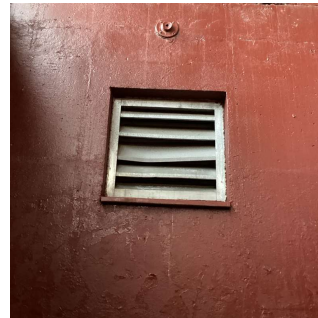
Near AW10

BROKEN/ DENTED BLADES

REPLACE

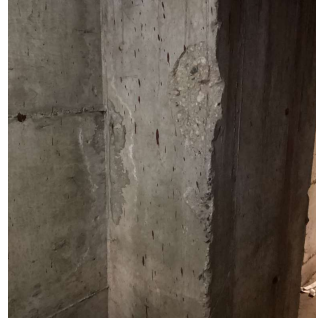
Crawlspace near the Stair F
 No violations recorded.

Question	Response
EXTERIOR	
WINDOWS	
LINTELS	Inaccessible
WINDOWS	Inspected
Material Type(s)	Aluminum
Instance on Aluminum - Other: All Facades	Inspected
Instance Condition	3 - Fair
Instance Quantity	12,000
Instance Quantity Uom	S.F.
Are these windows insulated	Yes
Installation Year	2009
Source of Installation	Custodial Staff
Deficiency	ALUMINUM - OTHER: HARDWARE POOR CONDITION/MISSING
Roof Plan reference	 
Elevation	 
Deficiency Quantity	100
Quantity Uom	EACH
Potential Action	MAINTENANCE
Urgency of Action	PRIORITY 3
Purpose of Action	LEVEL 2
Deficiency Photo1	No photo recorded
Violations	No violations recorded.
INTERIOR	Inspected
POOLS	Does not Exist
STRUCTURAL	Inspected
COLUMNS/BEAMS/BEARING WALLS	Inspected
Condition	3 - Fair
Deficiency	STEEL COLUMNS/BEAMS: DETERIORATED CONCRETE FIREPROOFING
Deficiency Location/Instance	Crawlspace near the Stair F
Deficiency Quantity	20
Quantity Uom	S.F.

Potential Action	REPLACE
Urgency of Action	PRIORITY 4
Purpose of Action	LEVEL 5
Deficiency Photo1

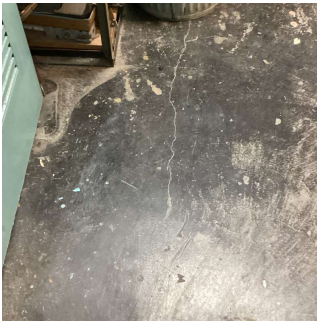
Deficiency	CONCRETE SLAB ON GRADE: THRU CRACKS
Deficiency Location/Instance	Basement - Rooms B04, B06, B08, Corridor near Room B00, Crawlspace by the Electrical Panel Room
Deficiency Quantity	180
Quantity Uom	S.F.
Potential Action	REPAIR
Urgency of Action	PRIORITY 3
Purpose of Action	LEVEL 5

Violations	Basement - Room B06 No violations recorded.
FOUNDATION WALLS	
Material Type(s)	Inspected Concrete, Masonry
Condition	2 - Between Good and Fair
Deficiency	CONCRETE: CRACKED/SPALLED/REINFORCEMENT EXPOSED
Deficiency Location/Instance	Sub-Basement - Boiler Room
Deficiency Quantity	20
Quantity Uom	S.F.
Potential Action	REPAIR
Urgency of Action	PRIORITY 3
Purpose of Action	LEVEL 5
Deficiency Photo1

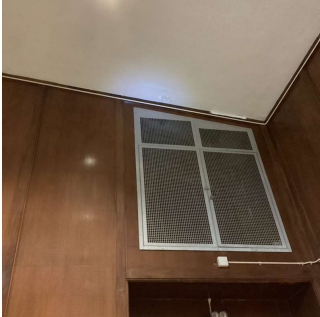
Question	Response
INTERIOR	
AUDITORIUM	
Instance on 1st Floor (1000 Seats)	Inspected
Ceiling	
Instance on 1st Floor (1000 Seats)	Inspected
Condition	2 - Between Good and Fair
Deficiency	PLASTER: CRACKS/SPALLING
Deficiency Location/Instance	Near Stage Right
Deficiency Quantity	10
Quantity Uom	S.F.
Potential Action	REPLACE
Urgency of Action	PRIORITY 3
Purpose of Action	LEVEL 2
Deficiency Photo1

Violations	Near Stage Right No violations recorded.
Door(s)	
Instance on 1st Floor (1000 Seats)	Inspected
Condition	5 - Poor
Deficiency	METAL: DETERIORATED DOOR AND FRAME
Deficiency Location/Instance	Exit Vestibule at Stage Left, Corridor Exit at Stage Right
Deficiency Quantity	4
Quantity Uom	EACH
Potential Action	MAINTENANCE
Urgency of Action	PRIORITY 3
Purpose of Action	LEVEL 2
Deficiency Photo1

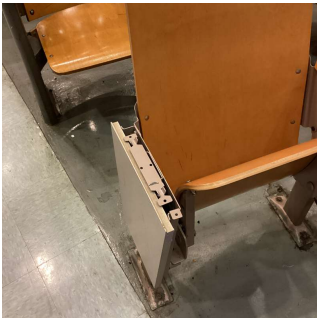
Question	Response
INTERIOR	
AUDITORIUM	
Fixed Seating	
Deficiency	DAMAGED/BROKEN/INOPERABLE
Deficiency Location/Instance	Seats F/1, Q/1, R/22, 27, U/27,
Deficiency Quantity	8
Quantity Uom	EACH
Potential Action	REPLACE
Urgency of Action	PRIORITY 3
Purpose of Action	LEVEL 2
Deficiency Photo1	 
Violations	Seat F/1 No violations recorded.
Deficiency	DAMAGED/BROKEN/INOPERABLE
Deficiency Location/Instance	Seat D/1
Deficiency Quantity	1
Quantity Uom	EACH
Potential Action	REPLACE
Urgency of Action	PRIORITY 5
Purpose of Action	LEVEL 6
Deficiency Photo1

Violations	Seat D/1 No violations recorded.
Floor Finish	
Instance on 1st Floor (1000 Seats)	Inspected
Condition	2 - Between Good and Fair
Deficiency	No deficiencies recorded
Sliding-folding Partition	
Instance on 1st Floor (1000 Seats)	Does not Exist
Stage	
Instance on 1st Floor (1000 Seats)	Inspected
Stage	
Instance on 1st Floor (1000 Seats)	Inspected
Condition	3 - Fair

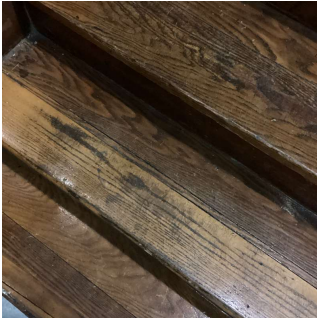
Question	Response
INTERIOR	
AUDITORIUM	
Stage	
Stage	
Deficiency	DAMAGED STEPS
Deficiency Location/Instance	Right Side
Deficiency Quantity	10
Quantity Uom	S.F.
Potential Action	REPLACE
Urgency of Action	PRIORITY 3
Purpose of Action	LEVEL 2
Deficiency Photo1

Violations	Right Side No violations recorded.
Deficiency	DAMAGED FASCIA
Deficiency Location/Instance	Center
Deficiency Quantity	10
Quantity Uom	S.F.
Potential Action	REPLACE
Urgency of Action	PRIORITY 3
Purpose of Action	LEVEL 2
Deficiency Photo1

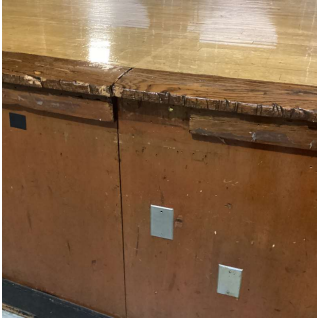
Violations	Center No violations recorded.
Deficiency	DAMAGED FLOOR
Deficiency Location/Instance	Center
Deficiency Quantity	40
Quantity Uom	S.F.
Potential Action	REPLACE
Urgency of Action	PRIORITY 3
Purpose of Action	LEVEL 2

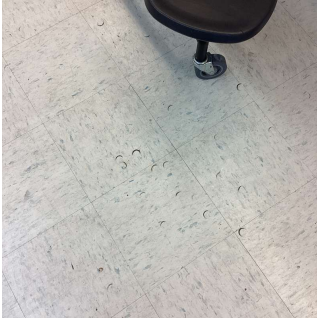
Deficiency	VINYL TILES: BROKEN/DETERIORATED/MISSING TILES
Deficiency Location/Instance	Left Side, Center, Right Side
Deficiency Quantity	100

Question	Response
INTERIOR	
CAFETERIA	
Floor Finish	
Quantity Uom	S.F.
Potential Action	REPLACE
Urgency of Action	PRIORITY 3
Purpose of Action	LEVEL 2
Deficiency Photo1

Left Side
Violations	No violations recorded.
Instance on 1st Floor Students Small (1000 SF)	Inspected
Condition	2 - Between Good and Fair
Deficiency	VINYL TILES: BROKEN/DETERIORATED/MISSING TILES
Deficiency Location/Instance	Near Entrance to Kitchen
Deficiency Quantity	10
Quantity Uom	S.F.
Potential Action	REPLACE
Urgency of Action	PRIORITY 3
Purpose of Action	LEVEL 2
Deficiency Photo1

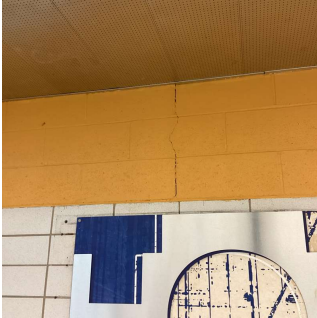
Condition	2 - Between Good and Fair
Deficiency	MASONRY: CRACKS/SPALLING
Deficiency Location/Instance	Right Side
Deficiency Quantity	10

Question	Response
INTERIOR	
CAFETERIA	
Walls	
Quantity Uom	S.F.
Potential Action	REPLACE
Urgency of Action	PRIORITY 3
Purpose of Action	LEVEL 2
Deficiency Photo1

Violations	Right Side No violations recorded.
Deficiency	GLAZED BLOCK: CRACKS/SPALLING
Deficiency Location/Instance	Left Side, Columns at Center, Near Rear Entrance
Deficiency Quantity	30
Quantity Uom	S.F.
Potential Action	REPLACE
Urgency of Action	PRIORITY 3
Purpose of Action	LEVEL 2
Deficiency Photo1

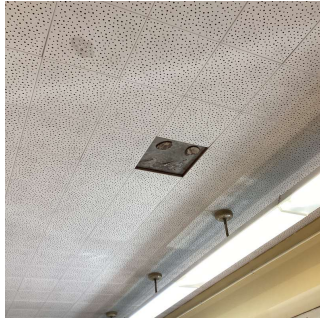
Question	Response
INTERIOR	
CLASSROOMS/CORRIDORS/ADMIN SPACES	
Ceiling	
Deficiency	ACOUSTIC TILES ON PLASTER: DAMAGED/MISSING
Deficiency Location/Instance	Room 302
Deficiency Quantity	10
Quantity Uom	S.F.
Potential Action	REPLACE
Urgency of Action	PRIORITY 4
Purpose of Action	LEVEL 4
Deficiency Photo1

Violations	Room 302 35671699H
Deficiency	METAL PAN: DAMAGED/MISSING
Deficiency Location/Instance	Corridor near Rooms 149, 230, 316, 322, Corridor near Stair D/3, and others
Deficiency Quantity	1,000
Quantity Uom	S.F.
Potential Action	REPLACE
Urgency of Action	PRIORITY 3
Purpose of Action	LEVEL 2
Deficiency Photo1

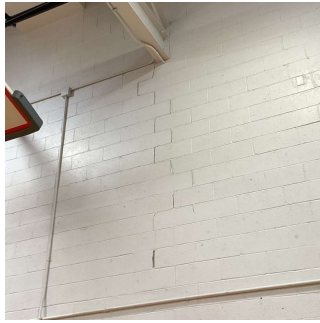
Question	Response
INTERIOR	
GYMNASIUM	
Walls	
Deficiency Photo1

Right Side
Violations	No violations recorded.
Deficiency	WALL PADDING: DETERIORATED
Deficiency Location/Instance	Near Office
Deficiency Quantity	40
Quantity Uom	S.F.
Potential Action	REPLACE
Urgency of Action	PRIORITY 3
Purpose of Action	LEVEL 2
Deficiency Photo1

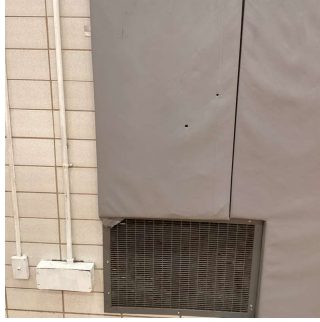
Near Office
Violations	No violations recorded.
Window Curtains/Shades/Blinds	
Instance on 1st Floor	Does not Exist
INTERIOR DOOR HARDWARE	
Condition	Inspected
Deficiency	3 - Fair
Deficiency	No deficiencies recorded
INTERIOR GUARDS	
Condition	Inspected
Deficiency	2 - Between Good and Fair
Deficiency	DETERIORATED/TORN-OUT/MISSING
Deficiency Location/Instance	Stairs B/3, J/3
Deficiency Quantity	40
Quantity Uom	S.F.
Potential Action	REPLACE
Urgency of Action	PRIORITY 3
Purpose of Action	LEVEL 2

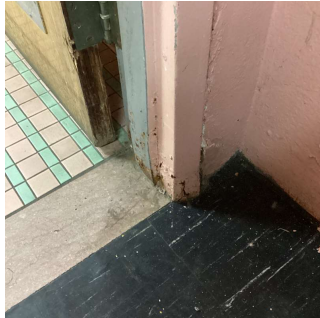
Room 174
Violations	No violations recorded.
Door(s)	Inspected
Condition	5 - Poor
Deficiency	METAL: DETERIORATED DOOR AND FRAME
Deficiency Location/Instance	Room 186
Deficiency Quantity	1
Quantity Uom	EACH
Potential Action	MAINTENANCE
Urgency of Action	PRIORITY 3
Purpose of Action	LEVEL 2
Deficiency Photo1

Room 186
Violations	No violations recorded.
Deficiency	WOOD: DETERIORATED DOOR
Deficiency Location/Instance	Kitchen, Rooms 174, 203, 325, 329, and others
Deficiency Quantity	7
Quantity Uom	EACH
Potential Action	MAINTENANCE
Urgency of Action	PRIORITY 3
Purpose of Action	LEVEL 2

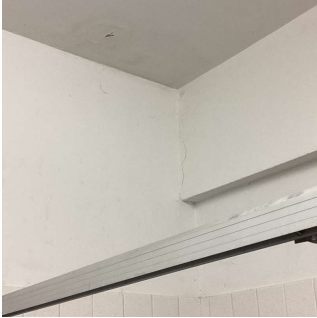
Room 170
Violations	No violations recorded.
Walls	Inspected
Condition	2 - Between Good and Fair
Deficiency	PLASTER: CRACKS/SPALLING
Deficiency Location/Instance	Room 120
Deficiency Quantity	10
Quantity Uom	S.F.
Potential Action	REPLACE
Urgency of Action	PRIORITY 3
Purpose of Action	LEVEL 2
Deficiency Photo1

Room 120
Violations	No violations recorded.
Deficiency	CERAMIC TILE: BROKEN/ MISSING
Deficiency Location/Instance	Rooms 161, 170, 259, 312, Boys Locker Room, and others
Deficiency Quantity	70
Quantity Uom	S.F.
Potential Action	REPLACE
