**NYC Department of Education**  
**Building Condition Assessment Survey 2023 - 2024**

Architectural Inspection

**Asset: SOUTH SHORE AF - BROOKLYN, 6565 FLATLANDS AVENUE, New York, 11236**

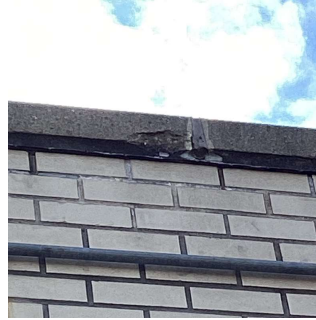
Roof 1

Question	Response
<b>Architectural</b>	
<b>EXTERIOR</b>	Inspected
<b>AREAWAY</b>	Does not Exist
<b>AWNINGS AND CANOPIES</b>	Does not Exist
<b>CHIMNEY</b>	Inspected
Material Type(s)	Metal
Condition	2 - Between Good and Fair
Deficiency	No deficiencies recorded
<b>COPING</b>	Inspected
Condition	3 - Fair
Deficiency	<b>CAST STONE: CRACKED/BROKEN PIECES</b>
Roof Plan reference

Deficiency Quantity	20
Quantity Uom	L.F.
Potential Action	REPLACE-IN-KIND
Urgency of Action	PRIORITY 4
Purpose of Action	LEVEL 2

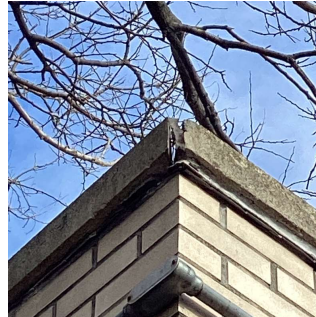
Roof 1

**CAST STONE: DETERIORATED TRANSVERSE JOINTS**

30

MAINTENANCE

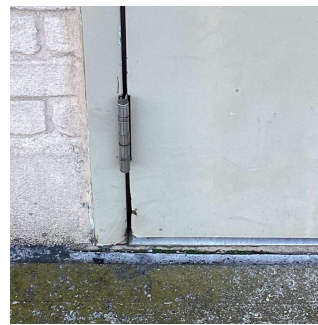
Facade E

METAL: DETERIORATED DOOR - MINOR DETERIORATION

1  
EACH  
MAINTENANCE  
PRIORITY 3  
LEVEL 2

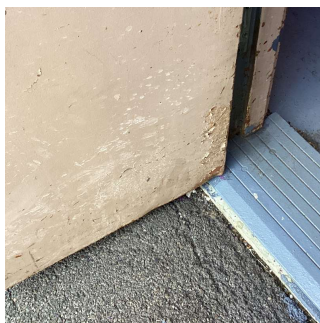
Question	Response
<b>EXTERIOR</b>	
<b>DOORS</b>	
<b>DOORS AND FRAMES</b>	
Deficiency Photo1	 
Violations	Facade C No violations recorded.
Deficiency	<b>METAL: DETERIORATED DOOR - MAJOR DETERIORATION</b>
Roof Plan reference

Deficiency Quantity	2
Quantity Uom	EACH
Potential Action	REPLACE
Urgency of Action	PRIORITY 4
Purpose of Action	LEVEL 2
Deficiency Photo1

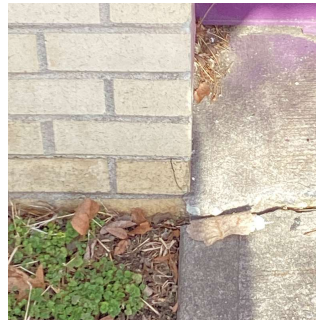
Facade A

Question	Response
<b>EXTERIOR</b>	
<b>EXTERIOR WALLS</b>	Inspected
Material Type(s)	Masonry, Steel
Replacement Quantity	4,000
Replacement Uom	S.F.
Instance on All Facades	Inspected
Instance Condition	5 - Poor
Instance Quantity	4,000
Instance Quantity Uom	S.F.
Deficiency	STUCCO CEMENT SURFACE: CRACKS, SPALLING
Roof Plan reference	 
Elevation	 
Deficiency Quantity	20
Quantity Uom	S.F.
Potential Action	REPLACE
Urgency of Action	PRIORITY 4
Purpose of Action	LEVEL 2
Deficiency Photo1	 
Violations	Facade F No violations recorded.
Deficiency	BRICK: MINOR CRACKS AND SPALLING

RESTITCH

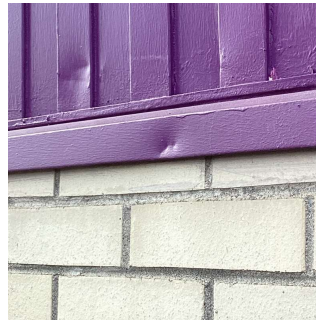
Facade D

**METAL PANEL: DAMAGED TRIM**

REPLACE

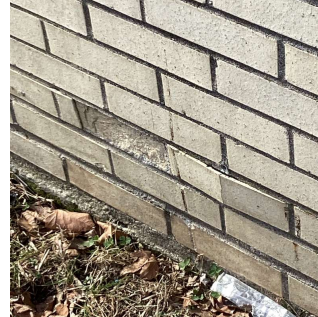
Facade D

**BRICK: MAJOR / THRU CRACKS**

PRIORITY 4  
LEVEL 2

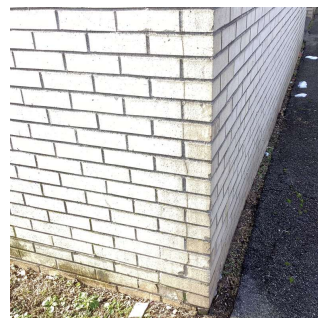
**BRICK: CRACKS/DISPLACED/SPALLED BRICK AT BUILDING CORNERS**

35  
S.F.  
REMOVE AND REBUILD  
PRIORITY 4  
LEVEL 2

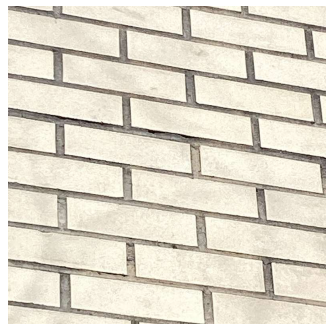
Question	Response
<b>EXTERIOR</b>	
<b>PARAPETS</b>	
Instance on Roof 1	Inspected
Instance Condition	3 - Fair
Instance Quantity	800
Instance Quantity Uom	C.F.
Deficiency	<b>BRICK: DETERIORATED JOINTS</b>
Roof Plan reference

Deficiency Quantity	30
Quantity Uom	S.F.
Potential Action	REPOINT
Urgency of Action	PRIORITY 3
Purpose of Action	LEVEL 2
Deficiency Photo1

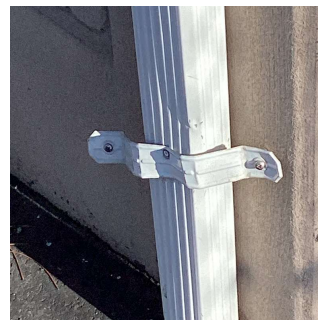
Facade H  
No violations recorded.

Violations	Roof 1 No violations recorded.
<b>PLAZA DECK</b>	Does not Exist
<b>ROOF</b>	Inspected
<b>Roofing</b>	Inspected
Replacement Quantity	4,200
Replacement Uom	S.F.
<b>ROOF HATCH/SMOKE HATCH</b>	Does not Exist
<b>LEADERS, GUTTERS, DOWNSPOUTS, SCUPPERS</b>	Inspected
Condition	3 - Fair
Deficiency	LOOSE

1  
EACH  
MAINTENANCE  
PRIORITY 3  
LEVEL 2

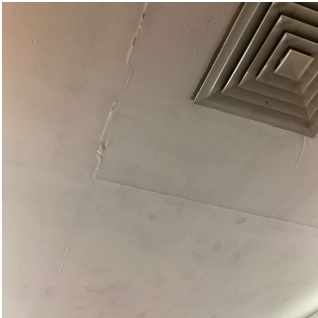
Question	Response
<b>INTERIOR</b>	
<b>CLASSROOMS/CORRIDORS/ADMIN SPACES</b>	
<b>Door(s)</b>	Inspected
Condition	2 - Between Good and Fair
Deficiency	No deficiencies recorded
<b>Floor Finish</b>	Inspected
Condition	2 - Between Good and Fair
Deficiency	No deficiencies recorded
<b>Walls</b>	Inspected
Condition	2 - Between Good and Fair
Deficiency	No deficiencies recorded
<b>INTERIOR DOOR HARDWARE</b>	
Condition	3 - Fair
Deficiency	No deficiencies recorded
<b>LOCKER ROOM</b>	
Instance on 1st Floor- East (52 Lockers)	Inspected
Alternative use	No
Instance on 1st Floor- Visitors (85 Lockers)	Inspected
Alternative use	No
Instance on 1st Floor- West (41 Lockers)	Inspected
Alternative use	No
<b>Ceiling</b>	
Instance on 1st Floor- East (52 Lockers)	Inspected
Condition	2 - Between Good and Fair
Deficiency	GYPSUM BOARD: DAMAGED/DETERIORATED
Deficiency Location/Instance	Center
Deficiency Quantity	30
Quantity Uom	S.F.
Potential Action	REPLACE

Urgency of Action	PRIORITY 3
Purpose of Action	LEVEL 2
Deficiency Photo1

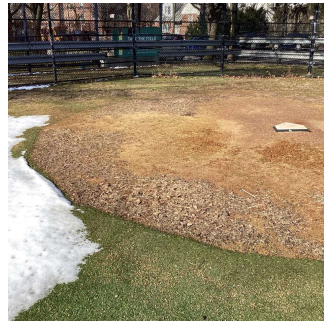
Question	Response
<b>INTERIOR</b>	Inspected
<b>TOILET ROOMS - STUDENTS</b>	Inspected
<b>Walls</b>	East Locker Room
Violations	No violations recorded.
<b>ATHLETIC FIELDS</b>	Inspected
<b>PLAYING SURFACE</b>	Inspected
Synthetic Turf Field exists?	Yes
Year of Installation	2002
Replacement Quantity	235,000
Replacement Uom	S.F.
Instance on Baseball Field	Inspected
Instance Condition	3 - Fair
Instance Quantity	80,000
Instance Quantity Uom	S.F.
Deficiency	NATURAL TURF: DAMAGED/WORN OUT
Deficiency Location/Instance	Baseball Field
Roof Plan reference	 
Deficiency Quantity	240
Quantity Uom	S.F.
Potential Action	REPLACE
Urgency of Action	PRIORITY 4
Purpose of Action	LEVEL 2
Deficiency Photo1

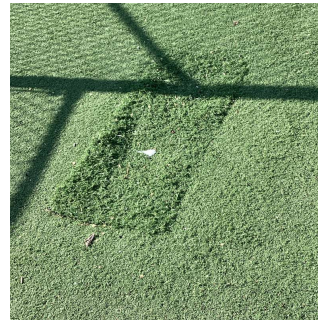
Violations	Home Plate No violations recorded.
Deficiency	ARTIFICIAL TURF: DAMAGED/WORN OUT
Deficiency Location/Instance	Baseball Field

REPLACE

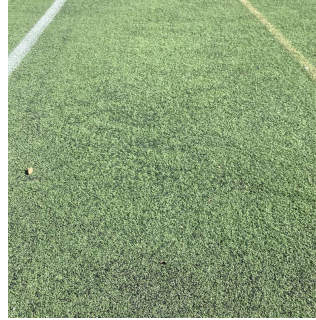
Football Field

ARTIFICIAL TURF: DAMAGED/WORN OUT

REPLACE

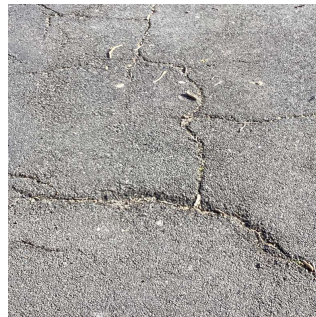
Handball Courts

**ASPHALT: DAMAGED/DETERIORATED**

**REPLACE**

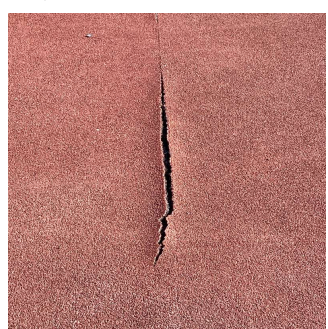
**ATHLETIC WEARING SURFACE: DAMAGED/DETERIORATED**

Question	Response
<b>ATHLETIC FIELDS</b>	
<b>PLAYING SURFACE</b>	
Deficiency Location/Instance	Running Track
Roof Plan reference

Deficiency Quantity	1,800
Quantity Uom	S.F.
Potential Action	REPLACE
Urgency of Action	PRIORITY 4
Purpose of Action	LEVEL 2
Deficiency Photo1

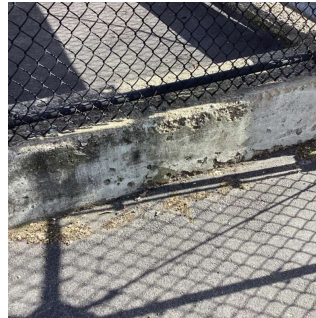
CONCRETE CURB: DAMAGED/DETERIORATED  
Flatlands Avenue  
30  
S.F.  
REPLACE  
PRIORITY 3  
LEVEL 2

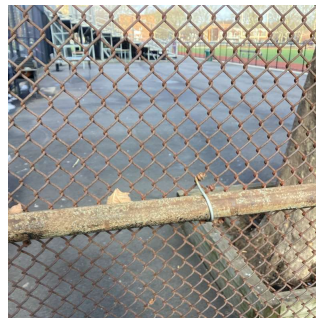
CHAIN LINK: RUST - MAJOR  
Near Handball Court  
2,000  
S.F.  
REPLACE  
PRIORITY 3  
LEVEL 2

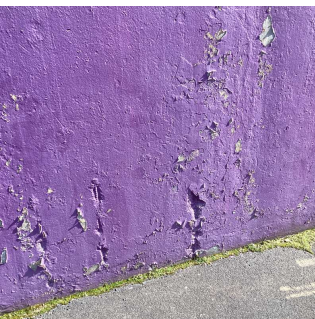
Handball Court
Violations	No violations recorded.
<b>STAIRS/RAMPS: EXTERIOR</b>	
	Does not Exist
<b>ARTWORK</b>	
	Does not Exist

Deficiency	CAST IN PLACE CONCRETE: CRACKS/SPALLING - MAJOR
Deficiency Location/Instance	Handball Court

Question	Response
<b>SITE</b>	
<b>SITE WALLS (NOT RETAINING WALLS)</b>	
Deficiency Quantity	20
Quantity Uom	S.F.
Potential Action	REPLACE
Urgency of Action	PRIORITY 3
Purpose of Action	LEVEL 2
Deficiency Photo1
