NYC Department of Education
Building Condition Assessment Survey 2023 - 2024

Architectural Inspection

K520

Asset: PACIFIC ALT HS - K, 112 SCHERMERHORN STREET, New York, 11201

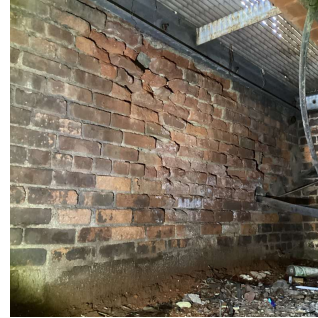
AW3

Question	Response
Architectural	
EXTERIOR	Inspected
AREAWAY	Inspected
Instance on AW1-AW3	Inspected
Instance Condition	4 - Between Fair and Poor
Instance Quantity	3
Instance Quantity Uom	EACH
Deficiency	AREAWAY WALLS: CRACKS AND SPALLING
Roof Plan reference

REPLACE
PRIORITY 4
LEVEL 2

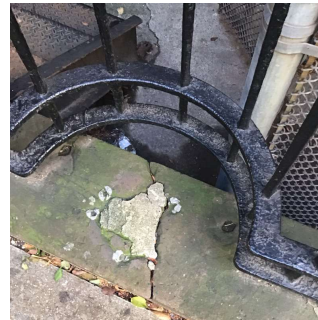
AW2

AREAWAY WALLS: DETERIORATED COPING STONE

50
S.F.
REPLACE
PRIORITY 4
LEVEL 2

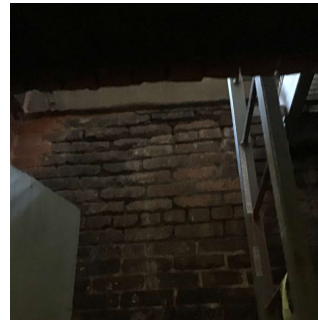
AW3

AREAWAY WALLS: DETERIORATED JOINTS

100
S.F.
REPAIR
PRIORITY 4
LEVEL 2

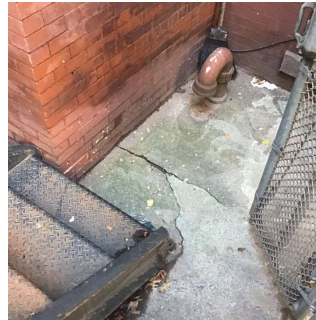
AW2
No violations recorded.

AREAWAY SLAB: CRACKS AND SPALLING

25
S.F.
REPLACE
PRIORITY 4
LEVEL 2

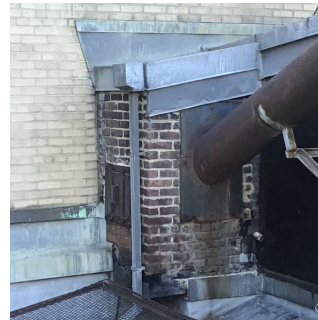
Chimney 3

BRICK: DETERIORATED JOINTS

60
 S.F.
 REPOINT
 PRIORITY 3
 LEVEL 2

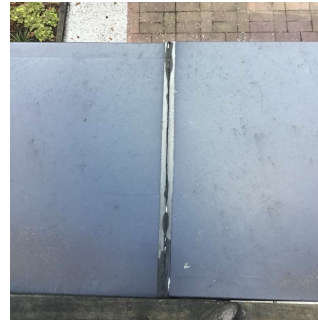
Roof 2

METAL: DETERIORATED TRANSVERSE JOINTS

50
 L.F.
 MAINTENANCE
 PRIORITY 3
 LEVEL 2

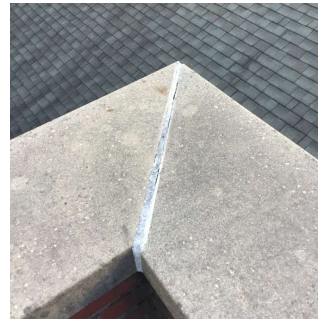
Roof 1

CAST STONE: DETERIORATED TRANSVERSE JOINTS

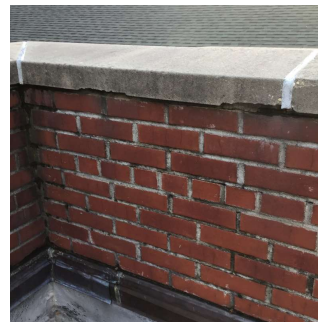
Roof 1
 No violations recorded.

CAST STONE: CRACKED/BROKEN PIECES

10
 L.F.
 REPLACE-IN-KIND
 PRIORITY 4
 LEVEL 2

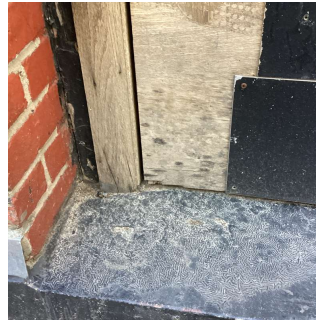
Facade G

WOOD: DETERIORATED DOOR AND FRAME - MAJOR DETERIORATION

1
 EACH
 REPLACE
 PRIORITY 4
 LEVEL 2

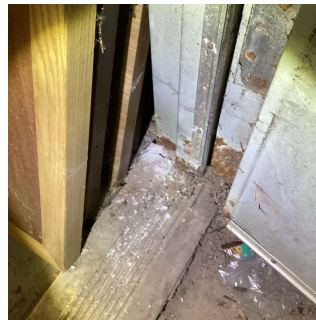
Facade B - AW3

METAL: DETERIORATED DOOR AND FRAME - MINOR DETERIORATION

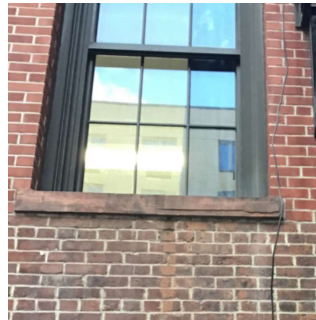
Facade G

BRICK: DETERIORATED MASONRY SILLS - MAJOR

REMOVE AND REPLACE

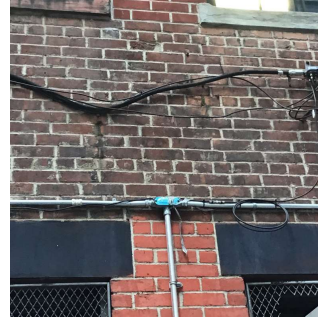
Facade G

BRICK: MINOR CRACKS AND SPALLING

PRIORITY 3
LEVEL 2

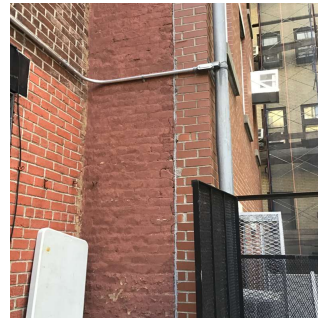
Facade D

BRICK: MAJOR / THRU CRACKS

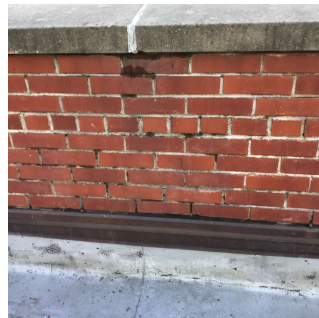
Question	Response
EXTERIOR	
EXTERIOR WALLS	Inspected
Violations	No violations recorded.
EXTERIOR SOFFITS	Inspected
Condition	2 - Between Good and Fair
Deficiency	No deficiencies recorded
LOADING DOCK	Does not Exist
LOUVER	Inspected
Condition	2 - Between Good and Fair
Deficiency	No deficiencies recorded
PARAPETS	Inspected
Material Type(s)	Masonry
Replacement Quantity	2,000
Replacement Uom	C.F.
Instance on All Roofs	Inspected
Instance Condition	3 - Fair
Instance Quantity	2,000
Instance Quantity Uom	C.F.
Deficiency	BRICK: DETERIORATED JOINTS
Roof Plan reference

Deficiency Quantity	100
Quantity Uom	S.F.
Potential Action	REPOINT
Urgency of Action	PRIORITY 3
Purpose of Action	LEVEL 2
Deficiency Photo1

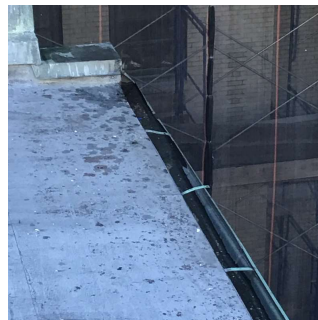
Gutter - Facade D
 No violations recorded.

Violations	No violations recorded.
ROOF BARRIER/FENCE	Inspected
Condition	1 - Good
Deficiency	No deficiencies recorded
ROOF CAGE	Does not Exist
ROOFING	Inspected
Instance on Modified Bitumen: Roofs 1, 3	Inspected
Instance Condition	4 - Between Fair and Poor

1
 EACH
 MAINTENANCE
 PRIORITY 3
 LEVEL 2

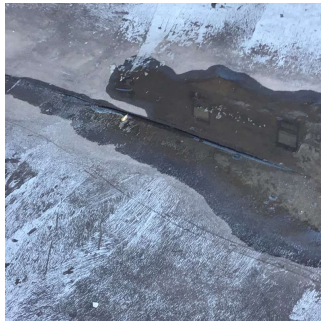
Roof 1
Instance Quantity	9,300
Instance Quantity Uom	S.F.
Does the roof have major mechanical equipment sitting on Dunnage Steel less than 18" above the Roofing?	No
Does this roof instance have a Sustainable Roof System?	No
Do solar panels exist on these roofs?	No
Is/Are the roof(s) suitable for Solar Panel installation?	No
Installation Year	2000
Source of Installation	Custodial Staff
Deficiency	MODIFIED BITUMEN: ROOFING: DELAMINATION
Roof Plan reference

Deficiency Quantity	20
Quantity Uom	S.F.
Potential Action	REPLACE ROOFING WITHOUT MAJOR EQUIPMENT REMOVAL
Urgency of Action	PRIORITY 4
Purpose of Action	LEVEL 2
Deficiency Photo1

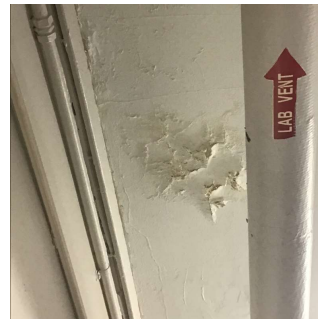
Roof 1 - Room 332
 No violations recorded.

Roof 1
Violations	No violations recorded.
Deficiency	MODIFIED BITUMEN: ROOFING: MAJOR ACTIVE ROOF LEAKS IN INSTRUCTIONAL SPACE

100
 S.F.
 REPLACE ROOFING WITHOUT MAJOR EQUIPMENT
 REMOVAL
 PRIORITY 5
 LEVEL 2

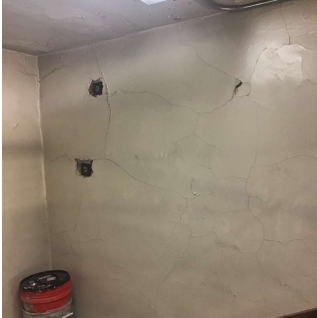
BULKHEAD/PENTHOUSE WALLS/INTERIOR: PLASTER
 CRACKS/SPALLING

Question	Response
EXTERIOR	
ROOF	
Specialties	
BULKHEAD/PENTHOUSE	
Potential Action	REPLACE
Urgency of Action	PRIORITY 3
Purpose of Action	LEVEL 2
Deficiency Photo1

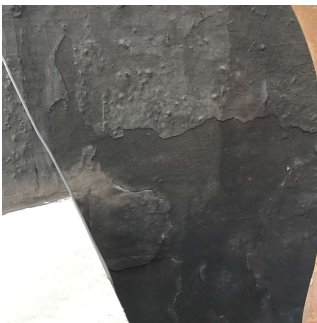
Violations	Bulkhead 1 No violations recorded.
Deficiency	BULKHEAD/PENTHOUSE WALLS/EXTERIOR: CRACKS/SPALLING - MINOR
Roof Plan reference

Deficiency Quantity	100
Quantity Uom	S.F.
Potential Action	REPAIR
Urgency of Action	PRIORITY 3
Purpose of Action	LEVEL 2
Deficiency Photo1

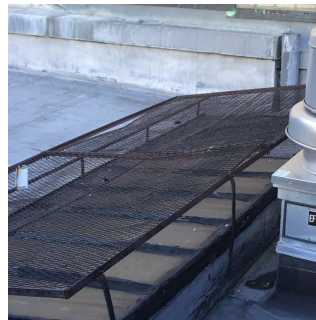
Skylight 2
No violations recorded.

Material Type(s)	Glass
Condition	3 - Fair
Deficiency	DAMAGED GUARDS
Roof Plan reference

75
S.F.
MAINTENANCE
PRIORITY 3
LEVEL 2

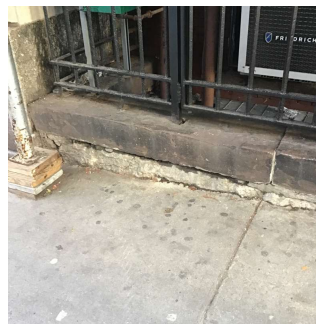
Facade A
 No violations recorded.

Deficiency Quantity	60
Quantity Uom	S.F.
Potential Action	REPOINT
Urgency of Action	PRIORITY 3
Purpose of Action	LEVEL 2
Deficiency Photo1	 
Violations	Main Entrance No violations recorded.
Deficiency	STONE: DETERIORATED COPING STONE

10
 S.F.
 REPAIR
 PRIORITY 3
 LEVEL 2

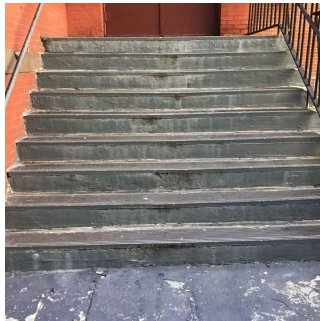
Inspected
 5 - Poor
 CONCRETE: WORN-OUT TREAD/RISER/NOSING

60
 S.F.
 REPLACE
 PRIORITY 4
 LEVEL 2

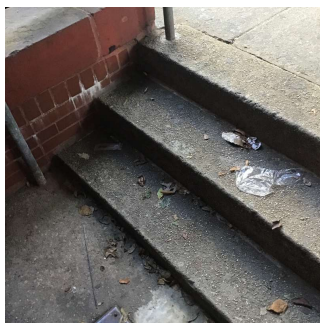
Violations	Main Entrance No violations recorded.
Deficiency	CONCRETE: CRACKS/SPALLING - MINOR
Roof Plan reference

Deficiency Quantity	10
Quantity Uom	S.F.
Potential Action	REPAIR
Urgency of Action	PRIORITY 3
Purpose of Action	LEVEL 2
Deficiency Photo1

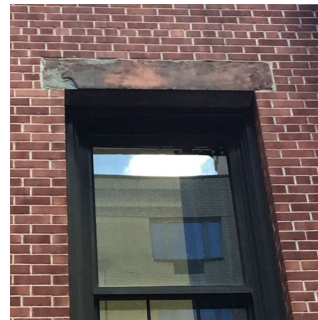
Facade G
No violations recorded.

Violations	Facade A No violations recorded.
WINDOWS	
Replacement Quantity	Inspected
Replacement Uom	3,000
EXTERIOR GUARDS	
Condition	S.F.
Deficiency	Inspected
Deficiency	2 - Between Good and Fair
Deficiency	No deficiencies recorded
LINTELS	
Condition	Inspected
Deficiency	2 - Between Good and Fair
Deficiency	STONE: CHIPPED/SPALLED/BROKEN PIECES

20
S.F.
REPAIR
PRIORITY 3
LEVEL 2

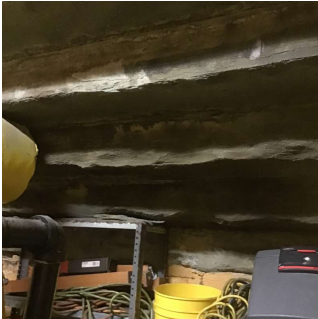
Question	Response
INTERIOR	
STRUCTURAL	
COLUMNS/BEAMS/BEARING WALLS	Inspected
Violations	No violations recorded.
FLOOR STRUCTURE	Inspected
Condition	3 - Fair
Deficiency	CONCRETE: CRACKS/SPALLED/REINFORCEMENT EXPOSED
Deficiency Location/Instance	Basement
Deficiency Quantity	70
Quantity Uom	S.F.
Potential Action	REPAIR
Urgency of Action	PRIORITY 3
Purpose of Action	LEVEL 5
Deficiency Photo1

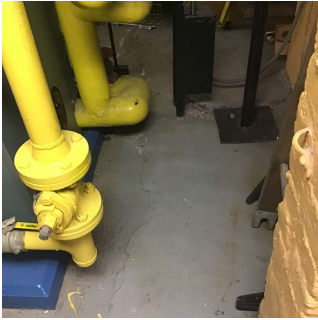
Violations	Basement Boiler Room - Main Entrance Stair above No violations recorded.
Deficiency	CONCRETE SLAB ON GRADE: THRU CRACKS
Deficiency Location/Instance	Sub-Basement Boiler Room
Deficiency Quantity	50
Quantity Uom	S.F.
Potential Action	REPAIR
Urgency of Action	PRIORITY 3
Purpose of Action	LEVEL 5
Deficiency Photo1

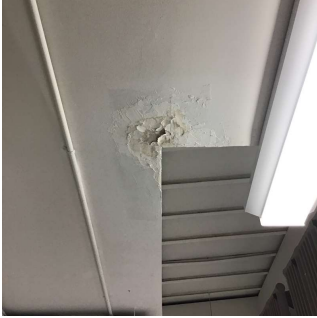
Question	Response
INTERIOR	
CAFETERIA	Inspected
Window Curtains/Shades/Blinds	
Instance on Basement (600 SF)	Does not Exist
CLASSROOMS/CORRIDORS/ADMIN SPACES	Inspected
Ceiling	Inspected
Condition	2 - Between Good and Fair
Deficiency	PLASTER: CRACKS/SPALLING
Deficiency Location/Instance	Room 334,114, Corridor near Room 335,331
Deficiency Quantity	50
Quantity Uom	S.F.
Potential Action	REPLACE
Urgency of Action	PRIORITY 3
Purpose of Action	LEVEL 2
Deficiency Photo1

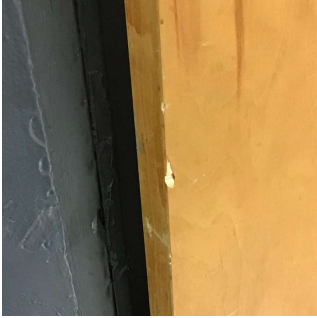
Room 334
Violations	No violations recorded.
Door(s)	Inspected
Condition	5 - Poor
Deficiency	WOOD: DETERIORATED DOOR
Deficiency Location/Instance	Rooms 117,114,B4,B2, Main Entrance Vestibule and others
Deficiency Quantity	8
Quantity Uom	EACH
Potential Action	MAINTENANCE
Urgency of Action	PRIORITY 3
Purpose of Action	LEVEL 2
Deficiency Photo1

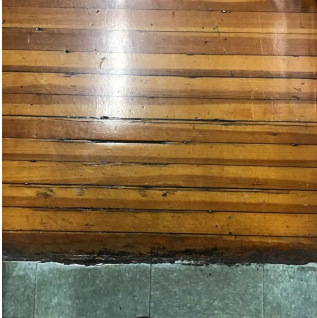
Room 117
Violations	No violations recorded.
Floor Finish	Inspected
Condition	4 - Between Fair and Poor
Deficiency	WOOD: DAMAGED/DETERIORATED

Deficiency Location/Instance	Room 110
Deficiency Quantity	20

Question	Response
INTERIOR	
CLASSROOMS/CORRIDORS/ADMIN SPACES	Inspected
Floor Finish	
Quantity Uom	S.F.
Potential Action	REPLACE
Urgency of Action	PRIORITY 3
Purpose of Action	LEVEL 2
Deficiency Photo1

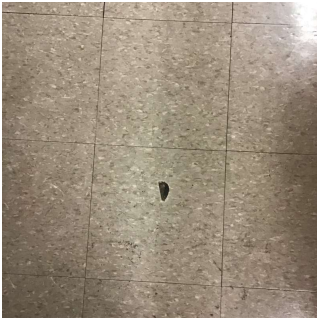
Room 110
Violations	No violations recorded.
Deficiency	VINYL TILES: BROKEN/DETERIORATED/MISSING TILES
Deficiency Location/Instance	Room 339,334,331,226, Corridor near Room 335, and others
Deficiency Quantity	600
Quantity Uom	S.F.
Potential Action	REPLACE
Urgency of Action	PRIORITY 3
Purpose of Action	LEVEL 2
Deficiency Photo1

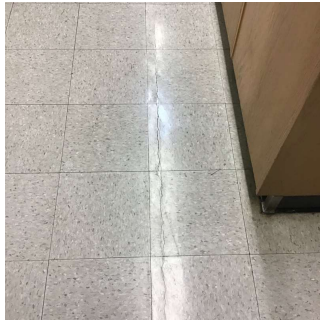
Room 334
Violations	No violations recorded.
Deficiency	VINYL TILES: DETERIORATED SUBSTRATE
Deficiency Location/Instance	Room 332,331,330, Corridor near Room 337,227, and others
Deficiency Quantity	1,000
Quantity Uom	S.F.
Potential Action	REPLACE
Urgency of Action	PRIORITY 3
Purpose of Action	LEVEL 2

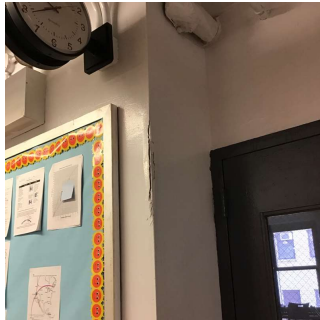
Room 332
Violations	No violations recorded.
Walls	
Condition	Inspected
	2 - Between Good and Fair
Deficiency	PLASTER: CRACKS/SPALLING
Deficiency Location/Instance	Room 339,334,225,Corridor near Room 335,331, and others
Deficiency Quantity	100
Quantity Uom	S.F.
Potential Action	REPLACE
Urgency of Action	PRIORITY 3
Purpose of Action	LEVEL 2
Deficiency Photo1

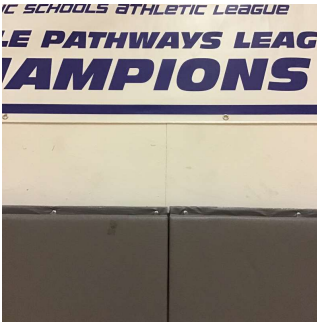
Question	Response
INTERIOR	
GYMNASIUM	
Walls	
Instance on Basement	Inspected
Condition	2 - Between Good and Fair
Deficiency	PLASTER: CRACKS/SPALLING
Deficiency Location/Instance	Near center
Deficiency Quantity	10
Quantity Uom	S.F.
Potential Action	REPLACE
Urgency of Action	PRIORITY 3
Purpose of Action	LEVEL 2
Deficiency Photo1

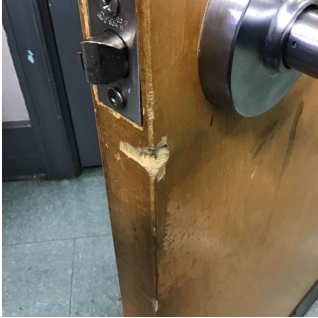
Violations	Entrance No violations recorded.

Instance on Room 113	Inspected
Condition	4 - Between Fair and Poor
Deficiency	WOOD: DETERIORATED DOOR
Deficiency Location/Instance	Entrance
Deficiency Quantity	2
Quantity Uom	EACH
Potential Action	MAINTENANCE
Urgency of Action	PRIORITY 3
Purpose of Action	LEVEL 2
Deficiency Photo1

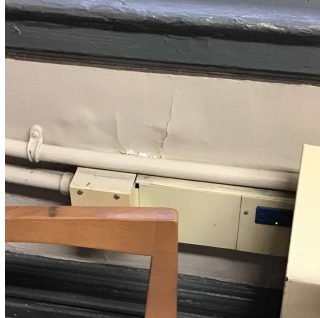
Instance on Room 113	Inspected
Condition	2 - Between Good and Fair
Deficiency	PLASTER: CRACKS/SPALLING
Deficiency Location/Instance	Near Windows
Deficiency Quantity	10

Question	Response
INTERIOR	
LIBRARY	
Walls	
Quantity Uom	S.F.
Potential Action	REPLACE
Urgency of Action	PRIORITY 3
Purpose of Action	LEVEL 2
Deficiency Photo1

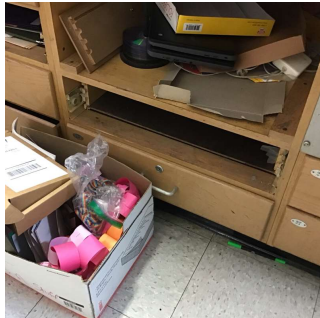
Near Windows
Violations	No violations recorded.
LOCKER ROOM	Does not Exist
MULTI-PURPOSE ROOM	Does not Exist
SCIENCE DEMO ROOM	Inspected
Instance on Room 114	Inspected
Alternative use	No
Instance on Room 222	Inspected
Alternative use	No
Fixed Equipment	
Instance on Room 222	Inspected
Condition	3 - Fair
Deficiency	CABINETS: MISSING/DAMAGED
Deficiency Location/Instance	Room 222
Deficiency Quantity	10
Quantity Uom	L.F.
Potential Action	REPLACE
Urgency of Action	PRIORITY 3
Purpose of Action	LEVEL 2
Deficiency Photo1
