**NYC Department of Education**  
**Building Condition Assessment Survey 2023 - 2024**

Architectural Inspection

**K521**

**Asset:** PS 160 ANNEX - BROOKLYN, 1057 52ND STREET, New York, 11219

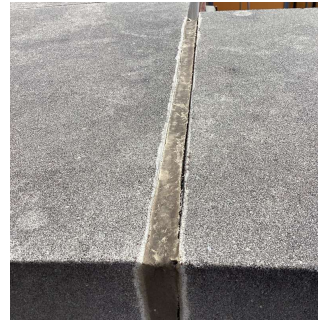
Roof 1

Deficiency CAST STONE: DETERIORATED TRANSVERSE JOINTS  
Roof Plan reference

Deficiency Quantity 50  
 Quantity Uom L.F.  
 Potential Action MAINTENANCE  
 Urgency of Action PRIORITY 3  
 Purpose of Action LEVEL 2

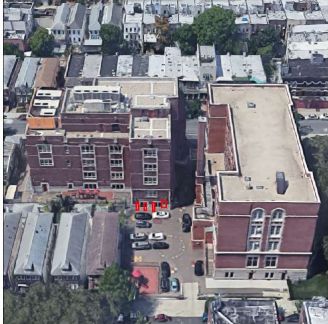
CAST IN PLACE / PRE-CAST CONCRETE: DETERIORATED CONTROL/EXPANSION JOINTS

Deficiency Quantity	60
Quantity Uom	L.F.
Potential Action	MAINTENANCE
Urgency of Action	PRIORITY 3
Purpose of Action	LEVEL 2
Deficiency Photo1	 
Violations	Facade G No violations recorded.
<b>EXTERIOR SOFFITS</b>	Inspected
Condition	2 - Between Good and Fair
Deficiency	No deficiencies recorded
<b>LOADING DOCK</b>	Does not Exist
<b>LOUVER</b>	Inspected
Condition	2 - Between Good and Fair
Deficiency	No deficiencies recorded
<b>PARAPETS</b>	Inspected
Material Type(s)	Concrete
Replacement Quantity	5,000
Replacement Uom	C.F.
Instance on All Facades	Inspected
Instance Condition	3 - Fair
Instance Quantity	5,000
Instance Quantity Uom	C.F.
Deficiency	CONCRETE: DETERIORATED CONTROL/EXPANSION JOINT

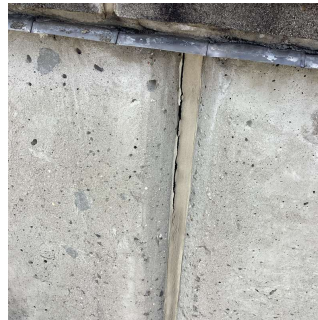
Roof 1  
No violations recorded.

50  
L.F.  
MAINTENANCE  
PRIORITY 3  
LEVEL 2

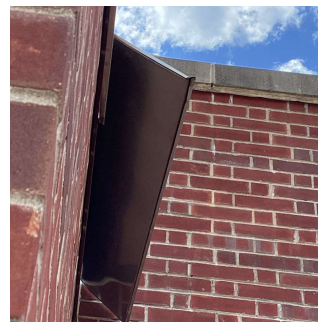
Roof 2

Priority Condition Exist Last Year?	Priority Category	Condition Description	Component Affected	Location Description	Person(s) Notified	Person(s) Title	PhotoImage
No	Potential Falling Debris	Deteriorated drip edge/gravel stop is a potential falling debris.	EXTERIOR   ROOF   Roofing   ROOFING	Penthouse roof on Main Roof on bridge side	Keith Cruz	Fireman

Do solar panels exist on these roofs?	No
Is/Are the roof(s) suitable for Solar Panel installation?	No
Installation Year	2012
Source of Installation	Custodial Staff
Deficiency	IRMA: FLASHING: DRIP EDGE/GRAVEL STOP DAMAGED

10  
L.F.  
REPLACE  
PRIORITY 5  
LEVEL 6

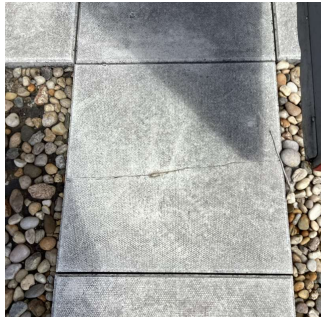
IRMA: ROOFING: DETERIORATED PAVERS WITH INTEGRAL INSULATION

10  
S.F.  
REPLACE  
PRIORITY 4  
LEVEL 2

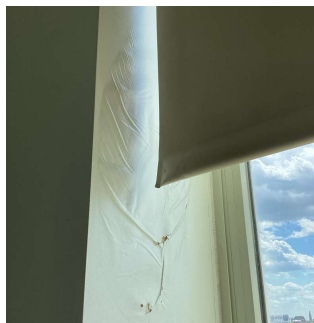
Deficiency ALUMINUM - OTHER: AIR/WATER INFILTRATION

Deficiency Quantity	800
Quantity Uom	L.F.
Potential Action	REPLACE TRIM, SILLS OR WEATHERSTRIPPING
Urgency of Action	PRIORITY 5
Purpose of Action	LEVEL 2

Facade A - Rooms 415 (Shown), 505, 509, Facade F - Room 122, 316, 414, 416, Library similar

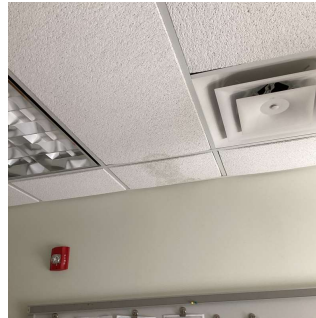
Question	Response
<b>INTERIOR</b>	
<b>CAFETERIA</b>	Inspected
<b>Floor Finish</b>	
Deficiency Photo1	 
Center	Center
Violations	No violations recorded.
<b>Sliding-folding Partition</b>	
Instance on Basement	Does not Exist
<b>Stage</b>	
Instance on Basement	Does not Exist
<b>Walls</b>	
Instance on Basement	Inspected
Condition	2 - Between Good and Fair
Deficiency	GYPSUM BOARD: DETERIORATED
Deficiency Location/Instance	Near Entrance
Deficiency Quantity	10
Quantity Uom	S.F.
Potential Action	REPLACE
Urgency of Action	PRIORITY 3
Purpose of Action	LEVEL 2
Deficiency Photo1	 
Center	Near Entrance
Violations	No violations recorded.
<b>Window Curtains/Shades/Blinds</b>	
Instance on Basement	Does not Exist
<b>CLASSROOMS/CORRIDORS/ADMIN SPACES</b>	Inspected
<b>Ceiling</b>	Inspected
Condition	2 - Between Good and Fair
Deficiency	ACOUSTIC TILES: DAMAGED/MISSING
Deficiency Location/Instance	Room 419A
Deficiency Quantity	10
Quantity Uom	S.F.

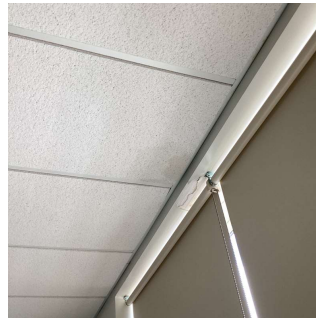
Room 415

ACOUSTIC TILES: DAMAGED/MISSING - ACTIVE LEAK

PRIORITY 5

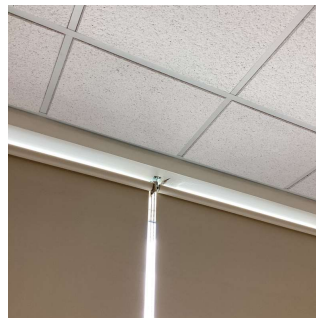
GYPSUM BOARD: DAMAGED/DETERIORATED - ACTIVE LEAK

Rooms 509, 505, 416, 415, 414, 316, 122

PRIORITY 5

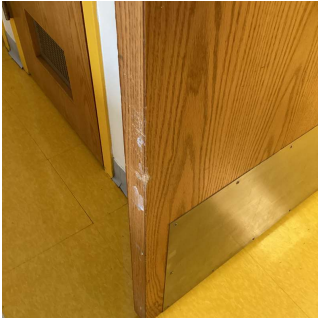
Question	Response
<b>INTERIOR</b>	
<b>CLASSROOMS/CORRIDORS/ADMIN SPACES</b>	
<b>Ceiling</b>	Inspected
	Room 505
Violations	No violations recorded.
<b>Door(s)</b>	Inspected
Condition	3 - Fair
Deficiency	WOOD: DETERIORATED DOOR
Deficiency Location/Instance	Room 406
Deficiency Quantity	1
Quantity Uom	EACH
Potential Action	MAINTENANCE
Urgency of Action	PRIORITY 3
Purpose of Action	LEVEL 2
Deficiency Photo1

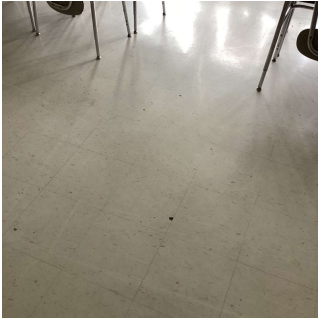
Room 406
Violations	No violations recorded.
<b>Floor Finish</b>	Inspected
Condition	2 - Between Good and Fair
Deficiency	VINYL TILES: BROKEN/DETERIORATED/MISSING TILES
Deficiency Location/Instance	Rooms 405, 309
Deficiency Quantity	20
Quantity Uom	S.F.
Potential Action	REPLACE
Urgency of Action	PRIORITY 3
Purpose of Action	LEVEL 2
Deficiency Photo1

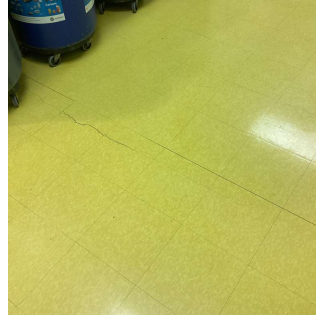
Corridor near Room C07  
No violations recorded.

Room 405
Violations	No violations recorded.
Deficiency	VINYL TILES: DETERIORATED SUBSTRATE
Deficiency Location/Instance	Corridor near Room C07, bridge to Old building

Deficiency Quantity	20
Quantity Uom	S.F.
Potential Action	REPLACE

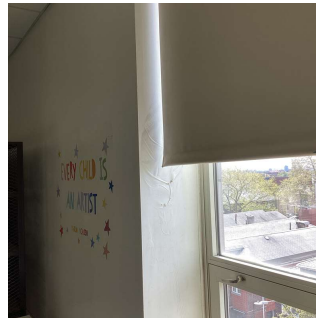
Room 415

GYPSUM BOARD: DETERIORATED - ACTIVE LEAK

PRIORITY 5

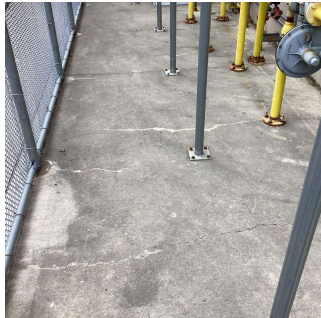
Question	Response
<b>SITE</b>	
<b>Drainage System for Asphalt</b>	Inspected
<b>Catch Basins/Manhole - Surrounded by asphalt</b>	Inspected
Condition	2 - Between Good and Fair
Deficiency	No deficiencies recorded
<b>Culverts - Asphalt Covering</b>	Does not Exist
<b>Drainage System for Concrete</b>	Inspected
<b>Catch Basins/Manhole - Surrounded by concrete</b>	Inspected
Condition	2 - Between Good and Fair
Deficiency	No deficiencies recorded
<b>Culverts - Concrete Covering</b>	Does not Exist
<b>Drainage System for Soil</b>	Does not Exist
<b>DRINKING FOUNTAINS</b>	Does not Exist
<b>FENCES</b>	Inspected
Condition	2 - Between Good and Fair
Deficiency	No deficiencies recorded
<b>IRRIGATION SYSTEM</b>	Does not Exist
<b>PAVING</b>	Inspected
<b>Student Non-Use</b>	Inspected
Gravel Exists?	No
<b>Asphalt</b>	Does not Exist
<b>Concrete</b>	Inspected
Condition	3 - Fair
Deficiency	CRACKS - MAJOR
Deficiency Location/Instance	Near Exit 3

Deficiency Quantity	125
Quantity Uom	S.F.
Potential Action	REPLACE
Urgency of Action	PRIORITY 3
Purpose of Action	LEVEL 2
Deficiency Photo1

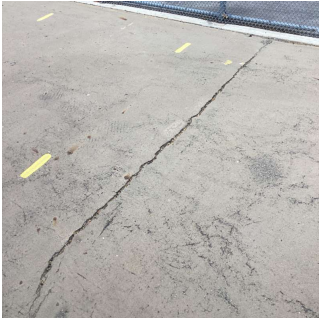
Near Exit 3	
Violations	No violations recorded.
<b>Pavers</b>	Does not Exist
<b>Student Use</b>	Does not Exist
<b>Site Sidewalks &amp; Walkways</b>	Inspected
<b>Asphalt</b>	Inspected
Condition	2 - Between Good and Fair
Deficiency	CRACKS - MAJOR
Deficiency Location/Instance	Exit 3
Deficiency Quantity	40

Question	Response
<b>SITE</b>	
<b>PAVING</b>	
<b>Site Sidewalks &amp; Walkways</b>	
<b>Asphalt</b>	
Quantity Uom	S.F.
Potential Action	REPLACE
Urgency of Action	PRIORITY 3
Purpose of Action	LEVEL 2
Deficiency Photo1

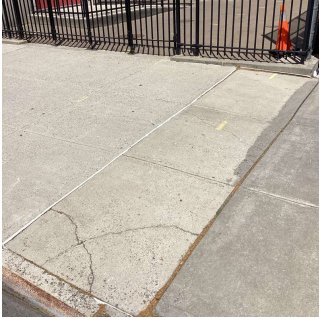
Exit 3
Violations	No violations recorded.
<b>Concrete</b>	Inspected
Condition	2 - Between Good and Fair
Deficiency	No deficiencies recorded
<b>Pavers</b>	Does not Exist
<b>DOT Sidewalk</b>	Inspected
<b>Asphalt</b>	Does not Exist
<b>Concrete</b>	Inspected
Condition	3 - Fair
Deficiency	DAMAGED/DETERIORATED/MISSING SECTIONS
Deficiency Location/Instance	52nd Street
Deficiency Quantity	150
Quantity Uom	S.F.
Potential Action	REPLACE
Urgency of Action	PRIORITY 3
Purpose of Action	LEVEL 2
Deficiency Photo1
