NYC Department of Education
Building Condition Assessment Survey 2023 - 2024

Architectural Inspection

Asset: P.S. 216 ANNEX - BROOKLYN, 2421 WEST STREET, New York, 11223

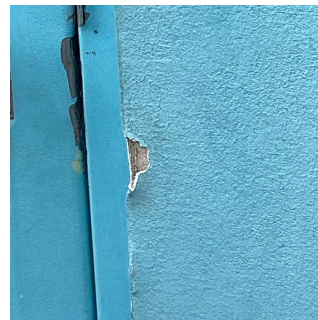
Facade A
No violations recorded.

Question	Response
Architectural	
EXTERIOR	Inspected
AREAWAY	Does not Exist
AWNINGS AND CANOPIES	Does not Exist
CHIMNEY	Does not Exist
COPING	Inspected
Condition	2 - Between Good and Fair
Deficiency	No deficiencies recorded
CORNICE	Does not Exist
DOORS	Inspected
DOORS AND FRAMES	Inspected
Condition	2 - Between Good and Fair
Deficiency	No deficiencies recorded
DOOR HARDWARE	Inspected
Condition	3 - Fair
Deficiency	No deficiencies recorded
LINTELS	Inspected
Condition	2 - Between Good and Fair
Deficiency	No deficiencies recorded
TRANSOM/SIDE LIGHT	Does not Exist
EXTERIOR WALLS	Inspected
Material Type(s)	Masonry, Wood
Replacement Quantity	2,500
Replacement Uom	S.F.
Instance on All Facades	Inspected
Instance Condition	3 - Fair
Instance Quantity	2,500
Instance Quantity Uom	S.F.
Deficiency	STUCCO CEMENT SURFACE: CRACKS, SPALLING

10
S.F.
REPLACE
PRIORITY 4
LEVEL 2
