**NYC Department of Education**  
**Building Condition Assessment Survey 2023 - 2024**

Architectural Inspection

**Asset: LEON GOLDSTEIN HS - BROOKLYN, 1830 SHORE BOULEVARD, New York, 11235**

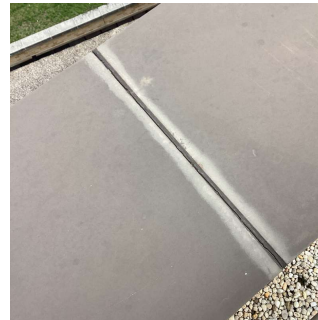
Roof 1 - Facade A

Question	Response
<b>Architectural</b>	
<b>EXTERIOR</b>	Inspected
<b>AREAWAY</b>	Does not Exist
<b>AWNINGS AND CANOPIES</b>	Does not Exist
<b>CHIMNEY</b>	Does not Exist
<b>COPING</b>	Inspected
Condition	3 - Fair
Deficiency	METAL: DETERIORATED TRANSVERSE JOINTS

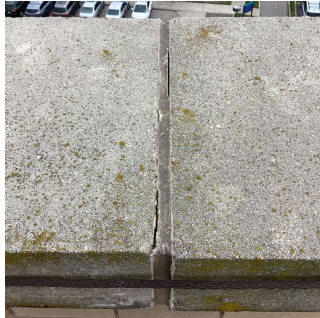
CAST STONE: DETERIORATED TRANSVERSE JOINTS

Violations	Roof 1 - Facade D No violations recorded.
<b>CORNICE</b>	Does not Exist
<b>DOORS</b>	Inspected
<b>DOORS AND FRAMES</b>	Inspected
Condition	5 - Poor
Deficiency	METAL: DETERIORATED DOOR AND FRAME - MAJOR DETERIORATION
Roof Plan reference

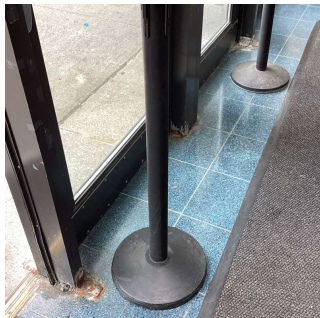
Violations	Facade A - Main Entrance No violations recorded.
<b>DOOR HARDWARE</b>	Inspected
Condition	3 - Fair
Deficiency	No deficiencies recorded
<b>LINTELS</b>	Inspected
Condition	2 - Between Good and Fair

Deficiency Quantity	8
Quantity Uom	EACH
Potential Action	REPLACE
Urgency of Action	PRIORITY 4
Purpose of Action	LEVEL 2
Deficiency Photo1

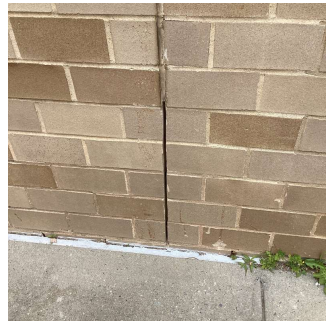
Question	Response
<b>EXTERIOR</b>	
<b>EXTERIOR WALLS</b>	Inspected
	Facade C - Corridor near Stair A/2 shown, Facade C - Corridor near Stair A/1 similar
Violations	No violations recorded.
Deficiency	<b>BRICK: DETERIORATED CONTROL/EXPANSION JOINTS</b>
Roof Plan reference

Violations	Facade F No violations recorded.
Deficiency	<b>BRICK: CRACKS/DISPLACED/SPALLED BRICK AT BUILDING CORNERS</b>

Deficiency Quantity	10
Quantity Uom	L.F.
Potential Action	MAINTENANCE
Urgency of Action	PRIORITY 3
Purpose of Action	LEVEL 2
Deficiency Photo1

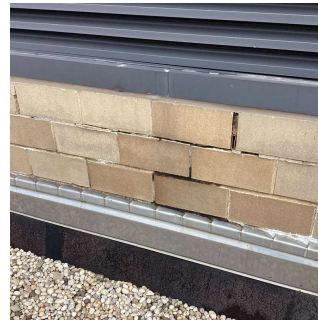
Roof 2 - Facade L

BRICK: DETERIORATED JOINTS

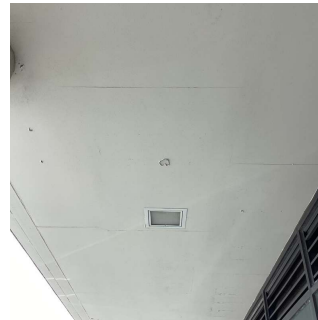
Facade E

STUCCO/PLASTER: MINOR CRACKS/SPALLING

REPAIR

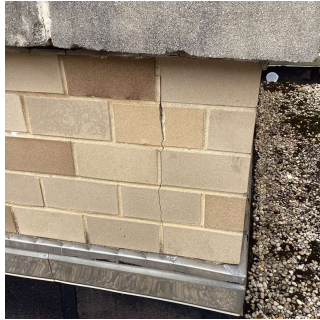
BRICK: MINOR CRACKS, SPALLING

Violations	Roof 3 - Facade G No violations recorded.
<b>PLAZA DECK</b>	Does not Exist
<b>ROOF</b>	Inspected
<b>Roofing</b>	Inspected
Replacement Quantity	40,000
Replacement Uom	S.F.
<b>ROOF HATCH/SMOKE HATCH</b>	Inspected
Condition	5 - Poor
Deficiency	INOPERABLE
Roof Plan reference

Deficiency Quantity	20
Quantity Uom	S.F.
Potential Action	REPAIR
Urgency of Action	PRIORITY 3
Purpose of Action	LEVEL 2

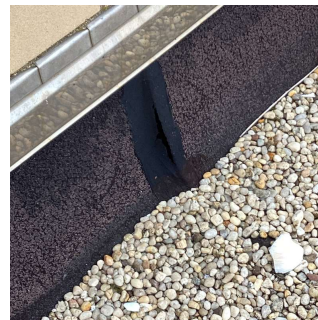
Roof 1 - Facade D

**BUILT-UP: FLASHING: DETERIORATED JOINTS**

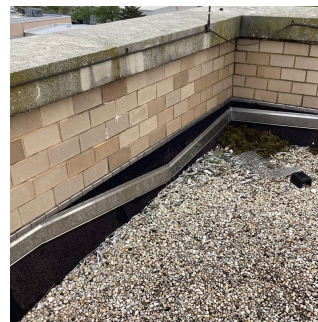
Roof 1 - Facade D

**BUILT-UP: FLASHING: CAP FLASHING DAMAGED**

70  
L.F.  
REPLACE  
PRIORITY 4  
LEVEL 2

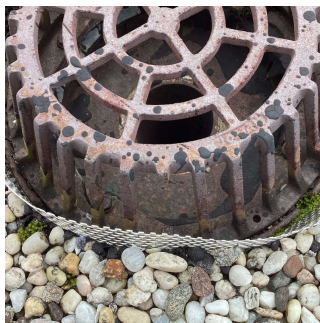
Violations	Roof 1 - Mechanical Equipment Room 423 No violations recorded.
<b>ROOFING DRAINS</b>	Inspected
Condition	3 - Fair
Deficiency	DETERIORATED
Roof Plan reference

Violations	Roof 1 No violations recorded.
<b>Specialties</b>	Inspected
<b>BULKHEAD/PENTHOUSE</b>	Inspected
Condition	2 - Between Good and Fair
Deficiency	No deficiencies recorded
<b>CUPOLA/ SPIRES/ TOWERS</b>	Does not Exist
<b>DORMER</b>	Does not Exist

Deficiency Quantity	1
Quantity Uom	EACH
Potential Action	REPLACE
Urgency of Action	PRIORITY 4
Purpose of Action	LEVEL 2
Deficiency Photo1

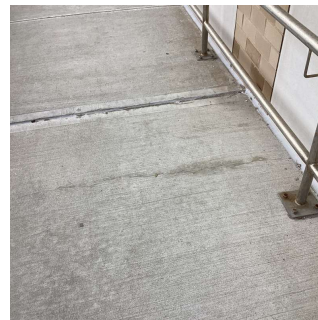
Facade E - HC Ramp

CONCRETE: CRACKS/SPALLING - MINOR

REPAIR

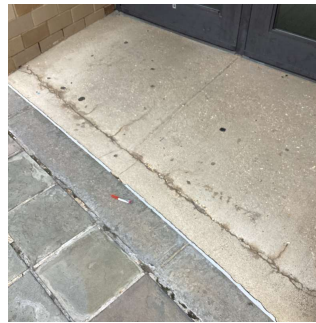
Facade J

CONCRETE: CRACKS/SPALLING - MAJOR

REPLACE

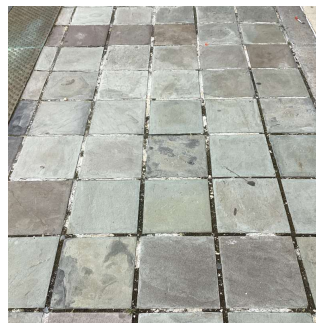
Facade J

**STONE: DETERIORATED JOINTS**

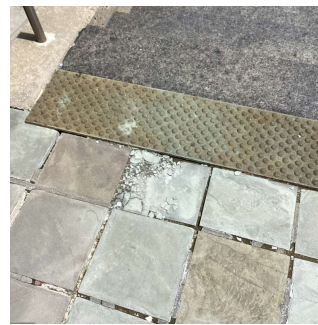
Facade D  
No violations recorded.

**STONE: CRACKS/SPALLING - MAJOR**

100  
S.F.  
REPLACE  
PRIORITY 4  
LEVEL 2

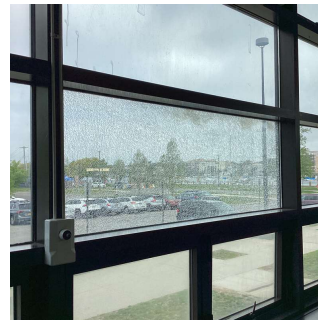
Facade J - Cafeteria

<b>WINDOWS</b>	Inspected
Replacement Quantity	3,500
Replacement Uom	S.F.
<b>EXTERIOR GUARDS</b>	Does not Exist
<b>LINTELS</b>	Inspected
Condition	2 - Between Good and Fair
Deficiency	No deficiencies recorded
<b>WINDOWS</b>	Inspected
Material Type(s)	Aluminum
Instance on Aluminum - Other: All Facades	Inspected
Instance Condition	3 - Fair
Instance Quantity	3,500
Instance Quantity Uom	S.F.
Are these windows insulated	Yes
Installation Year	2002
Source of Installation	Custodial Staff
Deficiency	ALUMINUM - OTHER: BROKEN PANE

60  
S.F.  
MAINTENANCE  
PRIORITY 3  
LEVEL 2

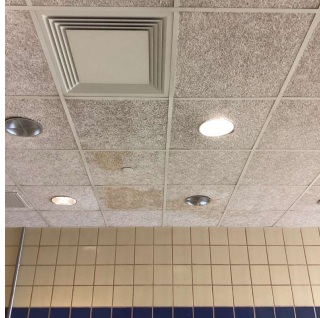
Near Windows
Violations	No violations recorded.
Deficiency	TECTUM: DAMAGED/MISSING

Near Main Entrance
	No violations recorded.
Violations	
<b>Door(s)</b>	
Instance on 1st Floor	Inspected
Condition	2 - Between Good and Fair
Deficiency	No deficiencies recorded
<b>Fixed Equipment</b>	
Instance on 1st Floor	Does not Exist
<b>Floor Finish</b>	
Instance on 1st Floor	Inspected
Condition	2 - Between Good and Fair
Deficiency	VINYL TILES: DETERIORATED SUBSTRATE
Deficiency Location/Instance	Near Main Entrance
Deficiency Quantity	10
Quantity Uom	S.F.
Potential Action	REPLACE
Urgency of Action	PRIORITY 3
Purpose of Action	LEVEL 2
Deficiency Photo1

Question	Response
<b>INTERIOR</b>	
<b>CAFETERIA</b>	
<b>Ceiling</b>	
Quantity Uom	S.F.
Potential Action	REPLACE
Urgency of Action	PRIORITY 3
Purpose of Action	LEVEL 2
Deficiency Photo1

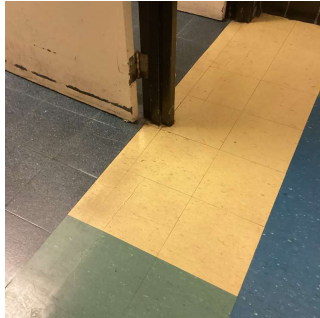
Near Main Entrance
	No violations recorded.
Violations	
Deficiency	VINYL TILES: BROKEN/DETERIORATED/MISSING TILES
Deficiency Location/Instance	Near Emergency Exit
Deficiency Quantity	10

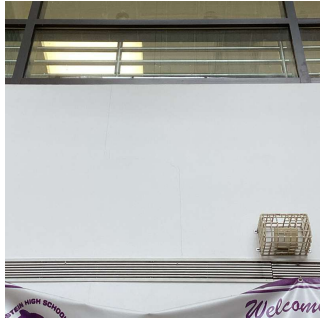
Question	Response
<b>INTERIOR</b>	
<b>CLASSROOMS/CORRIDORS/ADMIN SPACES</b>	
<b>Floor Finish</b>	Inspected
	Corridor near Room 407
Violations	No violations recorded.
<b>Walls</b>	Inspected
Condition	2 - Between Good and Fair
Deficiency	GYPSUM BOARD: DETERIORATED
Deficiency Location/Instance	Main Entrance Lobby
Deficiency Quantity	20
Quantity Uom	S.F.
Potential Action	REPLACE
Urgency of Action	PRIORITY 3
Purpose of Action	LEVEL 2
Deficiency Photo1

Violations	Main Entrance Lobby No violations recorded.
Deficiency	GLAZED BLOCK: CRACKS/SPALLING
Deficiency Location/Instance	Corridor near Gymnasium
Deficiency Quantity	10
Quantity Uom	S.F.
Potential Action	REPLACE
Urgency of Action	PRIORITY 3
Purpose of Action	LEVEL 2
Deficiency Photo1

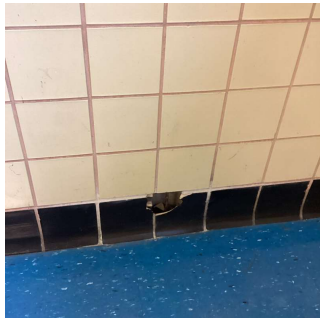
Violations	Corridor near Gymnasium No violations recorded.
<b>Specialties</b>	Inspected
<b>Classroom Locker(s)</b>	Inspected
Condition	2 - Between Good and Fair
Deficiency	No deficiencies recorded

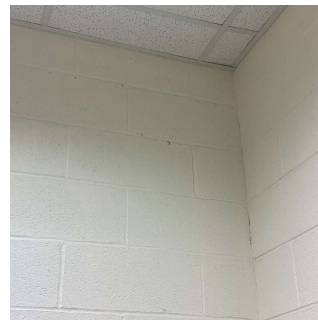
Deficiency	MASONRY: CRACKS/SPALLING
Deficiency Location/Instance	Office Room
Deficiency Quantity	10
Quantity Uom	S.F.
Potential Action	REPLACE
Urgency of Action	PRIORITY 3
Purpose of Action	LEVEL 2
Deficiency Photo1

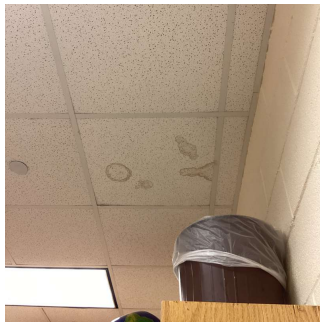
Violations	<p>Servery</p> <p>No violations recorded.</p>
<b>LIBRARY</b>	
Instance on Room 107	Inspected
<b>Built-in Furnishing</b>	Inspected
Instance on Room 107	Inspected
Condition	2 - Between Good and Fair
Deficiency	No deficiencies recorded
<b>Ceiling</b>	
Instance on Room 107	Inspected
Condition	5 - Poor
Deficiency	ACOUSTIC TILES: DAMAGED/MISSING
Deficiency Location/Instance	Room 107C
Deficiency Quantity	10
Quantity Uom	S.F.
Potential Action	REPLACE
Urgency of Action	PRIORITY 3
Purpose of Action	LEVEL 2
Deficiency Photo1

Violations	<p>Room 107C</p> <p>No violations recorded.</p>
Deficiency	GYPSUM BOARD: DAMAGED/DETERIORATED
Deficiency Location/Instance	Near Main Entrance, Center, Right and Left Side, close to Windows and others
Deficiency Quantity	160
Quantity Uom	S.F.
Potential Action	REPLACE
Urgency of Action	PRIORITY 3

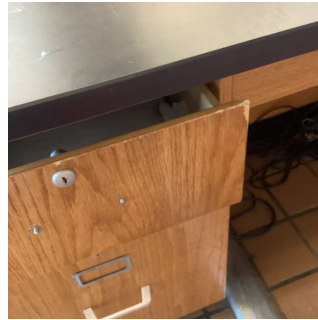
Room 354

Deficiency	CABINETS: MISSING/DAMAGED
Deficiency Location/Instance	Rooms 345, 354
Deficiency Quantity	10
Quantity Uom	L.F.
Potential Action	REPLACE
Urgency of Action	PRIORITY 3
Purpose of Action	LEVEL 2
Deficiency Photo1

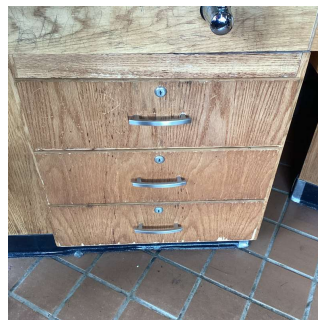
Deficiency	CABINETS: MISSING/DAMAGED
Deficiency Location/Instance	Rooms 340, 352, 356
Deficiency Quantity	54
Quantity Uom	L.F.
Potential Action	REPLACE
Urgency of Action	PRIORITY 3
Purpose of Action	LEVEL 2
Deficiency Photo1

Question	Response
<b>INTERIOR</b>	
<b>SCIENCE LAB</b>	Inspected
<b>Fixed Equipment</b>	
Violations	Room 352 No violations recorded.
<b>SCIENCE PREP ROOM</b>	Inspected
Instance on Room 341	Inspected
Alternative use	No
<b>Fixed Equipment</b>	
Instance on Room 341	Inspected
Condition	3 - Fair
Deficiency	CABINETS: MISSING/DAMAGED
Deficiency Location/Instance	Room 341
Deficiency Quantity	10
Quantity Uom	L.F.
Potential Action	REPLACE
Urgency of Action	PRIORITY 3
Purpose of Action	LEVEL 2
Deficiency Photo1
