NYC Department of Education
Building Condition Assessment Survey 2023 - 2024

Architectural Inspection

Asset: JOHN DEWEY HS - K, 50 AVENUE X, New York, 11223

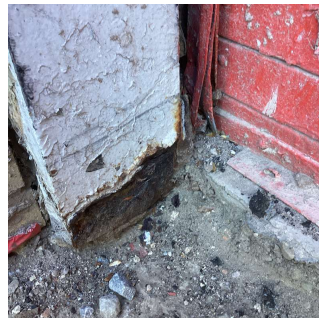
Question	Response
EXTERIOR	
DOORS	
DOORS AND FRAMES	Inspected
Condition	4 - Between Fair and Poor
Deficiency	ROLL-UP DOOR: DETERIORATED DOOR AND FRAME - MAJOR DETERIORATION
Roof Plan reference

Deficiency Quantity	300
Quantity Uom	S.F.
Potential Action	REPLACE
Urgency of Action	PRIORITY 4
Purpose of Action	LEVEL 2
Deficiency Photo1

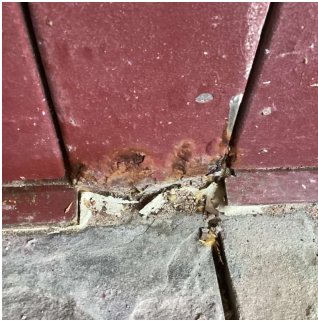
Violations	Facade P No violations recorded.
Deficiency	METAL: DETERIORATED DOOR AND FRAME - MAJOR DETERIORATION
Roof Plan reference

Deficiency Quantity	8
Quantity Uom	EACH
Potential Action	REPLACE
Urgency of Action	PRIORITY 4
Purpose of Action	LEVEL 2

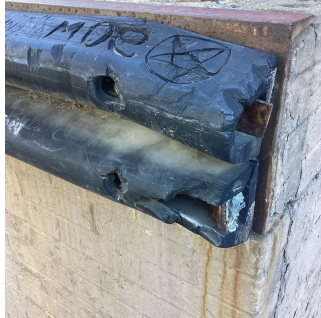
Question	Response
EXTERIOR	
LOADING DOCK	
Deficiency Quantity	1
Quantity Uom	EACH
Potential Action	REPLACE
Urgency of Action	PRIORITY 4
Purpose of Action	LEVEL 2
Deficiency Photo1

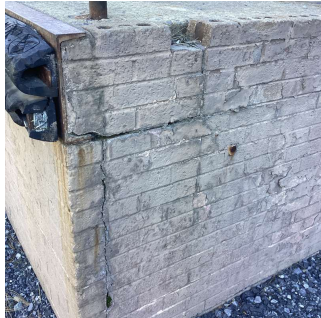
Violations	Facade P No violations recorded.
Deficiency	CHEEK WALL/CRACKS, SPALLING - MAJOR
Roof Plan reference

Deficiency Quantity	30
Quantity Uom	S.F.
Potential Action	REPLACE
Urgency of Action	PRIORITY 4
Purpose of Action	LEVEL 2
Deficiency Photo1

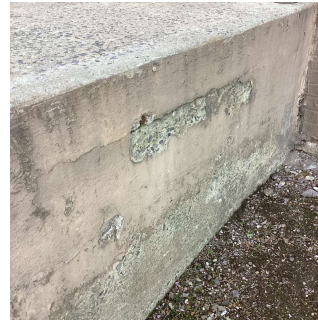
Facade P

CAST IN PLACE CONCRETE: CRACKS/SPALLING - MINOR

REPAIR

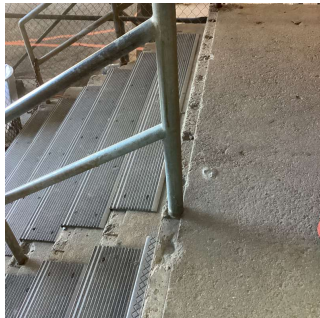
Violations	Facade G No violations recorded.
Deficiency	CONCRETE: WORN-OUT TREAD/RISER/NOSING
Roof Plan reference	<p>K540</p>

Deficiency Quantity	10
Quantity Uom	S.F.
Potential Action	REPLACE
Urgency of Action	PRIORITY 5
Purpose of Action	LEVEL 6
Deficiency Photo1

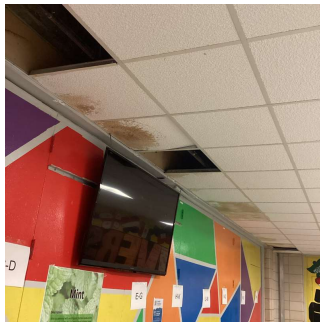
Question	Response
INTERIOR	
STRUCTURAL	
ROOF STRUCTURE	Inspected
Deficiency Photo1	 
	Roof 1 - Bulkhead/Penthouse 3
Violations	No violations recorded.
VAULTS-BUNKERS	Does not Exist
AUDITORIUM	Inspected
Instance on 1st Floor (980 Seats)	Under Construction
CAFETERIA	Inspected
Instance on 1st Floor - Staff (1500 SF)	Inspected
Instance on 1st Floor - Students	Inspected
Ceiling	
Instance on 1st Floor - Staff (1500 SF)	Inspected
Condition	2 - Between Good and Fair
Deficiency	ACOUSTIC TILES: DAMAGED/MISSING
Deficiency Location/Instance	Near Entrance, center
Deficiency Quantity	20
Quantity Uom	S.F.
Potential Action	REPLACE
Urgency of Action	PRIORITY 3
Purpose of Action	LEVEL 2
Deficiency Photo1	 
	Near center
Violations	No violations recorded.
Instance on 1st Floor - Students	Inspected
Condition	3 - Fair
Deficiency	ACOUSTIC TILES: DAMAGED/MISSING
Deficiency Location/Instance	Near Entrances
Deficiency Quantity	170
Quantity Uom	S.F.

Potential Action	REPLACE
Urgency of Action	PRIORITY 3
Purpose of Action	LEVEL 2

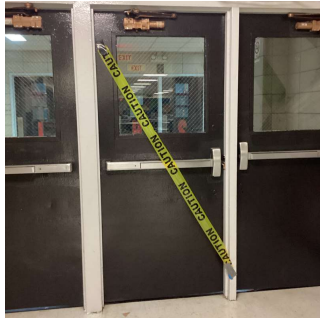
Violations	Near Entrance No violations recorded.
Door(s)	
Instance on 1st Floor - Students	Inspected
Condition	4 - Between Fair and Poor
Deficiency	METAL: DETERIORATED DOOR
Deficiency Location/Instance	Entrance
Deficiency Quantity	1
Quantity Uom	EACH
Potential Action	MAINTENANCE
Urgency of Action	PRIORITY 4
Purpose of Action	LEVEL 4
Deficiency Photo1

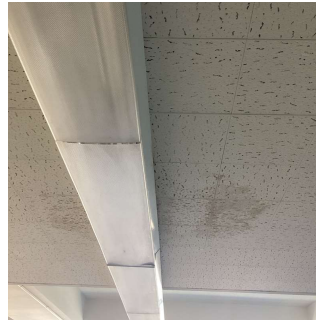
Room 370

Room 226
Violations	No violations recorded.
Deficiency	ACOUSTIC TILES ON PLASTER: DAMAGED/MISSING
Deficiency Location/Instance	Rooms 370, Corridor near Rooms 108, 118, 318, 327, and others
Deficiency Quantity	800
Quantity Uom	S.F.
Potential Action	REPLACE
Urgency of Action	PRIORITY 3
Purpose of Action	LEVEL 2

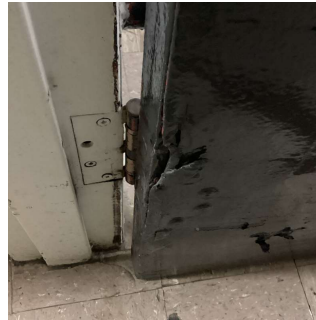
Corridor near Room C376

METAL: DETERIORATED DOOR

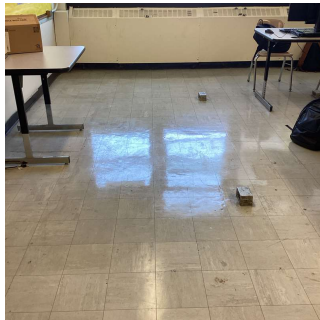
Corridor near Room 221
Violations	35654736N
Deficiency	VINYL TILES: TRIPPING HAZARD - ELECTRICAL OUTLET
Deficiency Location/Instance	Room 305
Deficiency Quantity	10
Quantity Uom	S.F.
Potential Action	REMOVE
Urgency of Action	PRIORITY 5
Purpose of Action	LEVEL 6
Deficiency Photo1

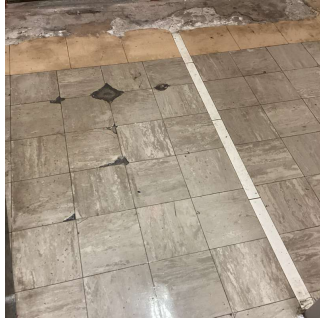
Corridor near Room 200
Violations	35654736N
Deficiency	VINYL TILES: BROKEN/DETERIORATED/MISSING TILES
Deficiency Location/Instance	Room 370, Corridor near Room 372, Vestibule Exit 7
Deficiency Quantity	800
Quantity Uom	S.F.
Potential Action	REPLACE
Urgency of Action	PRIORITY 3
Purpose of Action	LEVEL 2
Deficiency Photo1

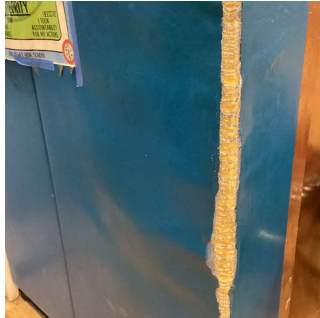
Question	Response
INTERIOR	
GYMNASIUM	
Walls	
Violations	Near Storage Room No violations recorded.
Deficiency	WALL PADDING: DETERIORATED
Deficiency Location/Instance	Near Entrance G/17, Windows, Storage Rooms
Deficiency Quantity	200
Quantity Uom	S.F.
Potential Action	REPLACE
Urgency of Action	PRIORITY 3
Purpose of Action	LEVEL 2
Deficiency Photo1

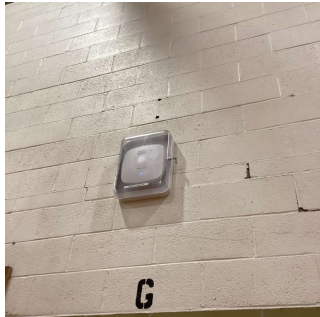
Violations	Near Entrance G/17 No violations recorded.
Instance on 1st Floor - G14	Inspected
Condition	3 - Fair
Deficiency	MASONRY: CRACKS/SPALLING
Deficiency Location/Instance	Near Entrance
Deficiency Quantity	10
Quantity Uom	S.F.
Potential Action	REPLACE
Urgency of Action	PRIORITY 3
Purpose of Action	LEVEL 2
Deficiency Photo1

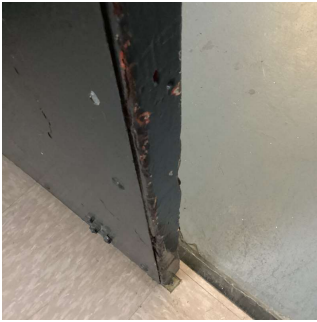
Violations	Entrance No violations recorded.
Instance on 1st Floor - Girls (1586 Lockers)	Inspected
Condition	5 - Poor
Deficiency	WOOD: DETERIORATED DOOR
Deficiency Location/Instance	Entrance,Exit
Deficiency Quantity	4
Quantity Uom	EACH
Potential Action	MAINTENANCE
Urgency of Action	PRIORITY 3
Purpose of Action	LEVEL 2
Deficiency Photo1

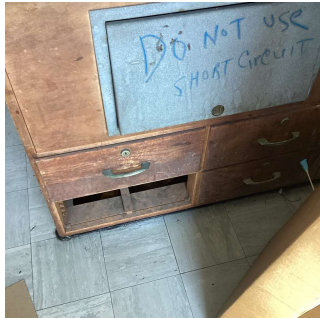
Question	Response
INTERIOR	
SCIENCE PREP ROOM	
Fixed Equipment	
Deficiency	CABINETS: MISSING/DAMAGED
Deficiency Location/Instance	Room 320
Deficiency Quantity	10
Quantity Uom	L.F.
Potential Action	REPLACE
Urgency of Action	PRIORITY 3
Purpose of Action	LEVEL 2
Deficiency Photo1

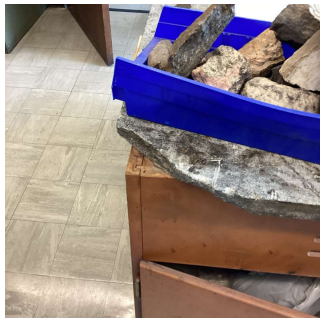
Room 320
Violations	No violations recorded.
Instance on Room 246, 322	Inspected
Condition	5 - Poor
Deficiency	DEMO TABLE: DAMAGED/DETERIORATED
Deficiency Location/Instance	Rooms 246, 322
Deficiency Quantity	2
Quantity Uom	EACH
Potential Action	REPLACE
Urgency of Action	PRIORITY 3
Purpose of Action	LEVEL 2
Deficiency Photo1

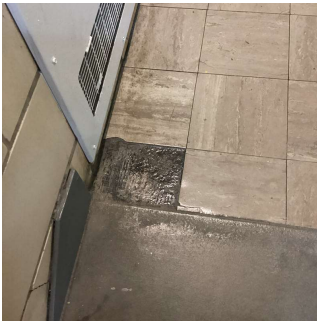
Violations	Stair E/1 No violations recorded.
Deficiency	VINYL TILES: BROKEN/DETERIORATED/MISSING TILES
Deficiency Location/Instance	Stairs D/1, 2, E/2, F/1, 3, and others
Deficiency Quantity	150
Quantity Uom	S.F.
Potential Action	REPLACE
Urgency of Action	PRIORITY 3
Purpose of Action	LEVEL 2
Deficiency Photo1

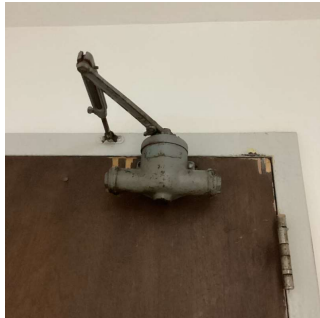
Violations	Room 2SMT No violations recorded.
Door(s)	Inspected
Condition	5 - Poor
Deficiency	WOOD: DETERIORATED DOOR
Deficiency Location/Instance	Rooms 1EMT, 1SFT, 1SMT, 2SMT, 2NFT, and others
Deficiency Quantity	11
Quantity Uom	EACH
Potential Action	MAINTENANCE
Urgency of Action	PRIORITY 3
Purpose of Action	LEVEL 2
Deficiency Photo1

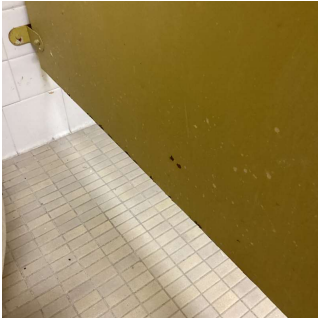
Room 3NG
Violations	No violations recorded.
Deficiency	RUST - MAJOR
Deficiency Location/Instance	Room 3NG
Deficiency Quantity	2
Quantity Uom	EACH
Potential Action	REPLACE
Urgency of Action	PRIORITY 3
Purpose of Action	LEVEL 2
Deficiency Photo1

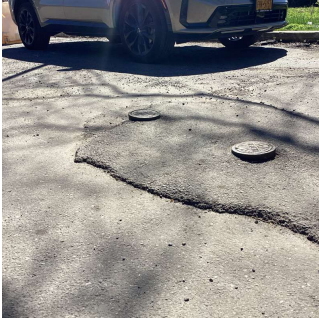
Violations	Stillwell Avenue No violations recorded.
IRRIGATION SYSTEM	
	Does not Exist
PAVING	
	Inspected
Student Non-Use	
Gravel Exists?	Inspected No
Asphalt	
Condition	Inspected 5 - Poor
Deficiency	HEAVING
Deficiency Location/Instance	Near Exit 5
Deficiency Quantity	20
Quantity Uom	S.F.
Potential Action	REPLACE
Urgency of Action	PRIORITY 5
Purpose of Action	LEVEL 6
Deficiency Photo1
