NYC Department of Education
Building Condition Assessment Survey 2023 - 2024

Architectural Inspection

K554

Asset: ALL CITY LEADERSHIP SECONDARY SCHOOL - BROOKLYN, 321 PALMETTO STREET, New York, 11237

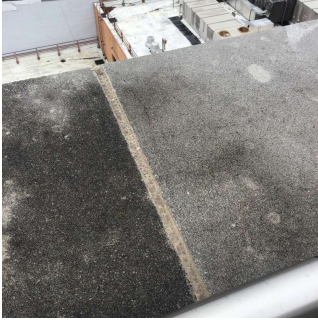
3 - Fair

CAST STONE: CRACKED/BROKEN PIECES

REPLACE-IN-KIND

PRIORITY 4

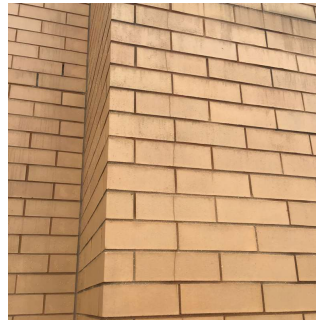
Facade A

Violations	Roof 1 No violations recorded.
CORNICE	Does not Exist
DOORS	Inspected
DOORS AND FRAMES	Inspected
Condition	2 - Between Good and Fair
Deficiency	No deficiencies recorded
DOOR HARDWARE	Inspected
Condition	2 - Between Good and Fair
Deficiency	No deficiencies recorded
LINTELS	Inspected
Condition	2 - Between Good and Fair
Deficiency	No deficiencies recorded
TRANSOM/SIDE LIGHT	Inspected
Condition	2 - Between Good and Fair
Deficiency	No deficiencies recorded
EXTERIOR WALLS	Inspected
Material Type(s)	Masonry
Replacement Quantity	50,000
Replacement Uom	S.F.
Instance on All Facades	Inspected
Instance Condition	2 - Between Good and Fair
Instance Quantity	50,000
Instance Quantity Uom	S.F.
Deficiency	BRICK: MINOR CRACKS AND SPALLING
Roof Plan reference

RESTITCH

PRIORITY 3

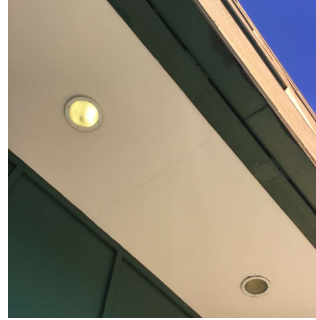
Facade A

STUCCO/PLASTER: MINOR CRACKS/SPALLING

Quantity Uom	S.F.
Potential Action	REPAIR
Urgency of Action	PRIORITY 3
Purpose of Action	LEVEL 2
Deficiency Photo1

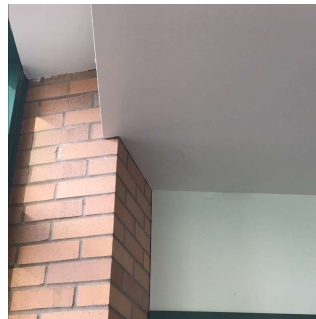
Roof 5 - 1st Floor Corridor
No violations recorded.

Is/Are the roof(s) suitable for Solar Panel installation?	No
Installation Year	2013
Source of Installation	Custodial Staff
Deficiency	IRMA: ROOFING: MAJOR ACTIVE ROOF LEAKS IN INSTRUCTIONAL SPACE

100
S.F.
REPLACE ROOFING WITHOUT MAJOR EQUIPMENT
REMOVAL
PRIORITY 5
LEVEL 2

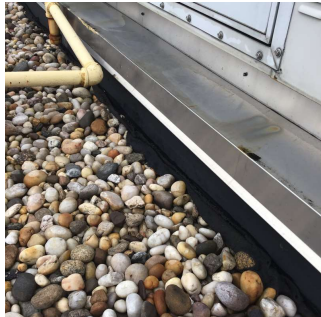
IRMA: FLASHING: BASE FLASHING DETERIORATED

30
S.F.
REPLACE
PRIORITY 4
LEVEL 2

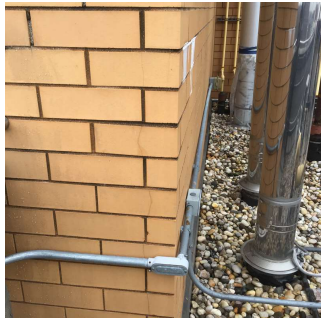
Roof 1 BH
Violations	No violations recorded.
Deficiency	BULKHEAD/PENTHOUSE WALLS/EXTERIOR: EFFLORESCENCE

Roof 1 RTU1
Violations	No violations recorded.
ROOFING DRAINS	Inspected
Condition	2 - Between Good and Fair
Deficiency	No deficiencies recorded
Specialties	Inspected
BULKHEAD/PENTHOUSE	Inspected
Condition	3 - Fair
Deficiency	BULKHEAD/PENTHOUSE WALLS/EXTERIOR: CRACKS/SPALLING - MINOR
Roof Plan reference

Deficiency Quantity	20
Quantity Uom	S.F.
Potential Action	REPAIR
Urgency of Action	PRIORITY 3
Purpose of Action	LEVEL 2
Deficiency Photo1

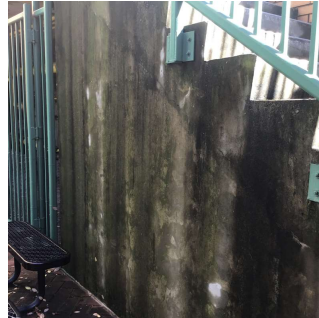
Violations	No violations recorded.
CUPOLA/ SPIRES/ TOWERS	Does not Exist
DORMER	Does not Exist
DUNNAGE STEEL	Does not Exist
SKYLIGHT/ROOF VENT	Does not Exist
ROOF/GRAVITY TANK	Does not Exist
STAIRS/RAMPS: EXTERIOR	Inspected
BUILDING CHEEK/FLANK WALLS	Inspected
Condition	2 - Between Good and Fair
Deficiency	No deficiencies recorded
RAILINGS	Inspected
Condition	2 - Between Good and Fair
Deficiency	No deficiencies recorded
STAIRS/RAMPS	Inspected
Condition	3 - Fair
Deficiency	CONCRETE: CRACKS/SPALLING - MINOR

Deficiency Quantity	30
Quantity Uom	S.F.
Potential Action	REPAIR
Urgency of Action	PRIORITY 3
Purpose of Action	LEVEL 2
Deficiency Photo1

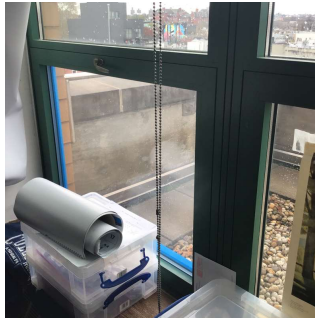
Facade B - Room 401B shown, Facade A Stair A/3 similar

Violations	Facade A No violations recorded.
WINDOWS	Inspected
Replacement Quantity	4,000
Replacement Uom	S.F.
EXTERIOR GUARDS	Inspected
Condition	2 - Between Good and Fair
Deficiency	No deficiencies recorded
LINTELS	Inspected
Condition	2 - Between Good and Fair
Deficiency	No deficiencies recorded
WINDOWS	Inspected
Material Type(s)	Aluminum
Instance on Aluminum - Other: All Facades except Facade E	Inspected
Instance Condition	3 - Fair
Instance Quantity	4,000
Instance Quantity Uom	S.F.
Are these windows insulated	Yes
Installation Year	2013
Source of Installation	Custodial Staff
Deficiency	ALUMINUM - OTHER: AIR/WATER INFILTRATION

REPLACE TRIM, SILLS OR WEATHERSTRIPPING

PRIORITY 5

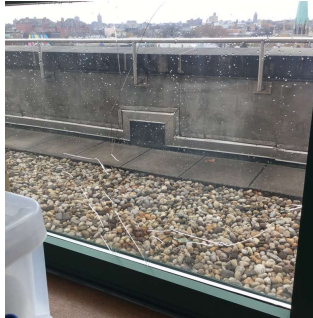
Room 401A

ALUMINUM - OTHER: BROKEN PANE

MAINTENANCE

PRIORITY 3

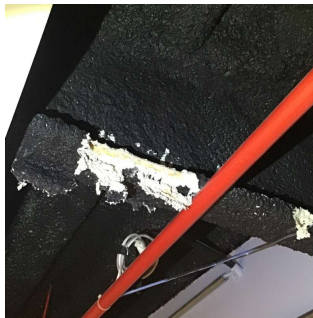
STEEL COLUMNS/BEAMS: DETERIORATED/MISSING SPRAY-ON FIREPROOFING

Auditorium

REPLACE

PRIORITY 3

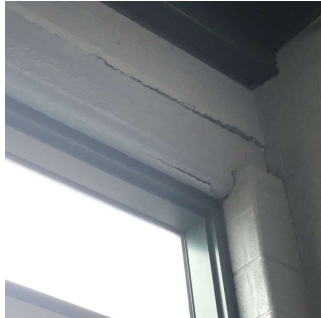
Question	Response
INTERIOR	
STRUCTURAL	
COLUMNS/BEAMS/BEARING WALLS	Inspected
	Stage Right
Violations	No violations recorded.
FLOOR STRUCTURE	Inspected
Condition	2 - Between Good and Fair
Deficiency	No deficiencies recorded
FOUNDATION WALLS	Inspected
Material Type(s)	Concrete
Condition	2 - Between Good and Fair
Deficiency	No deficiencies recorded
ROOF STRUCTURE	Inspected
Condition	2 - Between Good and Fair
Deficiency	STEEL COLUMNS/BEAMS: DETERIORATED CONCRETE FIREPROOFING
Deficiency Location/Instance	Facade A Stair A/4
Deficiency Quantity	20
Quantity Uom	S.F.
Potential Action	REPLACE
Urgency of Action	PRIORITY 3
Purpose of Action	LEVEL 5
Deficiency Photo1

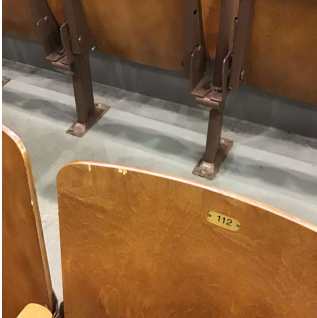
Question	Response
INTERIOR	
AUDITORIUM	
Fixed Seating	
Condition	3 - Fair
Deficiency	DAMAGED/BROKEN/INOPERABLE
Deficiency Location/Instance	Seats A/2,10,101,103,J12, and others
Deficiency Quantity	16
Quantity Uom	EACH
Potential Action	REPLACE
Urgency of Action	PRIORITY 3
Purpose of Action	LEVEL 2
Deficiency Photo1

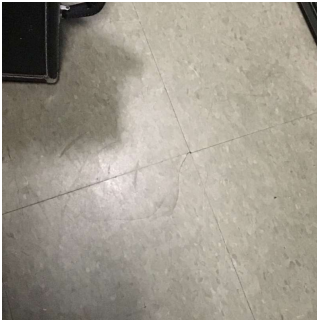
Violations	Seat J/112 No violations recorded.
Floor Finish	
Instance on 1st Floor (339 seats)	Inspected
Condition	2 - Between Good and Fair
Deficiency	VINYL TILES: BROKEN/DETERIORATED/MISSING TILES
Deficiency Location/Instance	Storage Room
Deficiency Quantity	10
Quantity Uom	S.F.
Potential Action	REPLACE
Urgency of Action	PRIORITY 3
Purpose of Action	LEVEL 2
Deficiency Photo1

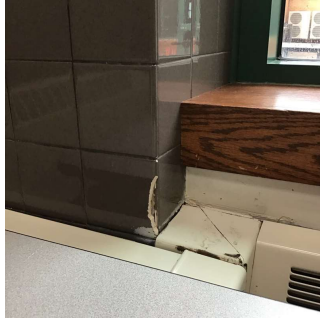
Question	Response
INTERIOR	
CAFETERIA	
Floor Finish	
Condition	2 - Between Good and Fair
Deficiency	No deficiencies recorded
Sliding-folding Partition	
Instance on Basement	Does not Exist
Stage	
Instance on Basement	Does not Exist
Walls	
Instance on Basement	Inspected
Condition	2 - Between Good and Fair
Deficiency	CERAMIC TILE: BROKEN/ MISSING
Deficiency Location/Instance	Near left side, windows, fountain, Servery
Deficiency Quantity	10
Quantity Uom	S.F.
Potential Action	REPLACE
Urgency of Action	PRIORITY 3
Purpose of Action	LEVEL 2
Deficiency Photo1

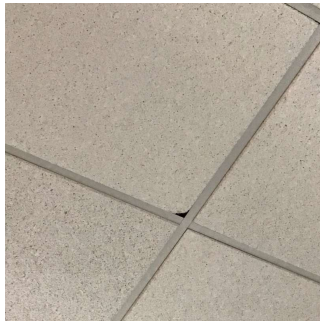
Violations	Near Windows No violations recorded.
Window Curtains/Shades/Blinds	
Instance on Basement	Does not Exist
CLASSROOMS/CORRIDORS/ADMIN SPACES	
Ceiling	
Condition	2 - Between Good and Fair
Deficiency	ACOUSTIC TILES: DAMAGED/MISSING
Deficiency Location/Instance	Room 412
Deficiency Quantity	10
Quantity Uom	S.F.
Potential Action	REPLACE
Urgency of Action	PRIORITY 3
Purpose of Action	LEVEL 2

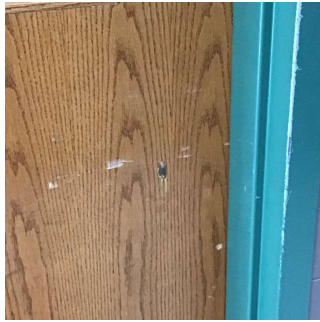
Room 412
Violations	No violations recorded.
Door(s)	Inspected
Condition	5 - Poor
Deficiency	WOOD: DETERIORATED DOOR
Deficiency Location/Instance	Rooms 412,405,404,312
Deficiency Quantity	4
Quantity Uom	EACH
Potential Action	MAINTENANCE
Urgency of Action	PRIORITY 3
Purpose of Action	LEVEL 2
Deficiency Photo1

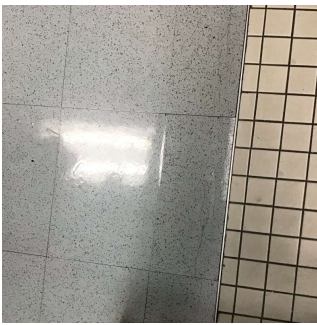
Room 404
Violations	No violations recorded.
Floor Finish	Inspected
Condition	2 - Between Good and Fair
Deficiency	VINYL TILES: DETERIORATED SUBSTRATE
Deficiency Location/Instance	Corridor near Stair A/4,3,2
Deficiency Quantity	10
Quantity Uom	S.F.
Potential Action	REPLACE
Urgency of Action	PRIORITY 3
Purpose of Action	LEVEL 2

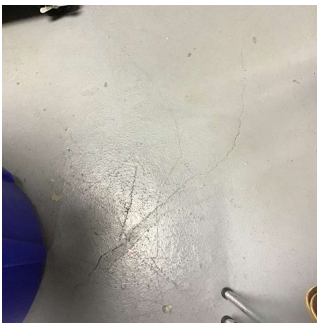
Condition	2 - Between Good and Fair
Deficiency	CONCRETE: CRACKS
Deficiency Location/Instance	Room 002B
Deficiency Quantity	10
Quantity Uom	S.F.
Potential Action	REPLACE
Urgency of Action	PRIORITY 3
Purpose of Action	LEVEL 2

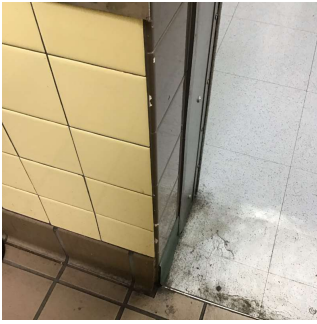
Room 002B
Violations	No violations recorded.
Walls	
Instance on Basement	Inspected
Condition	2 - Between Good and Fair
Deficiency	CERAMIC TILE: BROKEN/ MISSING
Deficiency Location/Instance	Near Servery, prep area
Deficiency Quantity	10
Quantity Uom	S.F.
Potential Action	REPLACE
Urgency of Action	PRIORITY 3
Purpose of Action	LEVEL 2
Deficiency Photo1

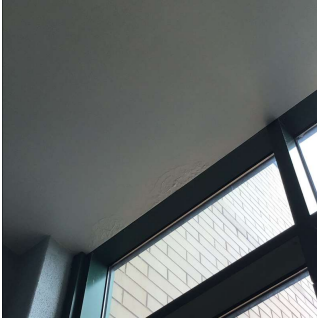
Question	Response
INTERIOR	
LIBRARY	
Floor Finish	
Deficiency	No deficiencies recorded
Walls	
Instance on Room 101	Inspected
Condition	2 - Between Good and Fair
Deficiency	No deficiencies recorded
LOCKER ROOM	Does not Exist
MULTI-PURPOSE ROOM	Does not Exist
SCIENCE DEMO ROOM	Does not Exist
SCIENCE LAB	Inspected
Instance on Rooms 404,412	Inspected
Alternative use	No
Fixed Equipment	
Instance on Rooms 404,412	Inspected
Condition	2 - Between Good and Fair
Deficiency	No deficiencies recorded
SCIENCE PREP ROOM	Inspected
Instance on Room 406	Inspected
Alternative use	No
Fixed Equipment	
Instance on Room 406	Inspected
Condition	2 - Between Good and Fair
Deficiency	No deficiencies recorded
SHOWER ROOM	Does not Exist
STAIRS/RAMPS: INTERIOR	Inspected
Do Letter Stair Signs Exist?	Yes
Ceiling	
Condition	2 - Between Good and Fair
Deficiency	GYPSUM BOARD: DAMAGED/DETERIORATED - ACTIVE LEAK
Deficiency Location/Instance	Stair A/3
Deficiency Quantity	10

Quantity Uom	S.F.
Potential Action	REPLACE
Urgency of Action	PRIORITY 5
Purpose of Action	LEVEL 2
Deficiency Photo1

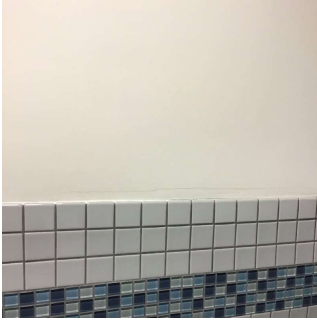
Question	Response
INTERIOR	
TOILET ROOMS - STAFF	
Walls	
Condition	2 - Between Good and Fair
Deficiency	GYPSUM BOARD: DETERIORATED
Deficiency Location/Instance	Room 408, 107F
Deficiency Quantity	10
Quantity Uom	S.F.
Potential Action	REPLACE
Urgency of Action	PRIORITY 3
Purpose of Action	LEVEL 2
Deficiency Photo1

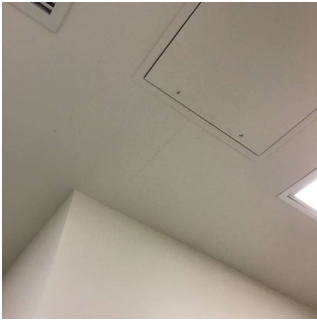
Violations	Room 408 No violations recorded.
TOILET ROOMS - STUDENTS	
Ceiling	
Condition	Inspected
Condition	2 - Between Good and Fair
Deficiency	GYPSUM BOARD: DAMAGED/DETERIORATED
Deficiency Location/Instance	Room 006
Deficiency Quantity	10
Quantity Uom	S.F.
Potential Action	REPLACE
Urgency of Action	PRIORITY 3
Purpose of Action	LEVEL 2
Deficiency Photo1

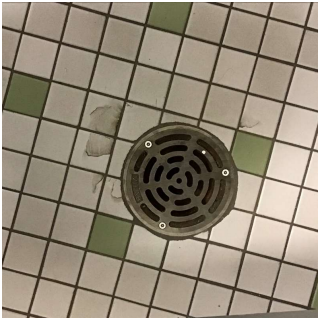
Violations	Room 006 No violations recorded.
Door(s)	
Condition	Inspected
Condition	2 - Between Good and Fair
Deficiency	No deficiencies recorded
Floor Finish	
Condition	Inspected
Condition	2 - Between Good and Fair
Deficiency	CERAMIC TILE: BROKEN/MISSING TILES

Deficiency Location/Instance	Room 008

Question	Response
INTERIOR	
TOILET ROOMS - STUDENTS	
Floor Finish	
Deficiency Quantity	10
Quantity Uom	S.F.
Potential Action	REPLACE
Urgency of Action	PRIORITY 3
Purpose of Action	LEVEL 2
Deficiency Photo1

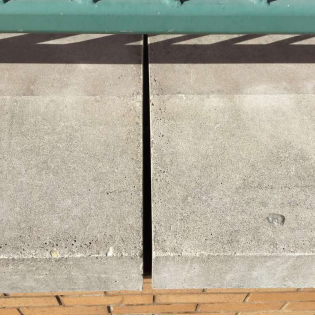
Question	Response
SITE	
PAVING	
DOT Sidewalk	
Concrete	
Deficiency Photo1	 
Violations	Along Palmetto Street No violations recorded.
Deficiency	DAMAGED CURBS
Deficiency Location/Instance	Along Palmetto Street
Deficiency Quantity	50
Quantity Uom	L.F.
Potential Action	REPLACE
Urgency of Action	PRIORITY 3
Purpose of Action	LEVEL 2
Deficiency Photo1	 
Violations	Along Palmetto Street No violations recorded.
Pavers	Does not Exist
PLAYGROUNDS	Does not Exist
PLAYING SURFACE	Does not Exist
RETAINING WALLS	Inspected
Are there any Retaining Walls 6' OR higher facing public street/sidewalk?	No
Condition	2 - Between Good and Fair
Deficiency	BRICK: DETERIORATED JOINT AT COPING STONE
Deficiency Location/Instance	Along Palmetto Street
Deficiency Quantity	10
Quantity Uom	L.F.
Potential Action	MAINTENANCE
Urgency of Action	PRIORITY 3
Purpose of Action	LEVEL 2

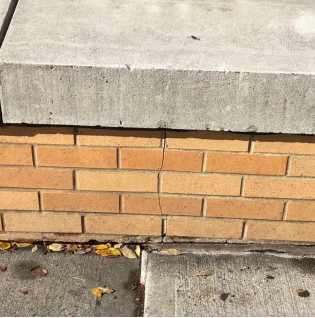
Violations	Along Palmetto Street No violations recorded.
Deficiency	BRICK: CRACKS/SPALLING - MAJOR
Deficiency Location/Instance	Along Palmetto Street
Deficiency Quantity	10
Quantity Uom	S.F.
Potential Action	REPLACE
Urgency of Action	PRIORITY 3
Purpose of Action	LEVEL 2
Deficiency Photo1
