NYC Department of Education
Building Condition Assessment Survey 2023 - 2024

Architectural Inspection

K555

Asset: BKLYN COLL ACAD (AT BKLYN COLL)-K, 2900 BEDFORD AVENUE, New York, 11210

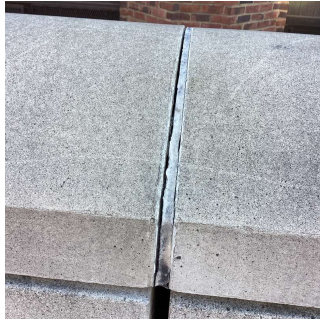
Question	Response
Architectural	
EXTERIOR	Inspected
AREAWAY	Inspected
Instance on AW1-AW3	Inspected
Instance Condition	3 - Fair
Instance Quantity	3
Instance Quantity Uom	EACH
Deficiency	AREAWAY WALLS: DETERIORATED JOINTS AT COPING STONES
Roof Plan reference	
	West Quad
Deficiency Quantity	30
Quantity Uom	L.F.
Potential Action	MAINTENANCE
Urgency of Action	PRIORITY 3
Purpose of Action	LEVEL 2

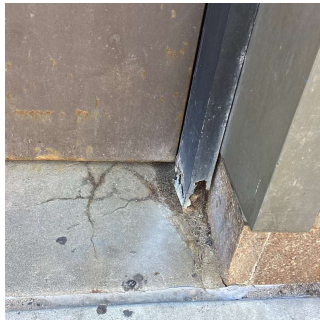
Violations	Facade B - HC Lift Entrance No violations recorded.
DOOR HARDWARE	Inspected
Condition	3 - Fair

Violations	AW2 No violations recorded.
AWNINGS AND CANOPIES	Does not Exist
CHIMNEY	Not Required
COPING	Not Required
CORNICE	Does not Exist
DOORS	Inspected
DOORS AND FRAMES	Inspected
Condition	5 - Poor
Deficiency	METAL: DETERIORATED DOOR AND FRAME - MAJOR DETERIORATION
Roof Plan reference	<p align="center">West Quad</p>

Deficiency Quantity	1
Quantity Uom	EACH
Potential Action	REPLACE
Urgency of Action	PRIORITY 4
Purpose of Action	LEVEL 2
Deficiency Photo1

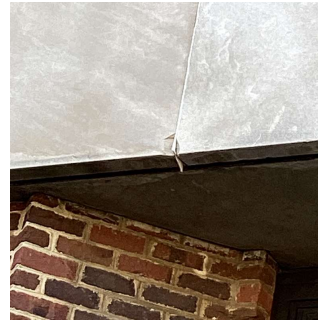
Facade A - Near AW1

CAST IN PLACE / PRE-CAST CONCRETE: MINOR
CRACKS/SPALLING

Deficiency Quantity

Potential Action

REPAIR

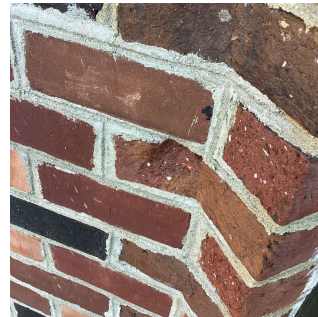
Facade A - Near Main Entrance

BRICK: MINOR CRACKS AND SPALLING

Deficiency Quantity

Potential Action

RESTITCH

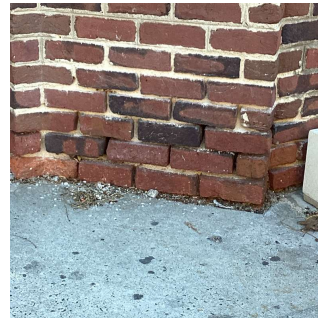
Facade A - Near Main Entrance

BRICK: DETERIORATED JOINTS

Deficiency Quantity

Potential Action

REPOINT

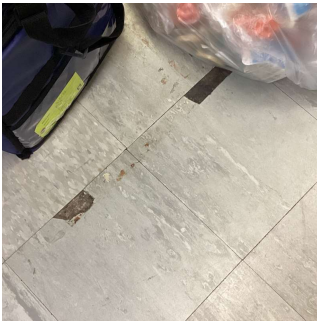
Room 1311

Question	Response
INTERIOR	
CLASSROOMS/CORRIDORS/ADMIN SPACES	
Floor Finish	
Deficiency Photo1

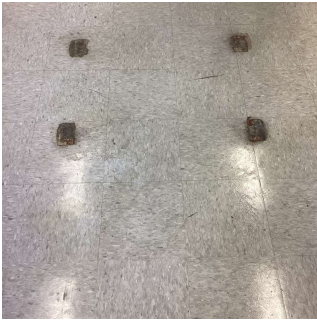
Room 0303A
Violations	No violations recorded.
Walls	Inspected
Condition	2 - Between Good and Fair
Deficiency	CERAMIC TILE: BROKEN/ MISSING
Deficiency Location/Instance	Room 0414
Deficiency Quantity	10
Quantity Uom	S.F.
Potential Action	REPLACE
Urgency of Action	PRIORITY 3
Purpose of Action	LEVEL 2
Deficiency Photo1

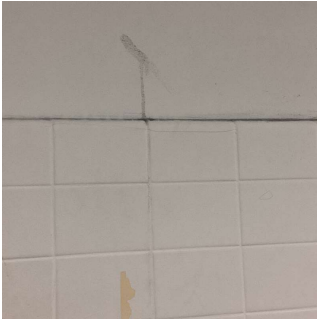
Room 0414
Violations	No violations recorded.
Deficiency	PLASTER: CRACKS/SPALLING
Deficiency Location/Instance	Room 1405
Deficiency Quantity	10
Quantity Uom	S.F.
Potential Action	REPLACE
Urgency of Action	PRIORITY 3

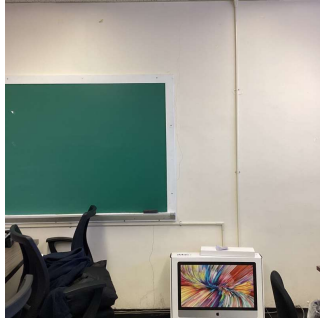
Room 1405
Violations	No violations recorded.
Specialties	Does not Exist
GYMNASIUM	Does not Exist
INTERIOR DOOR HARDWARE	Inspected
Condition	2 - Between Good and Fair
Deficiency	No deficiencies recorded
INTERIOR GUARDS	Does not Exist
KITCHEN	Does not Exist
LIBRARY	Does not Exist
LOCKER ROOM	Does not Exist
MULTI-PURPOSE ROOM	Does not Exist
SCIENCE DEMO ROOM	Does not Exist
SCIENCE LAB	Does not Exist
SCIENCE PREP ROOM	Does not Exist
SHOWER ROOM	Does not Exist
STAIRS/RAMPS: INTERIOR	Does not Exist
TOILET ROOMS - STAFF	Does not Exist
TOILET ROOMS - STUDENTS	Does not Exist
LIFE SAFETY	Inspected
F.D. HOLDING AREA	Does not Exist
STEEL STAIRS	Does not Exist
SITE	Does not Exist
ARTWORK	Does not Exist
