NYC Department of Education
Building Condition Assessment Survey 2023 - 2024

Architectural Inspection

Asset: **SUNSET PARK HS - BROOKLYN, 153 35TH STREET, New York, 11232**

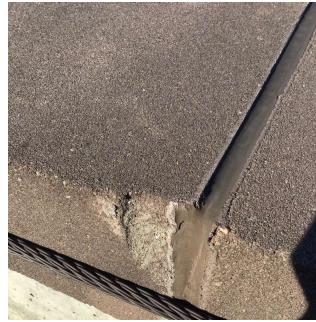
Roof 1

CAST STONE: CRACKED/BROKEN PIECES

REPLACE-IN-KIND

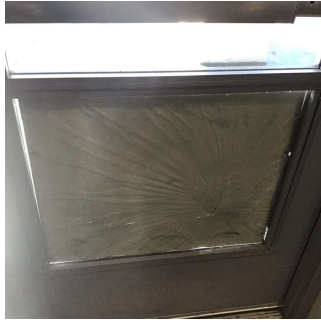
METAL: DETERIORATED DOOR AND FRAME - MAJOR DETERIORATION

Deficiency Quantity	2
Quantity Uom	EACH
Potential Action	REPLACE
Urgency of Action	PRIORITY 4
Purpose of Action	LEVEL 2
Deficiency Photo1

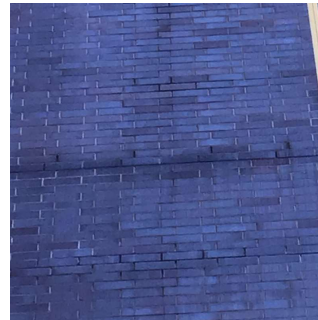
Facade C

Violations	Facade A No violations recorded.
DOOR HARDWARE	Inspected
Condition	3 - Fair
Deficiency	No deficiencies recorded
LINTELS	Inspected
Condition	2 - Between Good and Fair
Deficiency	No deficiencies recorded
TRANSOM/SIDE LIGHT	Inspected
Condition	2 - Between Good and Fair
Deficiency	No deficiencies recorded
EXTERIOR WALLS	Inspected
Material Type(s)	Masonry, Steel
Replacement Quantity	47,000
Replacement Uom	S.F.
Instance on All Facades	Inspected
Instance Condition	3 - Fair
Instance Quantity	47,000
Instance Quantity Uom	S.F.
Deficiency	BRICK: DETERIORATED JOINTS

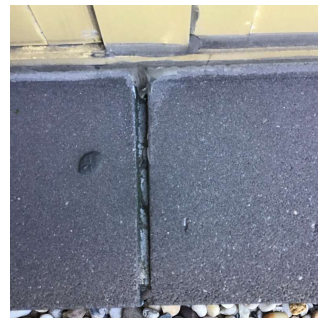
Facade F1

BRICK: MASONRY SILLS - DETERIORATED JOINTS

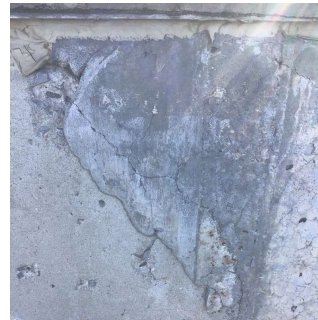
BH Roof

Material Type(s)	Inspected Concrete, Masonry
Replacement Quantity	5,000
Replacement Uom	C.F.
Instance on All Roofs	Inspected
Instance Condition	3 - Fair
Instance Quantity	5,000
Instance Quantity Uom	C.F.
Deficiency	CONCRETE: MAJOR DETERIORATION/CRACKS

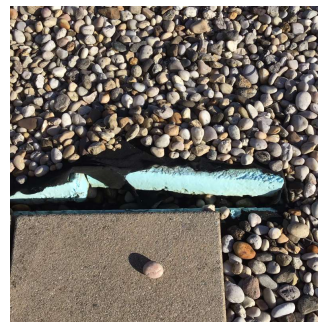
Roof 1

Is/Are the roof(s) suitable for Solar Panel installation?	Yes
Installation Year	2009
Source of Installation	Custodial Staff
Deficiency	IRMA: ROOFING: DAMAGED INSULATION

50
S.F.
REPLACE
PRIORITY 4
LEVEL 2

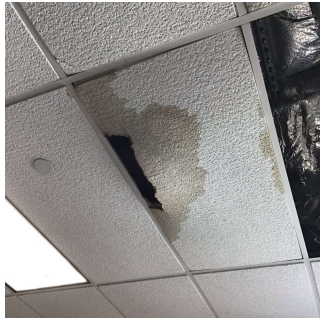
IRMA: ROOFING: MAJOR ACTIVE ROOF LEAKS IN INSTRUCTIONAL SPACE

Violations	Roof 1 - Rooms 514, 524, 526 (Shown), 528, 529 Roof 1 - Corridor near Rooms 508, 513, 515, 526, 529 Roof 2 - Gymnasium No violations recorded.
ROOFING DRAINS	Inspected
Condition	2 - Between Good and Fair
Deficiency	No deficiencies recorded
Specialties	Inspected
BULKHEAD/PENTHOUSE	Inspected
Condition	3 - Fair
Deficiency	BULKHEAD/PENTHOUSE WALLS/EXTERIOR: DETERIORATED JOINTS
Roof Plan reference

1,100
S.F.
REPLACE ROOFING WITHOUT MAJOR EQUIPMENT REMOVAL
PRIORITY 5
LEVEL 2

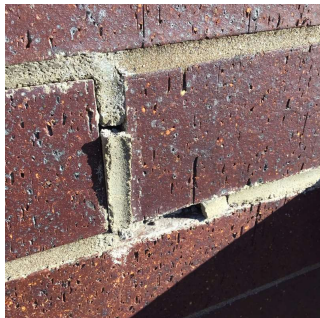
Deficiency Quantity	10
Quantity Uom	S.F.
Potential Action	REPOINT
Urgency of Action	PRIORITY 4
Purpose of Action	LEVEL 2
Deficiency Photo1

Violations	BH No violations recorded.

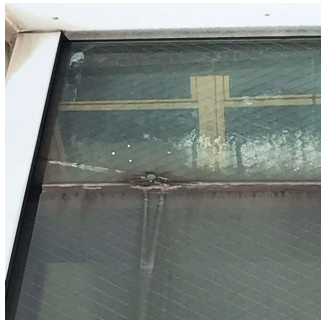
Question	Response
EXTERIOR	
ROOF	
Specialties	
CUPOLA/ SPIRES/ TOWERS	Does not Exist
DORMER	Does not Exist
DUNNAGE STEEL	Does not Exist
SKYLIGHT/ROOF VENT	Inspected
Material Type(s)	Glass
Condition	2 - Between Good and Fair
Deficiency	BROKEN GLASS
Roof Plan reference

Deficiency Quantity	10
Quantity Uom	S.F.
Potential Action	MAINTENANCE
Urgency of Action	PRIORITY 3
Purpose of Action	LEVEL 2
Deficiency Photo1

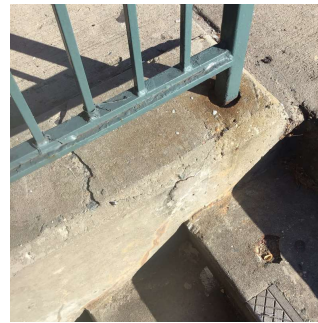
Facade H
 No violations recorded.

Violations	No violations recorded.
ROOF/GRAVITY TANK	Does not Exist
STAIRS/RAMPS: EXTERIOR	Inspected
BUILDING CHEEK/FLANK WALLS	Inspected
Condition	4 - Between Fair and Poor
Deficiency	CAST IN PLACE CONCRETE: CRACKS/SPALLING - MAJOR

10
 S.F.
 REPLACE
 PRIORITY 4
 LEVEL 2

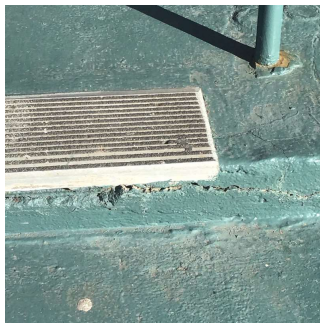
Violations	Facade A No violations recorded.
Deficiency	CONCRETE: WORN-OUT TREAD/RISER/NOSING
Roof Plan reference

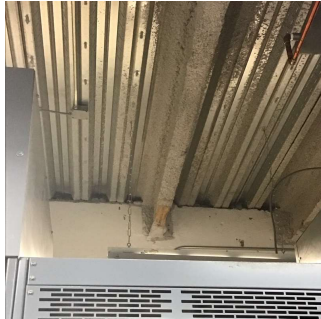
Question	Response
INTERIOR	Inspected
POOLS	Does not Exist
STRUCTURAL	Inspected
COLUMNS/BEAMS/BEARING WALLS	Inspected
Condition	3 - Fair
Deficiency	STEEL COLUMNS/BEAMS: DETERIORATED/MISSING SPRAY-ON FIREPROOFING
Deficiency Location/Instance	Basement - Switchgear Room, Roof Hatch Access Room
Deficiency Quantity	20
Quantity Uom	S.F.
Potential Action	REPLACE
Urgency of Action	PRIORITY 4
Purpose of Action	LEVEL 5
Deficiency Photo1

Violations	Basement - Switchgear Room No violations recorded.
FLOOR STRUCTURE	Inspected
Condition	3 - Fair
Deficiency	CONCRETE: CRACKS/SPALLED/REINFORCEMENT EXPOSED
Deficiency Location/Instance	PH
Deficiency Quantity	20
Quantity Uom	S.F.
Potential Action	REPAIR
Urgency of Action	PRIORITY 4
Purpose of Action	LEVEL 5
Deficiency Photo1

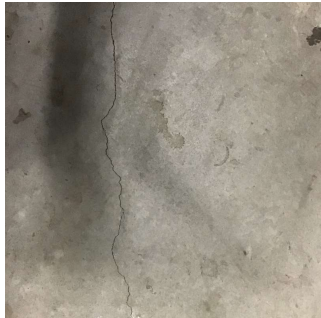
Violations	PH No violations recorded.
Deficiency	CONCRETE SLAB ON GRADE: THRU CRACKS
Deficiency Location/Instance	Basement - Main Sprinkler Valve Room, B25, Ejector Pump Room

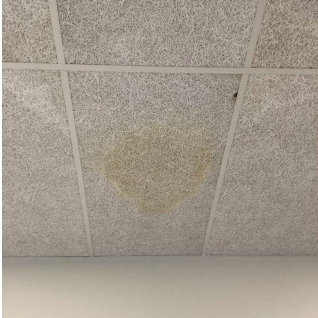
Question	Response
INTERIOR	
CLASSROOMS/CORRIDORS/ADMIN SPACES	
Ceiling	
Deficiency	TECTUM: DAMAGED/MISSING - ACTIVE LEAK
Deficiency Location/Instance	Corridor near Rooms 529, 526, 515, 513, 508
Deficiency Quantity	100
Quantity Uom	S.F.
Potential Action	REPLACE
Urgency of Action	PRIORITY 5
Purpose of Action	LEVEL 2
Deficiency Photo1

Corridor near Room 526
Violations	No violations recorded.
Deficiency	TECTUM: DAMAGED/MISSING
Deficiency Location/Instance	Corridor near Kitchen
Deficiency Quantity	20
Quantity Uom	S.F.
Potential Action	REPLACE
Urgency of Action	PRIORITY 3
Purpose of Action	LEVEL 2
Deficiency Photo1

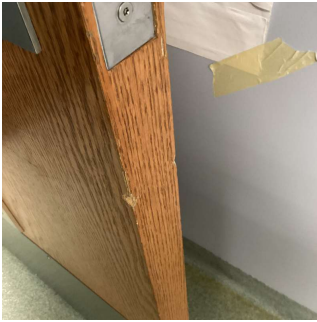
Violations	Corridor near Stair A/1 No violations recorded.
Door(s)	Inspected
Condition	3 - Fair
Deficiency	WOOD: DETERIORATED DOOR
Deficiency Location/Instance	Rooms 528, 527, 520, 506, 426
Deficiency Quantity	5
Quantity Uom	EACH
Potential Action	MAINTENANCE
Urgency of Action	PRIORITY 3
Purpose of Action	LEVEL 2
Deficiency Photo1

Violations	Room 528 No violations recorded.
Floor Finish	Inspected
Condition	2 - Between Good and Fair
Deficiency	VINYL TILES: BROKEN/DETERIORATED/MISSING TILES
Deficiency Location/Instance	Corridor near Stair C/5
Deficiency Quantity	10
Quantity Uom	S.F.
Potential Action	REPLACE
Urgency of Action	PRIORITY 3
Purpose of Action	LEVEL 2

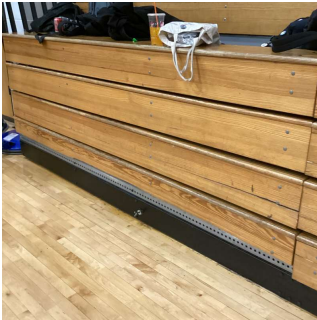
Left Side
Violations	No violations recorded.
Seating	
Instance on 1st Floor	Inspected
Condition	3 - Fair
Deficiency	DAMAGED BLEACHERS
Deficiency Location/Instance	Right Side
Deficiency Quantity	80
Quantity Uom	S.F.
Potential Action	REPLACE
Urgency of Action	PRIORITY 3
Purpose of Action	LEVEL 2
Deficiency Photo1

Right Side
Violations	No violations recorded.
Sliding-folding Partition	
Instance on 1st Floor	Inspected
Condition	2 - Between Good and Fair
Deficiency	No deficiencies recorded
Stage	
Instance on 1st Floor	Does not Exist
Walls	
Instance on 1st Floor	Inspected
Condition	2 - Between Good and Fair
Deficiency	GYPSUM BOARD: DETERIORATED - ACTIVE LEAK
Deficiency Location/Instance	Near Room 113D
Deficiency Quantity	10
Quantity Uom	S.F.
Potential Action	REPLACE
Urgency of Action	PRIORITY 5

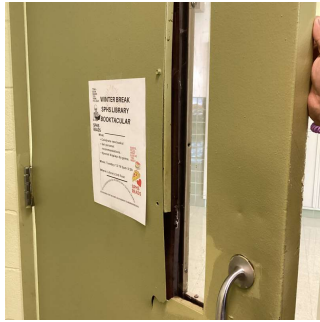
Stair C/5
Violations	No violations recorded.
Door(s)	Inspected
Condition	2 - Between Good and Fair
Deficiency	METAL: DETERIORATED DOOR
Deficiency Location/Instance	Stair B/4
Deficiency Quantity	1
Quantity Uom	EACH
Potential Action	MAINTENANCE
Urgency of Action	PRIORITY 3
Purpose of Action	LEVEL 2
Deficiency Photo1

Stair B/4
Violations	No violations recorded.
Partition	Does not Exist
Railings	Inspected
Condition	3 - Fair
Deficiency	METAL: DAMAGED
Deficiency Location/Instance	Stair A/Basement
Deficiency Quantity	10
Quantity Uom	L.F.
Potential Action	REPLACE
Urgency of Action	PRIORITY 3
Purpose of Action	LEVEL 2

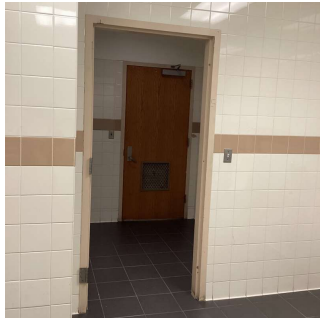
Question	Response
INTERIOR	
TOILET ROOMS - STUDENTS	
Door(s)	
Violations	Room 107 No violations recorded.
Deficiency	WOOD: MISSING DOOR
Deficiency Location/Instance	Room 310
Deficiency Quantity	1
Quantity Uom	EACH
Potential Action	MAINTENANCE
Urgency of Action	PRIORITY 3
Purpose of Action	LEVEL 2
Deficiency Photo1

Violations	Room 310 No violations recorded.
Deficiency	METAL: DAMAGED LOUVER
Deficiency Location/Instance	Rooms B20, B27, 204, 410, 414 and others
Deficiency Quantity	6
Quantity Uom	EACH
Potential Action	MAINTENANCE
Urgency of Action	PRIORITY 3
Purpose of Action	LEVEL 2
Deficiency Photo1
