NYC Department of Education
Building Condition Assessment Survey 2023 - 2024

Architectural Inspection

Asset: AUTOMOTIVE TRADES VOC HS - K, 50 BEDFORD AVENUE, New York, 11222

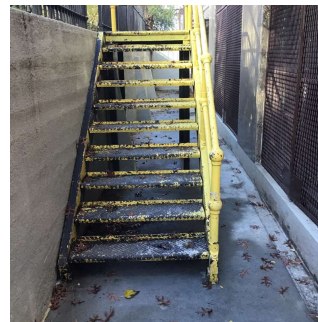
AW5

| Deficiency | AREAWAY STAIRS: DETERIORATED TREADS/RISERS/NOSINGS |

REPAIR

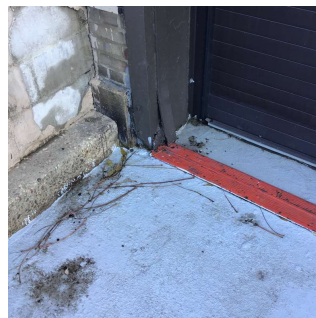
Roll-up - Facade E

ROLL-UP DOOR: DETERIORATED DOOR AND FRAME - MINOR DETERIORATION

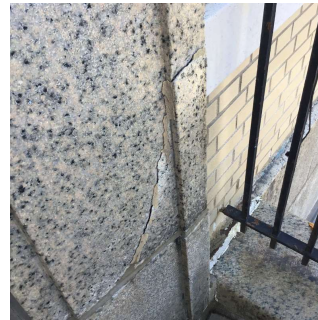
Exit C, 6/7

| Question | Response |
|---|--|
| Deficiency | STONE: CHIPPED/SPALLED/BROKEN PIECES - MAJOR |

REPLACE

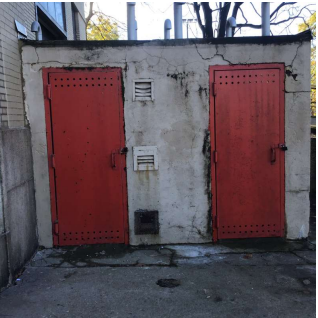
STUCCO CEMENT SURFACE: CRACKS, SPALLING

| Question | Response |
|---|---|
| Potential Action | REPLACE |

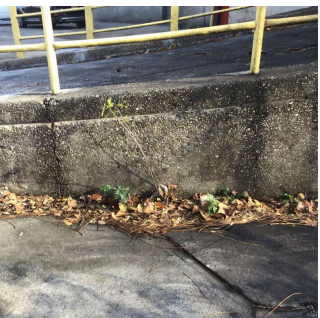
| Question | Response |
|---|---|
| | Ramp Facade E |

| Question | Response |
|---|---|
| Deficiency | CAST IN PLACE CONCRETE: CRACKS/SPALLING - MAJOR |

| Question | Response |
|---|---|
| Potential Action | REPLACE |

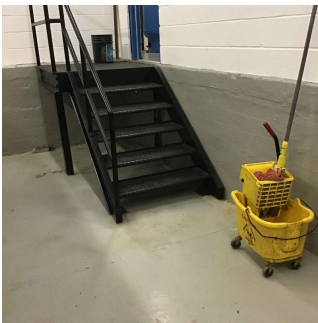
| Question | Response |
|---|--|
| | Oil Tank Room |

| Question | Response |
|---|--|
| Deficiency | CONCRETE SLAB ON GRADE: WATER INFILTRATION IN NON-INSTRUCTIONAL SPACE |
| Deficiency Location/Instance | Oil Tank Room, Water Heater in Boiler Room |

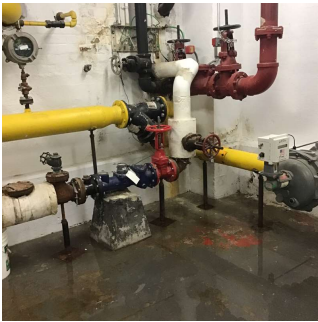
| Question | Response |
|---|--|
| | Gas Meter Room |

| Question | Response |
|---|--|
| Deficiency | CONCRETE: WATER INFILTRATION IN NON- INSTRUCTIONAL SPACE |
| Deficiency Location/Instance | Gas Meter Room |

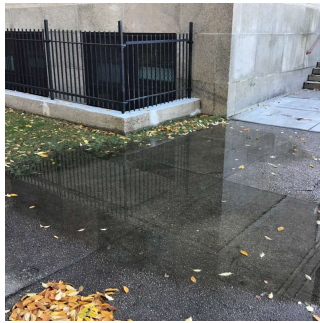
| Question | Response |
|---|--|
| Deficiency | CONCRETE: WATER INFILTRATION IN INSTRUCTIONAL SPACE |
| Deficiency Location/Instance | Facade K - Cafeteria |

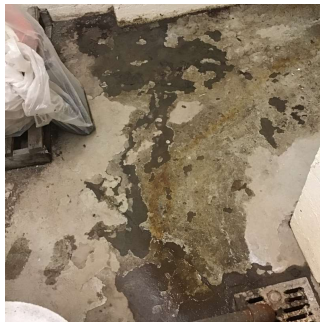
| Question | Response |
|---|--|
| Deficiency | CONCRETE SLAB ON GRADE: WATER INFILTRATION IN NON-INSTRUCTIONAL SPACE |
| Deficiency Location/Instance | Vault in Boiler Room |

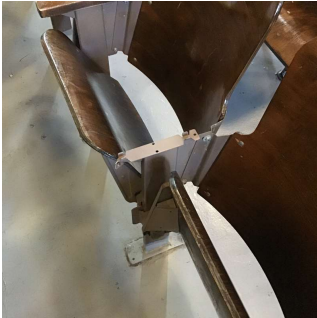
| Question | Response |
|---|--|
| | Seat B/12 |

| Question | Response |
|--|--|
| Deficiency | DAMAGED/BROKEN/INOPERABLE |
| Deficiency Location/Instance | Seats A/3, B/12, C/3, L/4, Q/3 |

| Question | Response |
|---|--|
| Potential Action | REPLACE |

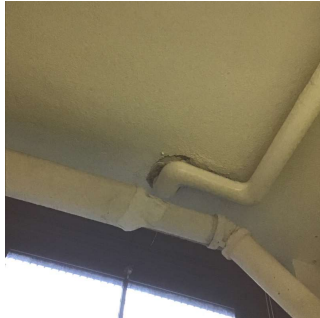
| Question | Response |
|---|--|
| Deficiency | PLASTER: CRACKS/SPALLING |
| Deficiency Location/Instance | Left Side |

| Question | Response |
|---|--|
| Potential Action | REPLACE |

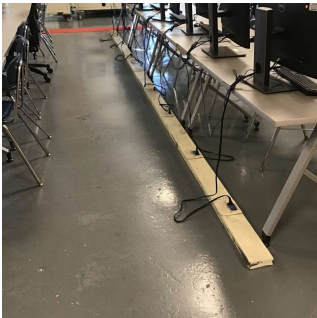
| Question | Response |
|--|--|
| Deficiency | CONCRETE: TRIPPING HAZARD - ELECTRICAL OUTLET |

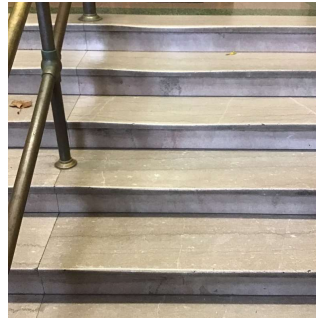
STONE: WORN-OUT TREAD/NOSINGS
Main Entrance Vestibule
50
S.F.
REPLACE
PRIORITY 3
LEVEL 2

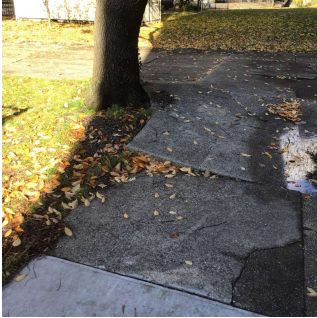
| Priority Condition Exist Last Year? | Priority Category | Condition Description | Component Affected | Location Description | Person(s) Notified | Person(s) Title | PhotoImage |
|---|---|--|---|---|---|---|---|
| Yes | Tripping Hazard | Severely damaged and heaving concrete walkway is a potential tripping hazard. | SITE PAVING Site Sidewalks & Walkways Concrete | Near Exit C | Charles Towns | Fireman | |
