NYC Department of Education
Building Condition Assessment Survey 2023 - 2024

Architectural Inspection

K611

**Asset: THE DOCK STREET EDUCATIONAL COMPLEX - BROOKLYN, 19 DOCK STREET,
 New York, 11201**

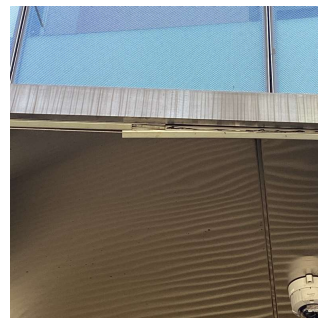
METAL: DETERIORATION/DAMAGED/MISSING PIECES

20

REPLACE

PRIORITY 4

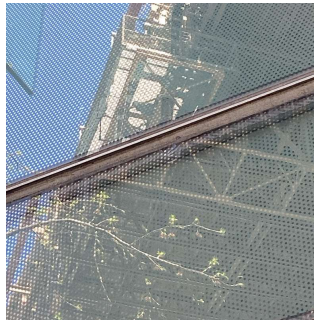
Question	Response
EXTERIOR	
AWNINGS AND CANOPIES	
Violations	Facade A No violations recorded.
CHIMNEY	
Material Type(s)	Inspected Metal
Condition	2 - Between Good and Fair
Deficiency	No deficiencies recorded
COPING	
Condition	Inspected 2 - Between Good and Fair
Deficiency	No deficiencies recorded
CORNICE	
	Does not Exist
DOORS	
DOORS AND FRAMES	
Condition	Inspected 2 - Between Good and Fair
Deficiency	No deficiencies recorded
DOOR HARDWARE	
Condition	Inspected 3 - Fair
Deficiency	No deficiencies recorded
LINTELS	
Condition	Inspected 2 - Between Good and Fair
Deficiency	No deficiencies recorded
TRANSOM/SIDE LIGHT	
	Does not Exist
EXTERIOR WALLS	
Material Type(s)	Inspected Steel
Replacement Quantity	6,600
Replacement Uom	S.F.
Instance on All Facades	Inspected
Instance Condition	3 - Fair
Instance Quantity	6,600
Instance Quantity Uom	S.F.
Deficiency	METAL/GLASS CURT WALL: BROKEN GLASS
Roof Plan reference

20

REPLACE

PRIORITY 3

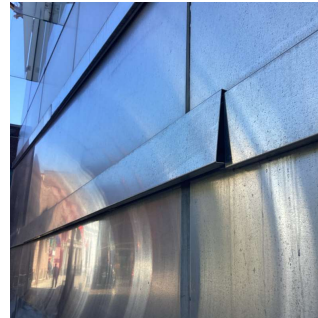
Facade C

METAL/GLASS CURT WALL: DAMAGED TRIM

10

REPLACE

PRIORITY 4
LEVEL 2

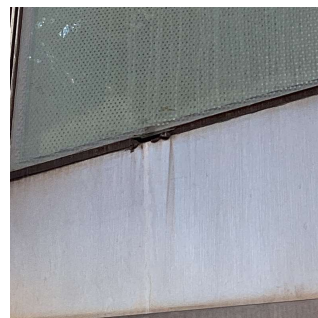
METAL/GLASS CURT WALL: DETERIORATED CONTROL/EXPANSION JOINTS

40
L.F.
MAINTENANCE
PRIORITY 3
LEVEL 2

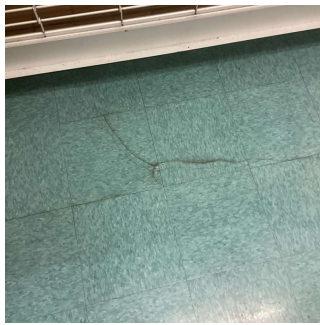
Question	Response
INTERIOR	
STRUCTURAL	
FOUNDATION WALLS	Inspected
Deficiency	No deficiencies recorded
ROOF STRUCTURE	Inspected
Condition	2 - Between Good and Fair
Deficiency	No deficiencies recorded
VAULTS-BUNKERS	Does not Exist
AUDITORIUM	Does not Exist
CAFETERIA	Inspected
Instance on 2nd Floor	Inspected
Ceiling	
Instance on 2nd Floor	Inspected
Condition	2 - Between Good and Fair
Deficiency	No deficiencies recorded
Door(s)	
Instance on 2nd Floor	Inspected
Condition	2 - Between Good and Fair
Deficiency	No deficiencies recorded
Fixed Equipment	
Instance on 2nd Floor	Does not Exist
Floor Finish	
Instance on 2nd Floor	Inspected
Condition	2 - Between Good and Fair
Deficiency	VINYL TILES: DETERIORATED SUBSTRATE
Deficiency Location/Instance	Near Servery
Deficiency Quantity	10
Quantity Uom	S.F.
Potential Action	REPLACE
Urgency of Action	PRIORITY 3
Purpose of Action	LEVEL 2
Deficiency Photo1

Near Servery
Violations	No violations recorded.

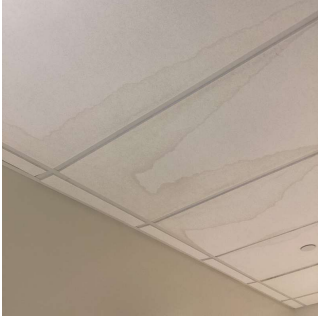
Question	Response
INTERIOR	
CAFETERIA	Inspected
Window Curtains/Shades/Blinds	
Instance on 2nd Floor	Does not Exist
CLASSROOMS/CORRIDORS/ADMIN SPACES	Inspected
Ceiling	Inspected
Condition	2 - Between Good and Fair
Deficiency	ACOUSTIC TILES: DAMAGED/MISSING
Deficiency Location/Instance	Room 208
Deficiency Quantity	15
Quantity Uom	S.F.
Potential Action	REPLACE
Urgency of Action	PRIORITY 3
Purpose of Action	LEVEL 2
Deficiency Photo1

Room 208
Violations	No violations recorded.
Door(s)	Inspected
Condition	2 - Between Good and Fair
Deficiency	No deficiencies recorded
Floor Finish	Inspected
Condition	2 - Between Good and Fair
Deficiency	CERAMIC TILE: BROKEN/MISSING TILES
Deficiency Location/Instance	Near Elevator A, Lobby
Deficiency Quantity	10
Quantity Uom	S.F.
Potential Action	REPLACE
Urgency of Action	PRIORITY 3
Purpose of Action	LEVEL 2
Deficiency Photo1

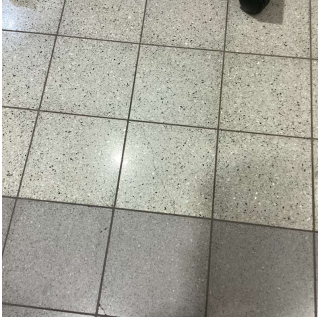
Near Elevator A
Violations	No violations recorded.
Walls	Inspected

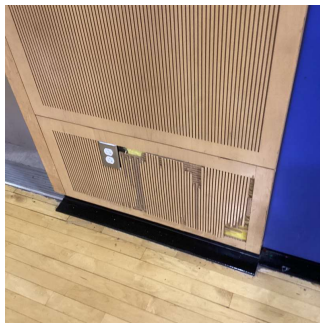
Walls	
Instance on 2nd Floor	Inspected
Condition	2 - Between Good and Fair
Deficiency	WOOD PANELING: DETERIORATED
Deficiency Location/Instance	Near Entrance
Deficiency Quantity	10
Quantity Uom	S.F.
Potential Action	REPLACE
Urgency of Action	PRIORITY 3
Purpose of Action	LEVEL 2

Violations	Near Entrance No violations recorded.
Window Curtains/Shades/Blinds	
Instance on 2nd Floor	Does not Exist
INTERIOR DOOR HARDWARE	Inspected
Condition	2 - Between Good and Fair
Deficiency	No deficiencies recorded
INTERIOR GUARDS	Does not Exist
KITCHEN	Inspected
Instance on 2nd Floor	Inspected
Ceiling	
Instance on 2nd Floor	Inspected
Condition	2 - Between Good and Fair
Deficiency	No deficiencies recorded
Door(s)	
Instance on 2nd Floor	Inspected
Condition	2 - Between Good and Fair
Deficiency	No deficiencies recorded
Floor Finish	
Instance on 2nd Floor	Inspected
Condition	2 - Between Good and Fair
Deficiency	No deficiencies recorded
Walls	
Instance on 2nd Floor	Inspected
Condition	2 - Between Good and Fair
Deficiency	No deficiencies recorded
LIBRARY	Inspected
Instance on Room 216	Inspected
Built-in Furnishing	
Instance on Room 216	Does not Exist
Ceiling

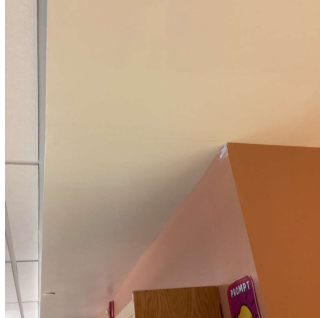
Instance on Room 216	Inspected
Condition	2 - Between Good and Fair
Deficiency	GYPSUM BOARD: DAMAGED/DETERIORATED
Deficiency Location/Instance	Near Entrance
Deficiency Quantity	10
Quantity Uom	S.F.
Potential Action	REPLACE

Question	Response
INTERIOR	
LIBRARY	
Ceiling	
Urgency of Action	PRIORITY 3
Purpose of Action	LEVEL 2
Deficiency Photo1

Near Entrance
Violations	No violations recorded.
Door(s)	
Instance on Room 216	Inspected
Condition	3 - Fair
Deficiency	WOOD: DETERIORATED DOOR
Deficiency Location/Instance	Entrance
Deficiency Quantity	1
Quantity Uom	EACH
Potential Action	MAINTENANCE
Urgency of Action	PRIORITY 3
Purpose of Action	LEVEL 2
Deficiency Photo1

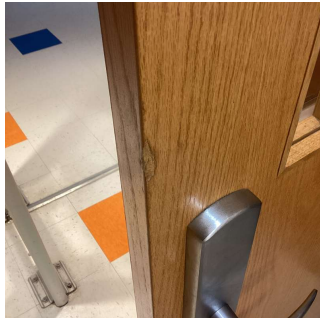
Entrance
Violations	No violations recorded.
Floor Finish	
Instance on Room 216	Inspected
Condition	1 - Good
Deficiency	No deficiencies recorded
Walls	
Instance on Room 216	Inspected
Condition	2 - Between Good and Fair
Deficiency	No deficiencies recorded
LOCKER ROOM	
Instance on 2nd Floor - Boys (222 Lockers)	Inspected
Alternative use	No
Instance on 2nd Floor - Girls (222 Lockers)	Inspected
Alternative use	No

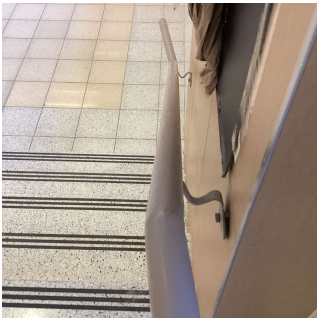
Question	Response
INTERIOR	
LOCKER ROOM	Inspected
Walls	
Deficiency	No deficiencies recorded
MULTI-PURPOSE ROOM	Does not Exist
SCIENCE DEMO ROOM	Does not Exist
SCIENCE LAB	Inspected
Instance on Room 244	Inspected
Alternative use	No
Fixed Equipment	
Instance on Room 244	Inspected
Condition	2 - Between Good and Fair
Deficiency	No deficiencies recorded
SCIENCE PREP ROOM	Inspected
Instance on Room 248	Inspected
Alternative use	No
Fixed Equipment	
Instance on Room 248	Inspected
Condition	2 - Between Good and Fair
Deficiency	No deficiencies recorded
SHOWER ROOM	Does not Exist
STAIRS/RAMPS: INTERIOR	Inspected
Do Letter Stair Signs Exist?	Yes
Ceiling	
Condition	2 - Between Good and Fair
Deficiency	No deficiencies recorded
Door(s)	
Condition	2 - Between Good and Fair
Deficiency	No deficiencies recorded
Partition	
Condition	Does not Exist
Railings	
Condition	2 - Between Good and Fair
Deficiency	METAL: BROKEN BRACKET
Deficiency Location/Instance	Stair E/1

Deficiency Quantity	1
Quantity Uom	EACH
Potential Action	REPLACE
Urgency of Action	PRIORITY 3
Purpose of Action	LEVEL 2
Deficiency Photo1

Violations	Stair E/1 No violations recorded.
