NYC Department of Education
Building Condition Assessment Survey 2023 - 2024

Architectural Inspection

Asset: PRE-K CENTER @ 369 93RD STREET - BROOKLYN, 369 93 STREET, 11209

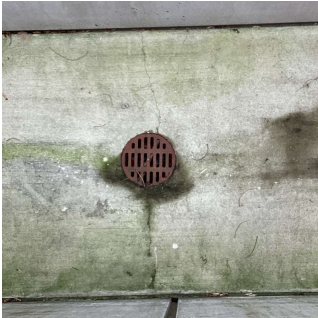
Question	Response
Architectural	
EXTERIOR	Inspected
AREAWAY	Inspected
Instance on AW1	Inspected
Instance Condition	3 - Fair
Instance Quantity	1
Instance Quantity Uom	EACH
Deficiency	AREAWAY SLAB: CRACKS AND SPALLING
Roof Plan reference

Deficiency Quantity	25
Quantity Uom	S.F.
Potential Action	REPAIR
Urgency of Action	PRIORITY 3
Purpose of Action	LEVEL 2

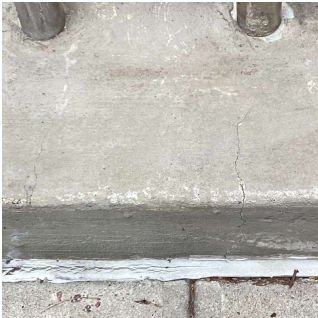
Violations	AW1 No violations recorded.
Deficiency	AREAWAY WALLS: CRACKS AND SPALLING
Roof Plan reference

Deficiency Quantity	10
Quantity Uom	S.F.
Potential Action	REPAIR
Urgency of Action	PRIORITY 3
Purpose of Action	LEVEL 2
Deficiency Photo1

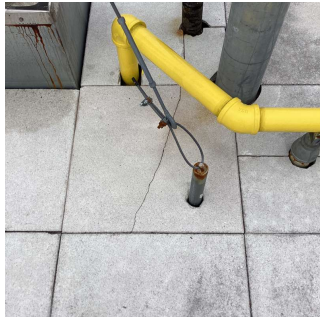
IRMA: ROOFING: DETERIORATED PAVERS WITH INTEGRAL INSULATION

Deficiency Quantity

20

REPLACE

PRIORITY 4

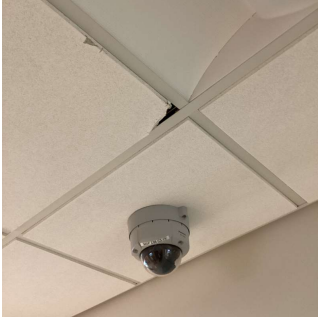
Question	Response
INTERIOR	
STRUCTURAL	Inspected
VAULTS-BUNKERS	Does not Exist
AUDITORIUM	Does not Exist
CAFETERIA	Does not Exist
CLASSROOMS/CORRIDORS/ADMIN SPACES	Inspected
Ceiling	Inspected
Condition	2 - Between Good and Fair
Deficiency	ACOUSTIC TILES: DAMAGED/MISSING
Deficiency Location/Instance	Corridor near room 304
Deficiency Quantity	10
Quantity Uom	S.F.
Potential Action	REPLACE
Urgency of Action	PRIORITY 3
Purpose of Action	LEVEL 2
Deficiency Photo1

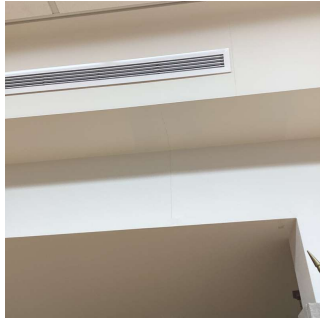
Near Entrance
Violations	No violations recorded.
Door(s)	
Instance on Basement	Inspected
Condition	2 - Between Good and Fair
Deficiency	No deficiencies recorded

Question	Response
INTERIOR	
KITCHEN	
Door(s)	
Instance on Basement	Inspected
Condition	2 - Between Good and Fair
Deficiency	No deficiencies recorded
Floor Finish	
Instance on Basement	Inspected
Condition	2 - Between Good and Fair
Deficiency	No deficiencies recorded
Walls	
Instance on Basement	Inspected
Condition	2 - Between Good and Fair
Deficiency	No deficiencies recorded
LIBRARY	Does not Exist
LOCKER ROOM	Does not Exist
MULTI-PURPOSE ROOM	Inspected
Instance on Basement	Inspected
Ceiling	
Instance on Basement	Inspected
Condition	2 - Between Good and Fair
Deficiency	GYPSON BOARD: DAMAGED/DETERIORATED
Deficiency Location/Instance	Near Entrance
Deficiency Quantity	10
Quantity Uom	S.F.
Potential Action	REPLACE
Urgency of Action	PRIORITY 3
Purpose of Action	LEVEL 2
Deficiency Photo1

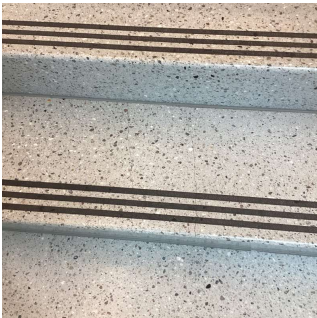
Stair A/Basement
Violations	No violations recorded.
Walls	
	Inspected
Condition	2 - Between Good and Fair

Question	Response
INTERIOR	
MULTI-PURPOSE ROOM	
Sliding-folding Partition	
Instance on Basement	Does not Exist
Stage	
Instance on Basement	Does not Exist
Walls	
Instance on Basement	Inspected
Condition	2 - Between Good and Fair
Deficiency	No deficiencies recorded
Window Curtains/Shades/Blinds	
Instance on Basement	Does not Exist
SCIENCE DEMO ROOM	
	Does not Exist
SCIENCE LAB	
	Does not Exist
SCIENCE PREP ROOM	
	Does not Exist
SHOWER ROOM	
	Does not Exist
STAIRS/RAMPS: INTERIOR	
	Inspected
Do Letter Stair Signs Exist?	Yes
Ceiling	
	Inspected
Condition	2 - Between Good and Fair
Deficiency	No deficiencies recorded
Door(s)	
	Inspected
Condition	2 - Between Good and Fair
Deficiency	No deficiencies recorded
Partition	
	Does not Exist
Railings	
	Inspected
Condition	2 - Between Good and Fair
Deficiency	No deficiencies recorded
Stairs and Landings	
	Inspected
Condition	2 - Between Good and Fair
Deficiency	TERRAZZO: CRACKS
Deficiency Location/Instance	Stair A/Basement, B/Basement

Deficiency Quantity	25
Quantity Uom	S.F.
Potential Action	REPLACE
Urgency of Action	PRIORITY 3
Purpose of Action	LEVEL 2
Deficiency Photo1

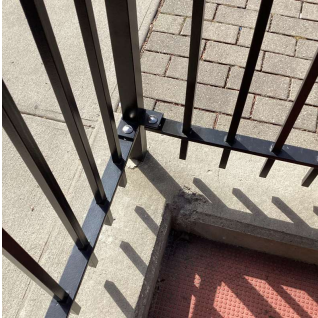
LIFE SAFETY	Inspected
F.D. HOLDING AREA	Does not Exist
STEEL STAIRS	Does not Exist
SITE	Inspected
CONTAINERIZATION	Does not Exist
Drainage System for Asphalt	Does not Exist
Drainage System for Concrete	Inspected
Catch Basins/Manhole - Surrounded by concrete	Inspected
Condition	2 - Between Good and Fair
Deficiency	No deficiencies recorded
Culverts - Concrete Covering	Does not Exist
Drainage System for Soil	Does not Exist
DRINKING FOUNTAINS	Does not Exist
FENCES	Inspected
Condition	2 - Between Good and Fair
Deficiency	CONCRETE CURB: DAMAGED/DETERIORATED
Deficiency Location/Instance	93rd Street

Question	Response
SITE	
FENCES	
Deficiency Quantity	20
Quantity Uom	S.F.
Potential Action	REPLACE
Urgency of Action	PRIORITY 3
Purpose of Action	LEVEL 2
Deficiency Photo1

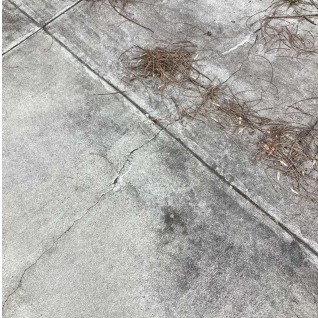
Violations	Rear No violations recorded.
Pavers	Does not Exist
Student Use	Does not Exist
Site Sidewalks & Walkways	Inspected
Asphalt	Does not Exist
Concrete	Inspected
Condition	3 - Fair

Violations	93rd Street No violations recorded.
IRRIGATION SYSTEM	Does not Exist
PAVING	Inspected
Student Non-Use	Inspected
Gravel Exists?	No
Asphalt	Does not Exist
Concrete	Inspected
Condition	3 - Fair
Deficiency	CRACKS - MAJOR
Deficiency Location/Instance	Rear
Deficiency Quantity	75
Quantity Uom	S.F.
Potential Action	REPLACE
Urgency of Action	PRIORITY 3
Purpose of Action	LEVEL 2
Deficiency Photo1

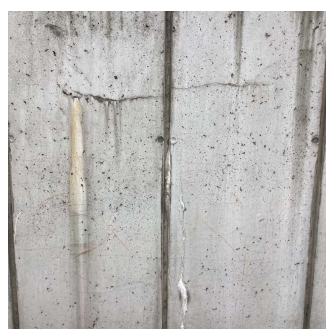
Violations	Near East Side Exit
	No violations recorded.
STAIRS/RAMPS: EXTERIOR	
	Does not Exist
ARTWORK	
	Does not Exist

Instance on 93rd Street - East	Inspected
Condition	2 - Between Good and Fair
Deficiency	No deficiencies recorded
Unpaved Area	
Instance on 93rd Street - West	Does not Exist
Instance on 93rd Street - East	Does not Exist
PLAYING SURFACE	
	Does not Exist
RETAINING WALLS	
Are there any Retaining Walls 6' OR higher facing public street/sidewalk?	Inspected
	No
Condition	2 - Between Good and Fair
Deficiency	No deficiencies recorded
SEATING	
	Does not Exist
SITE WALLS (NOT RETAINING WALLS)	
	Inspected
Condition	2 - Between Good and Fair
Deficiency	CAST IN PLACE CONCRETE: CRACKS/SPALLING - MAJOR
Deficiency Location/Instance	Near East Side Exit
Deficiency Quantity	20
Quantity Uom	S.F.
Potential Action	REPLACE
Urgency of Action	PRIORITY 3

Question	Response
SITE	
SITE WALLS (NOT RETAINING WALLS)	
Purpose of Action	LEVEL 2
Deficiency Photo1
