**NYC Department of Education**  
**Building Condition Assessment Survey 2023 - 2024**

Architectural Inspection

**K615**

**Asset: E NY VOC HS OF TRANSIT TECH.-K, 1 WELLS STREET, New York, 11208**

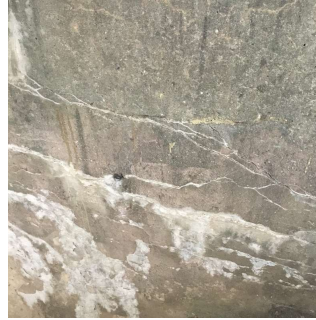
AW8

AREAWAY WALLS: CRACKS AND SPALLING

REPAIR

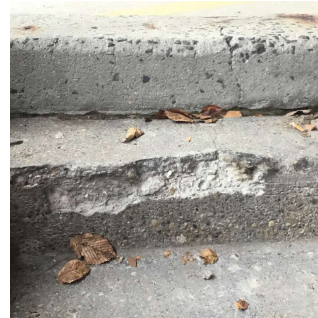
AW8  
No violations recorded.

AREAWAY STAIRS: DETERIORATED TREADS/RISERS/NOSINGS

15  
S.F.  
REPLACE  
PRIORITY 5  
LEVEL 6

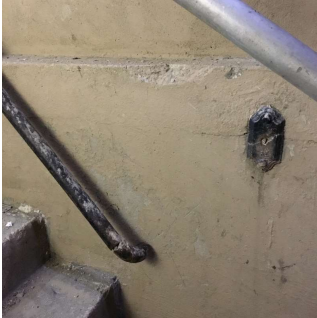
AREAWAY STAIRS: DETERIORATED RAILINGS

25  
L.F.  
REPLACE  
PRIORITY 4  
LEVEL 2

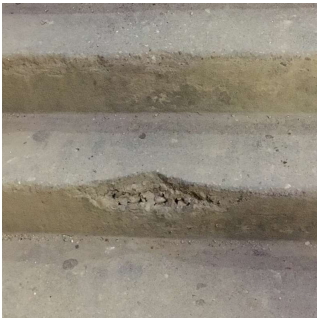
AW8
Violations	No violations recorded.
Deficiency	AREAWAY STAIRS: DETERIORATED TREADS/RISERS/NOSINGS
Roof Plan reference

Deficiency Quantity	20
Quantity Uom	S.F.
Potential Action	REPLACE
Urgency of Action	PRIORITY 4
Purpose of Action	LEVEL 2
Deficiency Photo1

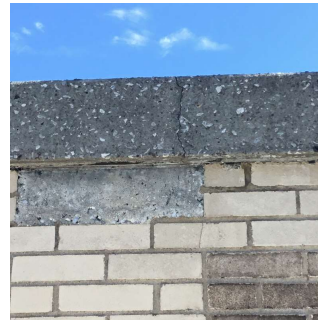
CHI

AW8
Violations	No violations recorded.
<b>AWNINGS AND CANOPIES</b>	
Condition	Inspected
Deficiency	2 - Between Good and Fair
	No deficiencies recorded
<b>CHIMNEY</b>	
Material Type(s)	Inspected
Condition	Masonry
Deficiency	3 - Fair
	BRICK: DETERIORATED CAP

REPLACE

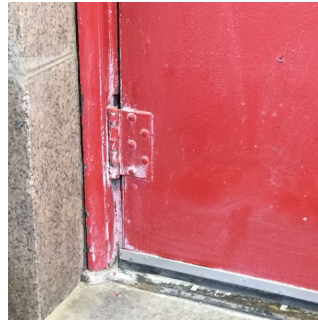
Facade A

METAL CLAD: DETERIORATED DOOR AND FRAME - MINOR DETERIORATION

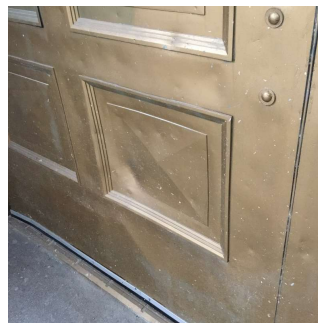
Facade J

**METAL: DETERIORATED DOOR - MINOR DETERIORATION**

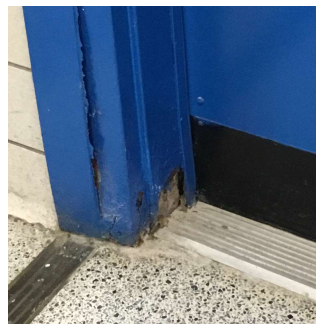
Facade D

**METAL: DETERIORATED DOOR AND FRAME - MAJOR DETERIORATION**

14  
 EACH  
 REPLACE  
 PRIORITY 4  
 LEVEL 2

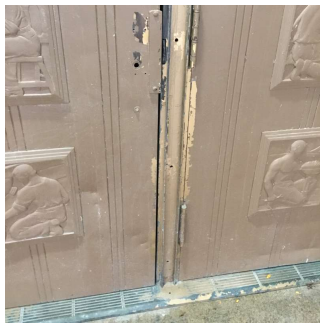
**METAL: DETERIORATED DOOR AND FRAME - MINOR DETERIORATION**

Violations	Facade B No violations recorded.
<b>DOOR HARDWARE</b>	
Condition	Inspected 3 - Fair
Deficiency	No deficiencies recorded
<b>LINTELS</b>	
Condition	Inspected 3 - Fair
Deficiency	STEEL: MAJOR RUSTING
Roof Plan reference

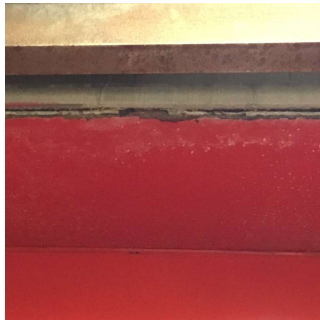
Deficiency Quantity	15
Quantity Uom	L.F.
Potential Action	REPLACE
Urgency of Action	PRIORITY 4
Purpose of Action	LEVEL 2
Deficiency Photo1

Violations	Facade D No violations recorded.
<b>TRANSOM/SIDE LIGHT</b>	
Condition	Inspected 5 - Poor
Deficiency	METAL: DENTED, MAJOR RUSTING

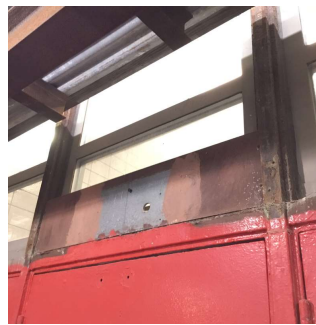
Facade D  
No violations recorded.

30  
S.F.  
REPLACE  
PRIORITY 4  
LEVEL 2

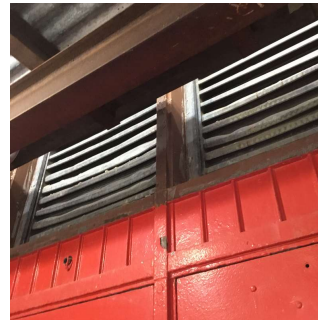
Facade E

BROKEN/ DENTED BLADES

REPLACE

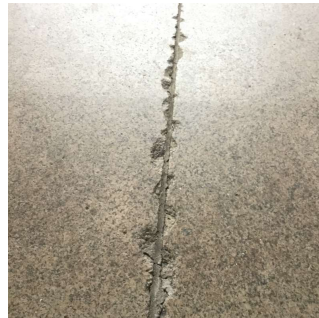
Question	Response
<b>EXTERIOR</b>	
<b>ROOF</b>	
<b>Specialties</b>	
<b>BULKHEAD/PENTHOUSE</b>	
Potential Action	REPLACE
Urgency of Action	PRIORITY 4
Purpose of Action	LEVEL 2
Deficiency Photo1	No photo recorded
Violations	No violations recorded.
<b>CUPOLA/ SPIRES/ TOWERS</b>	
	Does not Exist
<b>DORMER</b>	
	Does not Exist
<b>DUNNAGE STEEL</b>	
	Does not Exist
<b>SKYLIGHT/ROOF VENT</b>	
	Under Construction
<b>ROOF/GRAVITY TANK</b>	
	Does not Exist
<b>STAIRS/RAMPS: EXTERIOR</b>	
	Inspected
<b>BUILDING CHEEK/FLANK WALLS</b>	
Condition	5 - Poor
Deficiency	STONE: CRACKS/SPALLING - MAJOR
Roof Plan reference

Deficiency Quantity	10
Quantity Uom	S.F.
Potential Action	REPLACE
Urgency of Action	PRIORITY 4
Purpose of Action	LEVEL 2
Deficiency Photo1

Violations	No violations recorded.
Deficiency	STONE: CRACKS/SPALLING - MINOR

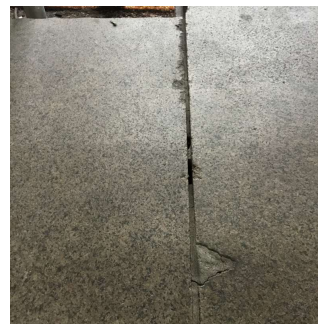
Facade A  
 No violations recorded.

20  
 S.F.  
 REPAIR  
 PRIORITY 3  
 LEVEL 2

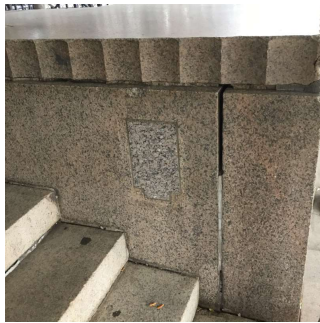
STONE: DETERIORATED JOINTS

Violations	Facade A No violations recorded.
<b>RAILINGS</b>	Inspected
Condition	2 - Between Good and Fair
Deficiency	No deficiencies recorded
<b>STAIRS/RAMPS</b>	Inspected
Condition	5 - Poor
Deficiency	STONE: CRACKS/SPALLING - MINOR
Roof Plan reference

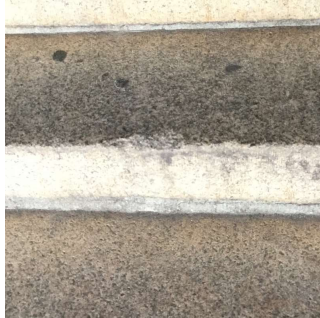
Deficiency Quantity	10
Quantity Uom	S.F.
Potential Action	REPAIR
Urgency of Action	PRIORITY 3
Purpose of Action	LEVEL 2
Deficiency Photo1

Violations	Facade A No violations recorded.
Deficiency	STONE: DETERIORATED JOINTS

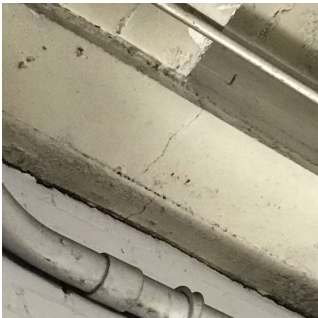
Question	Response
<b>EXTERIOR</b>	Inspected
<b>WINDOWS</b>	Inspected
<b>WINDOWS</b>	
Deficiency	No deficiencies recorded
<b>INTERIOR</b>	Inspected
<b>POOLS</b>	Does not Exist
<b>STRUCTURAL</b>	Inspected
<b>COLUMNS/BEAMS/BEARING WALLS</b>	Inspected
Condition	3 - Fair
Deficiency	STEEL COLUMNS/BEAMS: DETERIORATED CONCRETE FIREPROOFING
Deficiency Location/Instance	Basement
Deficiency Quantity	40
Quantity Uom	S.F.
Potential Action	REPLACE
Urgency of Action	PRIORITY 3
Purpose of Action	LEVEL 5
Deficiency Photo1

Violations	Custodian Shop (Basement Fan Room, Boiler Room, Basement Storage Room similar) No violations recorded.
Deficiency	STEEL COLUMNS/BEAMS: DETERIORATED MASONRY FIREPROOFING
Deficiency Location/Instance	5th Floor
Deficiency Quantity	10
Quantity Uom	S.F.
Potential Action	REPLACE
Urgency of Action	PRIORITY 3
Purpose of Action	LEVEL 5
Deficiency Photo1

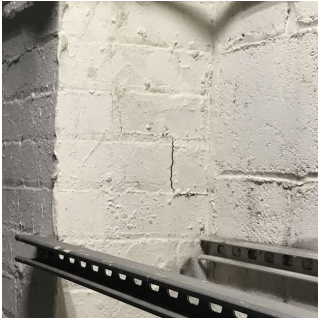
Violations	Room 550 - Fan Room No violations recorded.

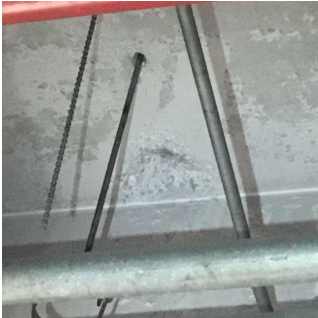
<b>Question</b>	<b>Response</b>
<b>INTERIOR</b>	Inspected
<b>STRUCTURAL</b>	Inspected
<b>FLOOR STRUCTURE</b>	
Deficiency	CONCRETE: CRACKS/SPALLED/REINFORCEMENT EXPOSED
Deficiency Location/Instance	Basement
Deficiency Quantity	15
Quantity Uom	S.F.
Potential Action	REPAIR
Urgency of Action	PRIORITY 4
Purpose of Action	LEVEL 5
Deficiency Photo1

Violations	Boiler Room No violations recorded.
Deficiency	CONCRETE SLAB ON GRADE: THRU CRACKS
Deficiency Location/Instance	Basement
Deficiency Quantity	40
Quantity Uom	S.F.
Potential Action	REPLACE
Urgency of Action	PRIORITY 4
Purpose of Action	LEVEL 5
Deficiency Photo1

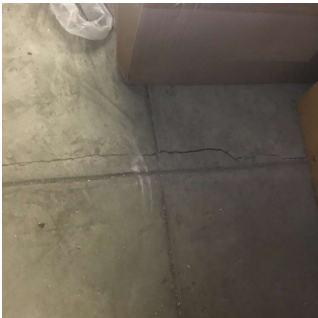
Violations	Crawl Space (Boiler Room similar) No violations recorded.
Deficiency	CONCRETE SLAB ON GRADE: THRU CRACKS
Deficiency Location/Instance	Basement
Deficiency Quantity	60
Quantity Uom	S.F.
Potential Action	REPAIR
Urgency of Action	PRIORITY 3
Purpose of Action	LEVEL 5

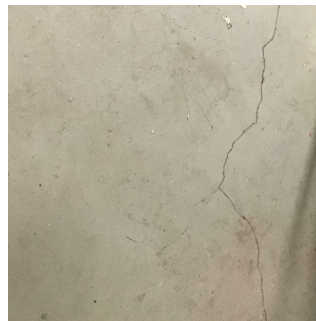
Room 550 - Fan Room

Deficiency	CONCRETE: CRACKS/SPALLED/REINFORCEMENT EXPOSED
Deficiency Location/Instance	5th Floor
Deficiency Quantity	35
Quantity Uom	S.F.
Potential Action	REPAIR
Urgency of Action	PRIORITY 3
Purpose of Action	LEVEL 5
Deficiency Photo1

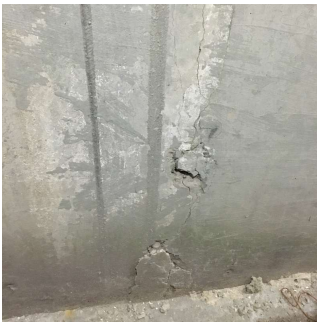
Deficiency	CONCRETE: CRACKED/SPALLED/REINFORCEMENT EXPOSED
Deficiency Location/Instance	Basement
Deficiency Quantity	40
Quantity Uom	S.F.
Potential Action	REPAIR
Urgency of Action	PRIORITY 4
Purpose of Action	LEVEL 5

AW7
Violations	No violations recorded.
<b>ROOF STRUCTURE</b>	Inspected
Condition	2 - Between Good and Fair
Deficiency	No deficiencies recorded
<b>VAULTS-BUNKERS</b>	Inspected
<b>Foundation Walls</b>	Inspected
Condition	3 - Fair
Deficiency	CRACKS, SPALLING
Deficiency Location/Instance	Vault
Deficiency Quantity	10
Quantity Uom	S.F.
Potential Action	REPAIR
Urgency of Action	PRIORITY 4
Purpose of Action	LEVEL 5
Deficiency Photo1

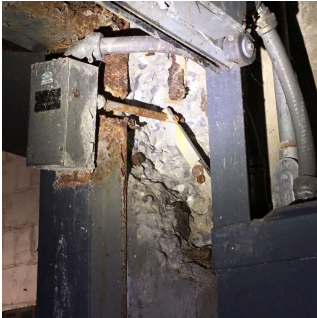
Vault
Violations	No violations recorded.
<b>Slab Structure</b>	Inspected
Condition	3 - Fair
Deficiency	CONCRETE: CRACKS/SPALLED/REINFORCEMENT EXPOSED
Deficiency Location/Instance	Vault
Deficiency Quantity	15
Quantity Uom	S.F.
Potential Action	REPAIR
Urgency of Action	PRIORITY 4
Purpose of Action	LEVEL 5

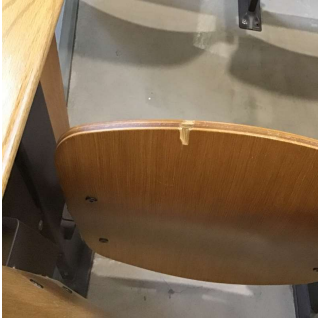
Question	Response
<b>INTERIOR</b>	
<b>AUDITORIUM</b>	
<b>Fixed Seating</b>	
Instance on 1st Floor (616 seats)	Inspected
Condition	2 - Between Good and Fair
Deficiency	DAMAGED/BROKEN/INOPERABLE
Deficiency Location/Instance	Seats C/4, R/25, U/2, V/15
Deficiency Quantity	4
Quantity Uom	EACH
Potential Action	REPLACE
Urgency of Action	PRIORITY 3
Purpose of Action	LEVEL 2
Deficiency Photo1

Violations	Seat R/25 No violations recorded.
<b>Floor Finish</b>	
Instance on 1st Floor (616 seats)	Inspected
Condition	2 - Between Good and Fair
Deficiency	CONCRETE: CRACKS
Deficiency Location/Instance	Near Seats F/22, L/22, R/6,22
Deficiency Quantity	80
Quantity Uom	S.F.
Potential Action	REPLACE
Urgency of Action	PRIORITY 3
Purpose of Action	LEVEL 2
Deficiency Photo1	 
Violations	Seat F/22 No violations recorded.
<b>Sliding-folding Partition</b>	
Instance on 1st Floor (616 seats)	Does not Exist
<b>Stage</b>	
Instance on 1st Floor (616 seats)	Inspected

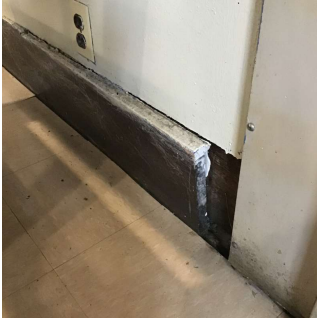
Question	Response
<b>INTERIOR</b>	
<b>AUDITORIUM</b>	
<b>Stage</b>	
<b>Stage</b>	
Condition	3 - Fair
Deficiency	DAMAGED FASCIA
Deficiency Location/Instance	Near left side
Deficiency Quantity	10
Quantity Uom	S.F.
Potential Action	REPLACE
Urgency of Action	PRIORITY 3
Purpose of Action	LEVEL 2
Deficiency Photo1

Near left side
Violations	No violations recorded.
Deficiency	DAMAGED FLOOR
Deficiency Location/Instance	Near center, left side, right side
Deficiency Quantity	20
Quantity Uom	S.F.
Potential Action	REPLACE
Urgency of Action	PRIORITY 3
Purpose of Action	LEVEL 2
Deficiency Photo1

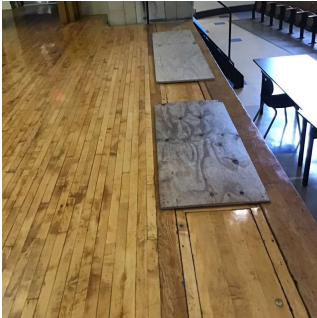
Near center
Violations	No violations recorded.
<b>Stage Curtain Rigging</b>	Inspected
Instance on 1st Floor (616 seats)	Inspected
Condition	2 - Between Good and Fair
Deficiency	No deficiencies recorded
<b>Stage Curtains</b>	Inspected
Instance on 1st Floor (616 seats)	Inspected
Condition	3 - Fair
Deficiency	WORN/DETERIORATED
Deficiency Location/Instance	Left side

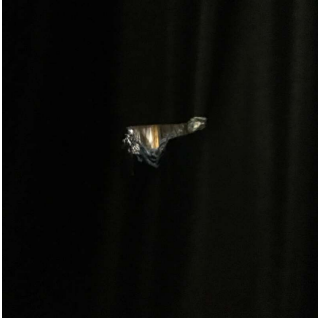
Question	Response
<b>INTERIOR</b>	
<b>AUDITORIUM</b>	
<b>Stage</b>	
<b>Stage Curtains</b>	
Deficiency Quantity	200
Quantity Uom	S.F.
Potential Action	REPLACE
Urgency of Action	PRIORITY 3
Purpose of Action	LEVEL 2
Deficiency Photo1

Left side
Violations	No violations recorded.
<b>Walls</b>	
Instance on 1st Floor (616 seats)	Inspected
Condition	2 - Between Good and Fair
Deficiency	PLASTER: CRACKS/SPALLING
Deficiency Location/Instance	Right side of stage
Deficiency Quantity	10
Quantity Uom	S.F.
Potential Action	REPLACE
Urgency of Action	PRIORITY 3
Purpose of Action	LEVEL 2
Deficiency Photo1

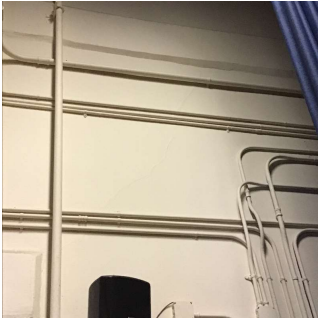
Right side of stage
Violations	No violations recorded.
<b>Window Curtains/Shades/Blinds</b>	
Instance on 1st Floor (616 seats)	Inspected
Condition	2 - Between Good and Fair
Deficiency	No deficiencies recorded
<b>CAFETERIA</b>	
Instance on Basement	Inspected
<b>Ceiling</b>	
Instance on Basement	Inspected
Condition	2 - Between Good and Fair

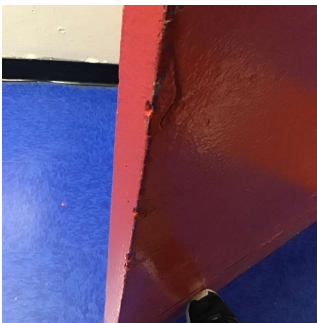
Question	Response
<b>INTERIOR</b>	
<b>CAFETERIA</b>	
<b>Ceiling</b>	
Deficiency	ACOUSTIC TILES ON PLASTER: DAMAGED/MISSING
Deficiency Location/Instance	Near Entrance
Deficiency Quantity	10
Quantity Uom	S.F.
Potential Action	REPLACE
Urgency of Action	PRIORITY 3
Purpose of Action	LEVEL 2
Deficiency Photo1	 
Violations	Near Entrance No violations recorded.
<b>Door(s)</b>	
Instance on Basement	Inspected
Condition	4 - Between Fair and Poor
Deficiency	WOOD: DETERIORATED DOOR
Deficiency Location/Instance	Entrance
Deficiency Quantity	2
Quantity Uom	EACH
Potential Action	MAINTENANCE
Urgency of Action	PRIORITY 3
Purpose of Action	LEVEL 2
Deficiency Photo1

Violations	Entrance No violations recorded.
<b>Fixed Equipment</b>	
Instance on Basement	Does not Exist
<b>Floor Finish</b>	
Instance on Basement	Inspected
Condition	2 - Between Good and Fair
Deficiency	No deficiencies recorded
<b>Sliding-folding Partition</b>	
Instance on Basement	Does not Exist

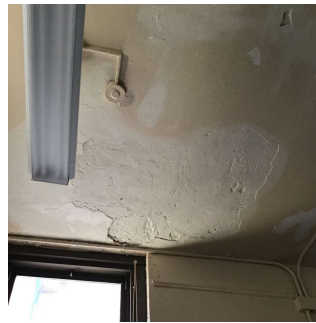
Room 210
Violations	No violations recorded.
Deficiency	PLASTER: CRACKS/SPALLING
Deficiency Location/Instance	Room 315
Deficiency Quantity	10
Quantity Uom	S.F.
Potential Action	REPLACE
Urgency of Action	PRIORITY 3
Purpose of Action	LEVEL 2

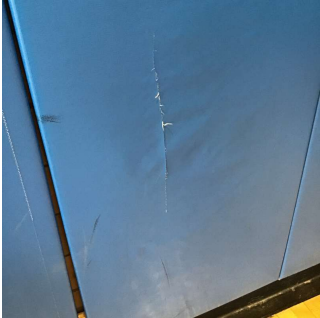
Question	Response
<b>INTERIOR</b>	
<b>GYMNASIUM</b>	Inspected
<b>Walls</b>	
Condition	3 - Fair
Deficiency	WALL PADDING: DETERIORATED
Deficiency Location/Instance	Near Entrance, left side, right side
Deficiency Quantity	360
Quantity Uom	S.F.
Potential Action	REPLACE
Urgency of Action	PRIORITY 3
Purpose of Action	LEVEL 2
Deficiency Photo1

Violations	Near Entrance No violations recorded.
<b>Window Curtains/Shades/Blinds</b>	
Instance on 4th Floor	Does not Exist
<b>INTERIOR DOOR HARDWARE</b>	Inspected
Condition	3 - Fair
Deficiency	No deficiencies recorded
<b>INTERIOR GUARDS</b>	Inspected
Condition	3 - Fair
Deficiency	DETERIORATED/TORN-OUT/MISSING
Deficiency Location/Instance	Stair A/3, B/2, E/2, F/4, G/3
Deficiency Quantity	50
Quantity Uom	S.F.
Potential Action	REPLACE
Urgency of Action	PRIORITY 3
Purpose of Action	LEVEL 2
Deficiency Photo1

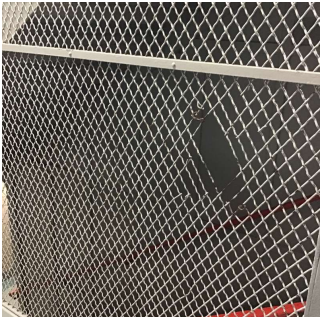
Violations	Stair E/2 No violations recorded.
<b>KITCHEN</b>	Inspected
Instance on Basement	Inspected

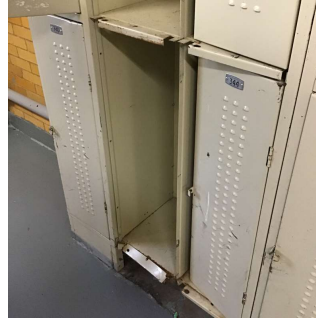
Locker 342

No	Protruding Elements	Severely damaged locker with protruding metal is a potential safety hazard.	INTERIOR   LOCKER ROOM   Locker Room Lockers	Locker 341, 342, 343, 344,	Joseph Gallucio	Fireman

Locker 37
Violations	No violations recorded.
Instance on 3rd Floor - Boys (666 lockers)	Inspected
Condition	4 - Between Fair and Poor
Deficiency	DAMAGED UNITS
Deficiency Location/Instance	Locker 341, 342, 343, 344,
Deficiency Quantity	4
Quantity Uom	EACH

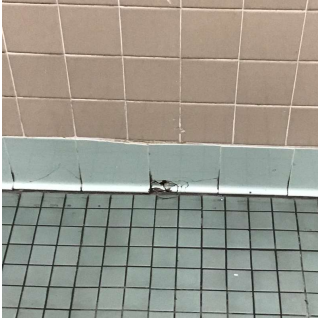
Violations	Room 353A No violations recorded.
Instance on 3rd Floor - Boys	Inspected
Condition	3 - Fair
Deficiency	CERAMIC TILE: BROKEN/ MISSING
Deficiency Location/Instance	Room 348C
Deficiency Quantity	10
Quantity Uom	S.F.
Potential Action	REPLACE
Urgency of Action	PRIORITY 3
Purpose of Action	LEVEL 2
Deficiency Photo1

Violations	Room 348C No violations recorded.
Deficiency	CERAMIC TILE: BROKEN/ MISSING
Deficiency Location/Instance	Room 348C
Deficiency Quantity	10
Quantity Uom	S.F.
Potential Action	REPLACE
Urgency of Action	PRIORITY 5
Purpose of Action	LEVEL 6

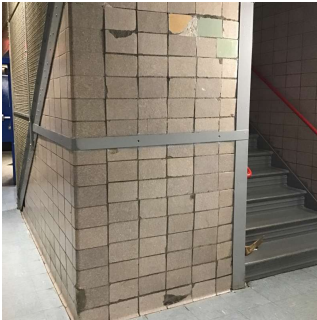
Stair F/Basement
Violations	No violations recorded.
<b>Walls</b>	Inspected
Condition	2 - Between Good and Fair
Deficiency	GLAZED BLOCK: CRACKS/SPALLING
Deficiency Location/Instance	Stair D/4, 2, A/4, 3, C/1, and others
Deficiency Quantity	80
Quantity Uom	S.F.
Potential Action	REPLACE
Urgency of Action	PRIORITY 3
Purpose of Action	LEVEL 2
Deficiency Photo1

Stair C/1
Violations	No violations recorded.
<b>TOILET ROOMS - STAFF</b>	Inspected
<b>Ceiling</b>	Inspected
Condition	2 - Between Good and Fair
Deficiency	No deficiencies recorded
<b>Door(s)</b>	Inspected
Condition	2 - Between Good and Fair
Deficiency	No deficiencies recorded
<b>Floor Finish</b>	Inspected
Condition	2 - Between Good and Fair
Deficiency	No deficiencies recorded
<b>Stalls</b>	Inspected
Condition	5 - Poor
Deficiency	RUST - MAJOR

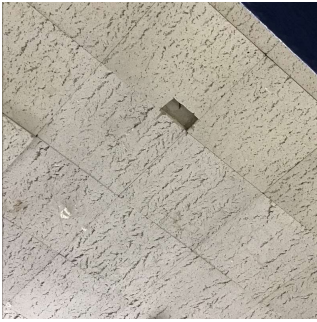
Violations	Room 309 No violations recorded.
<b>TOILET ROOMS - STUDENTS</b>	
<b>Ceiling</b>	Inspected
Condition	2 - Between Good and Fair
Deficiency	ACOUSTIC TILES ON PLASTER: DAMAGED/MISSING
Deficiency Location/Instance	Room B25
Deficiency Quantity	10
Quantity Uom	S.F.
Potential Action	REPLACE
Urgency of Action	PRIORITY 3
Purpose of Action	LEVEL 2
Deficiency Photo1

Violations	Room B25 No violations recorded.
<b>Door(s)</b>	
Condition	5 - Poor
Deficiency	WOOD: DETERIORATED DOOR
Deficiency Location/Instance	3rd Floor - Boys, Rooms B25, B24
Deficiency Quantity	3
Quantity Uom	EACH
Potential Action	MAINTENANCE
Urgency of Action	PRIORITY 3
Purpose of Action	LEVEL 2
