NYC Department of Education
Building Condition Assessment Survey 2023 - 2024

Architectural Inspection

K625

Asset: ROBESON HS COMP&BUS TC (A HML)-K, 150 ALBANY AVENUE, New York, 11213

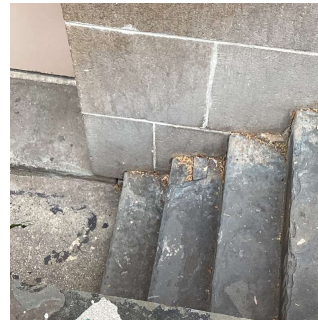
AW3
No violations recorded.

AREAWAY WALLS: CRACKS AND SPALLING

10
S.F.
REPAIR
PRIORITY 3
LEVEL 2

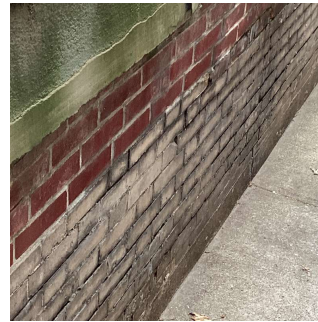
AW5
No violations recorded.

AREAWAY WALLS: DETERIORATED COPING STONE

40
S.F.
REPLACE
PRIORITY 4
LEVEL 2

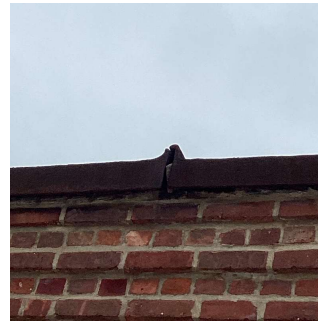
CH
No violations recorded.

CAST STONE: DETERIORATED BED JOINT

10
L.F.
REPOINT
PRIORITY 3
LEVEL 2

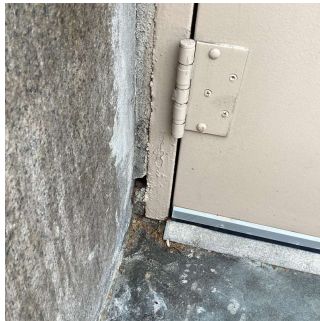
Violations	Facade D - Exit 4 No violations recorded.
Deficiency	METAL: DETERIORATED DOOR AND FRAME - MINOR DETERIORATION
Roof Plan reference

Deficiency Quantity	6
Quantity Uom	EACH
Potential Action	MAINTENANCE
Urgency of Action	PRIORITY 3
Purpose of Action	LEVEL 2
Deficiency Photo1

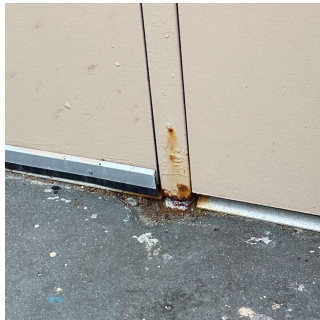
Violations	Facade J - Exit 1 No violations recorded.
DOOR HARDWARE	Inspected
Condition	3 - Fair
Deficiency	No deficiencies recorded
LINTELS	Inspected
Condition	2 - Between Good and Fair
Deficiency	No deficiencies recorded
TRANSOM/SIDE LIGHT	Inspected
Condition	2 - Between Good and Fair
Deficiency	No deficiencies recorded

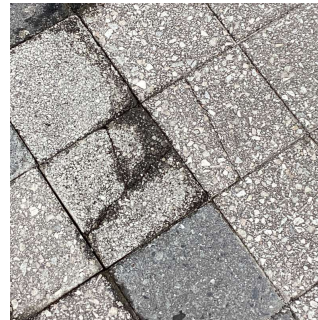
Plaza Deck - Near Main Entrance

PAVERS: DETERIORATED JOINTS

10
L.F.
REPOINT
PRIORITY 4
LEVEL 2

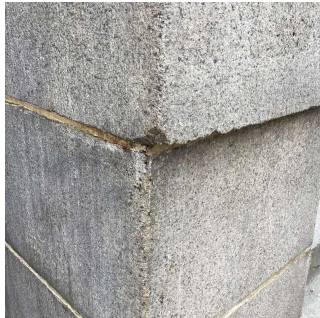
Violations	Facade A - Main Entrance No violations recorded.
Deficiency	CAST IN PLACE CONCRETE: CRACKS/SPALLING - MINOR
Roof Plan reference

Deficiency Quantity	20
Quantity Uom	S.F.
Potential Action	REPAIR
Urgency of Action	PRIORITY 3
Purpose of Action	LEVEL 2
Deficiency Photo1

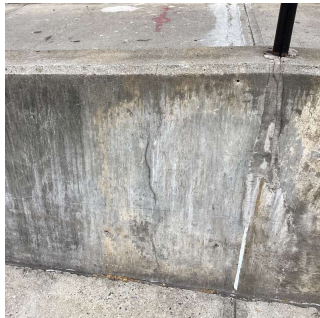
Violations	Facade C No violations recorded.
RAILINGS	Inspected
Condition	2 - Between Good and Fair
Deficiency	No deficiencies recorded
STAIRS/RAMPS	Inspected
Condition	5 - Poor
Deficiency	STONE: WORN-OUT TREAD/RISER/NOSING

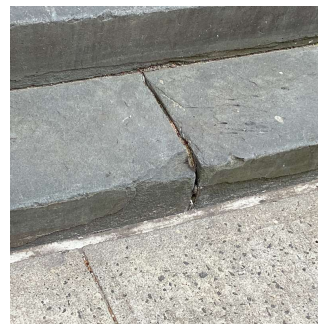
Facade J - Exit 2
No violations recorded.

STONE: DETERIORATED JOINTS

10
L.F.
REPOINT
PRIORITY 3
LEVEL 2

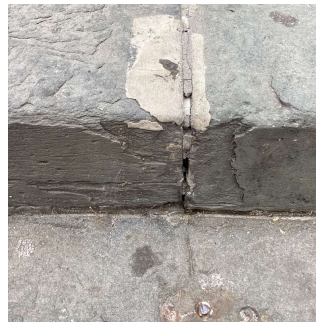
Facade A - Main Entrance

DETERIORATED/TORN-OUT/MISSING

REPLACE

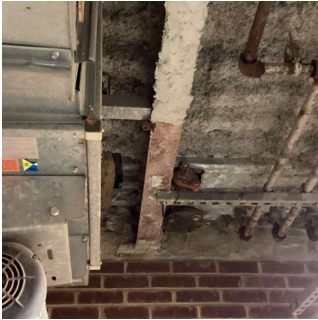
Violations	Basement - Room B80 No violations recorded.
FLOOR STRUCTURE	
Condition	Inspected 3 - Fair
Deficiency	CLAY TILE: PLASTER MISSING
Deficiency Location/Instance	Basement - Near the Generator/Oil Tank Room
Deficiency Quantity	50
Quantity Uom	S.F.
Potential Action	REPLACE
Urgency of Action	PRIORITY 3
Purpose of Action	LEVEL 5
Deficiency Photo1

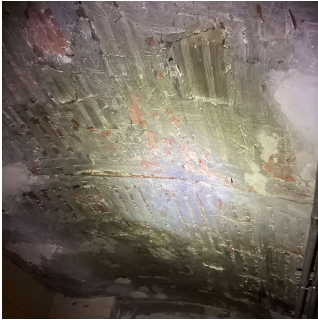
Violations	Basement - Near the Generator/Oil Tank Room No violations recorded.
Deficiency	CONCRETE: CRACKS/SPALLED/REINFORCEMENT EXPOSED
Deficiency Location/Instance	Narrow corridor leadings to the Boiler Room

Deficiency Quantity	10
Quantity Uom	S.F.
Potential Action	REPAIR
Urgency of Action	PRIORITY 4
Purpose of Action	LEVEL 5
