NYC Department of Education
Building Condition Assessment Survey 2023 - 2024

Architectural Inspection

K656

Asset: BKLYN HS OF THE ARTS AX (S J HL)-K, 500 PACIFIC STREET, New York, 11217

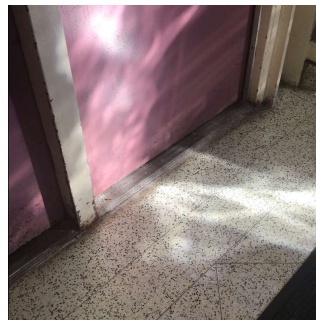
Facade A - Main Entrance

METAL: DETERIORATED DOOR AND FRAME - MINOR DETERIORATION

2
EACH
MAINTENANCE
PRIORITY 3
LEVEL 2

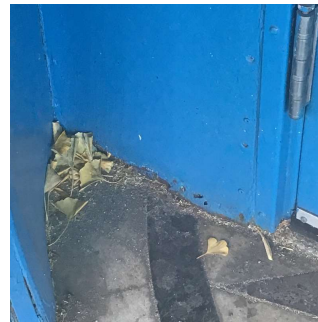
Facade D - Exit 3

METAL: DENTED, MAJOR RUSTING

REPLACE

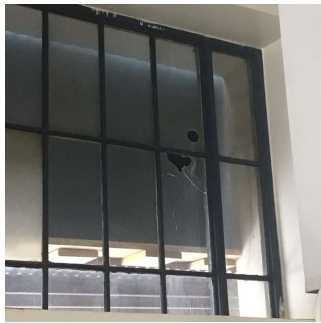
METAL: BROKEN GLASS

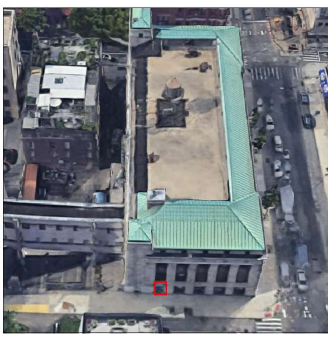
Violations	Facade D - Exit 4 No violations recorded.
EXTERIOR WALLS	Inspected
Material Type(s)	Concrete, Masonry
Replacement Quantity	28,500
Replacement Uom	S.F.
Instance on All Facades	Under Construction
Instance Quantity	28,500
Instance Quantity Uom	S.F.
EXTERIOR SOFFITS	Inspected
Condition	2 - Between Good and Fair
Deficiency	CONCRETE: MINOR CRACKS/SPALLING
Roof Plan reference	K656

Deficiency Quantity	20
Quantity Uom	S.F.
Potential Action	REPAIR
Urgency of Action	PRIORITY 3
Purpose of Action	LEVEL 2

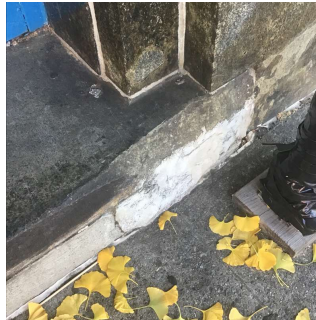
Violations	Facade D - Exit 4 No violations recorded.
Deficiency	STONE: CRACKS/SPALLING - MINOR

20
S.F.
REPAIR
PRIORITY 3
LEVEL 2

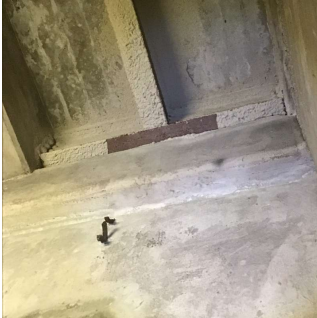
Question	Response
INTERIOR	
STRUCTURAL	
COLUMNS/BEAMS/BEARING WALLS	Inspected
Condition	3 - Fair
Deficiency	STEEL COLUMNS/BEAMS: DETERIORATED/MISSING SPRAY-ON FIREPROOFING
Deficiency Location/Instance	Sub-Basement - Room SB60
Deficiency Quantity	20
Quantity Uom	S.F.
Potential Action	REPLACE
Urgency of Action	PRIORITY 3
Purpose of Action	LEVEL 5
Deficiency Photo1

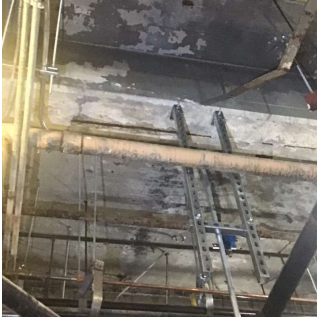
Violations	Room SB60 No violations recorded.
Deficiency	STEEL COLUMNS/BEAMS: DETERIORATED CONCRETE FIREPROOFING
Deficiency Location/Instance	Sub-Basement - Boiler Room, Room SB60
Deficiency Quantity	30
Quantity Uom	S.F.
Potential Action	REPLACE
Urgency of Action	PRIORITY 3
Purpose of Action	LEVEL 5
Deficiency Photo1

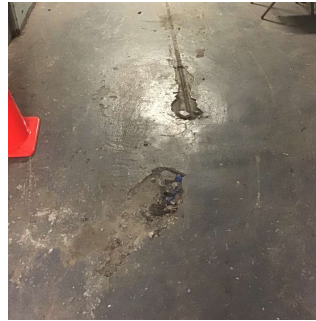
Sub-Basement - Corridor near Stair G

Violations	Boiler Room No violations recorded.
FLOOR STRUCTURE	
	Inspected
Condition	4 - Between Fair and Poor
Deficiency	CONCRETE SLAB ON GRADE: THRU CRACKS
Deficiency Location/Instance	Sub-Basement - Boiler Room, Corridor near Stair G

Deficiency Quantity	200
Quantity Uom	S.F.
Potential Action	REPLACE
Urgency of Action	PRIORITY 4
Purpose of Action	LEVEL 5

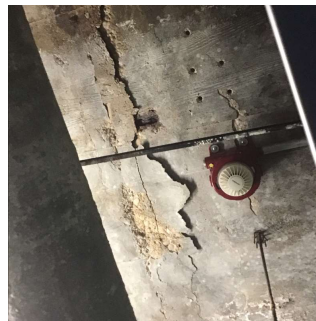
Basement - Gas Meter Room

CONCRETE: CRACKS/SPALLED/REINFORCEMENT EXPOSED

REPAIR

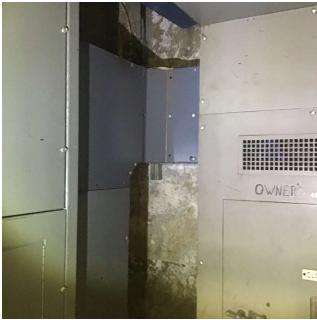
Question	Response
INTERIOR	
STRUCTURAL	
FOUNDATION WALLS	Inspected
Material Type(s)	Concrete
Condition	5 - Poor
Deficiency	CONCRETE: WATER INFILTRATION IN ELECTRICAL PANEL ROOM
Deficiency Location/Instance	Sub-Basement - Electrical Panel Room
Deficiency Quantity	100
Quantity Uom	S.F.
Potential Action	INSTALL WATERPROOFING
Urgency of Action	PRIORITY 5
Purpose of Action	LEVEL 6
Deficiency Photo1

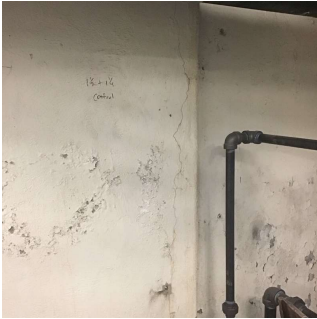
Sub-Basement - Electrical Panel Room
Violations	No violations recorded.
Deficiency	CONCRETE: CRACKED/SPALLED/REINFORCEMENT EXPOSED
Deficiency Location/Instance	Sub-Basement - Rooms SB51, SB60
Deficiency Quantity	50
Quantity Uom	S.F.
Potential Action	REPAIR
Urgency of Action	PRIORITY 3
Purpose of Action	LEVEL 5
Deficiency Photo1

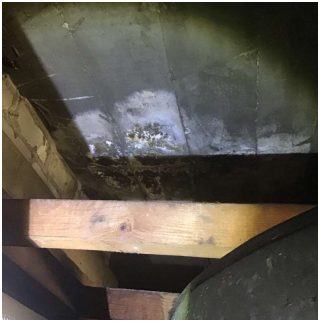
Violations	BH1 No violations recorded.
VAULTS-BUNKERS	
Foundation Walls	Inspected
Condition	2 - Between Good and Fair
Deficiency	No deficiencies recorded
Slab Structure	Inspected
Condition	4 - Between Fair and Poor
Deficiency	CONCRETE: WATER INFILTRATION IN NON- INSTRUCTIONAL SPACE
Deficiency Location/Instance	Basement - Water Meter Room M54A
Deficiency Quantity	100
Quantity Uom	S.F.
Potential Action	INSTALL WATERPROOFING
Urgency of Action	PRIORITY 5
Purpose of Action	LEVEL 5
Deficiency Photo1

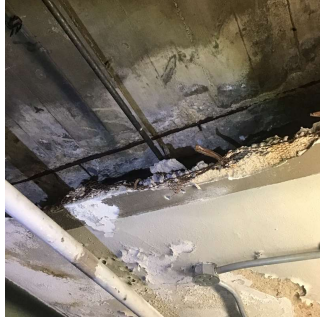
Violations	Water Meter Room M54A No violations recorded.
Deficiency	CONCRETE: CRACKS/SPALLED/REINFORCEMENT EXPOSED
Deficiency Location/Instance	Basement - Water Meter Room M54A
Deficiency Quantity	10
Quantity Uom	S.F.
Potential Action	REPAIR
Urgency of Action	PRIORITY 5
Purpose of Action	LEVEL 5

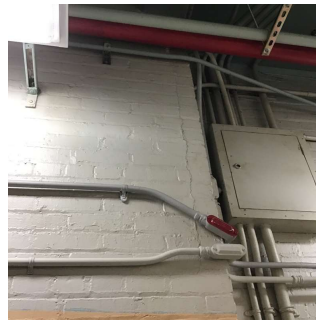
Corridor near Room 351

BRICK: CRACKS/SPALLING

REPLACE

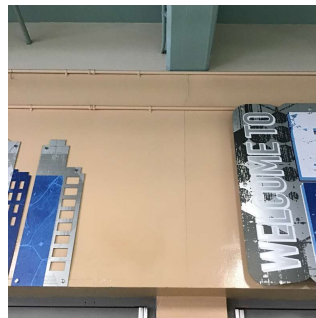
GYPSUM BOARD: DETERIORATED

REPLACE

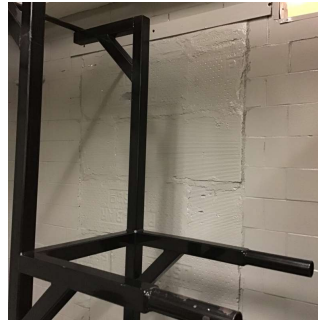
Weight Room

BRICK: CRACKS/SPALLING

REPLACE

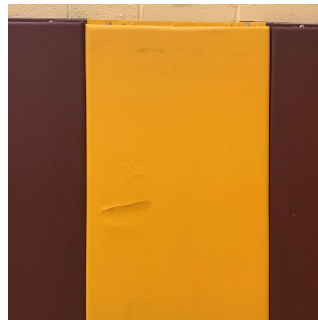
Left Side

WALL PADDING: DETERIORATED

REPLACE

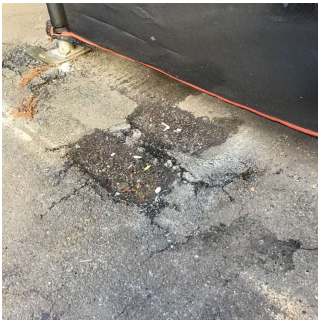
Violations	Dean Street No violations recorded.
IRRIGATION SYSTEM	Does not Exist
PAVING	Inspected
Student Non-Use	Inspected
Gravel Exists?	No
Asphalt	Inspected
Condition	4 - Between Fair and Poor
Deficiency	HEAVING
Deficiency Location/Instance	Parking Lot
Deficiency Quantity	10
Quantity Uom	S.F.
Potential Action	REPLACE
Urgency of Action	PRIORITY 5
Purpose of Action	LEVEL 6
Deficiency Photo1

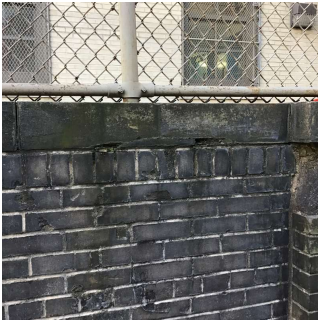
Violations	North East of Building No violations recorded.
SEATING	Does not Exist
SITE WALLS (NOT RETAINING WALLS)	Inspected
Condition	3 - Fair
Deficiency	BRICK: DETERIORATED COPING STONE
Deficiency Location/Instance	North East of Building
Deficiency Quantity	10
Quantity Uom	S.F.
Potential Action	REPLACE
Urgency of Action	PRIORITY 3
Purpose of Action	LEVEL 2
Deficiency Photo1
