NYC Department of Education
Building Condition Assessment Survey 2023 - 2024

Architectural Inspection

K660

Asset: WILLIAM MAXWELL CTE HS - K, 145 PENNSYLVANIA AVENUE, New York, 11207

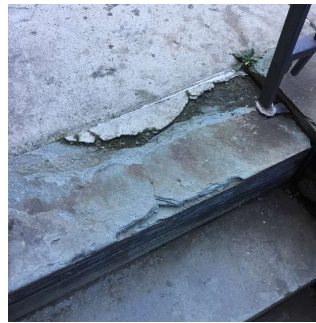
AW4

Violations	No violations recorded.
Deficiency	AREAWAY STAIRS: DETERIORATED TREADS/RISERS/NOSINGS
Roof Plan reference

Deficiency Quantity	15
Quantity Uom	S.F.
Potential Action	REPLACE
Urgency of Action	PRIORITY 5

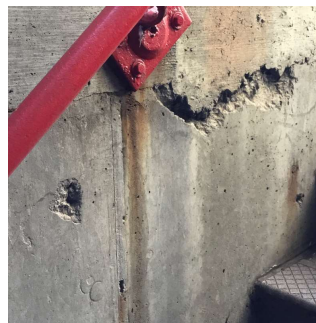
AW1

AREAWAY WALLS: CRACKS AND SPALLING

30
S.F.
REPLACE
PRIORITY 4
LEVEL 2

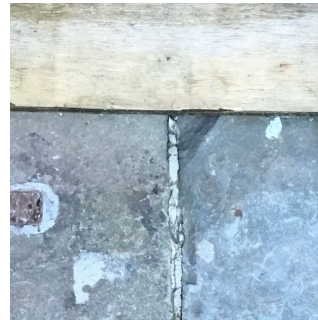
AW6

AREAWAY WALLS: DETERIORATED COPING STONE

REPLACE

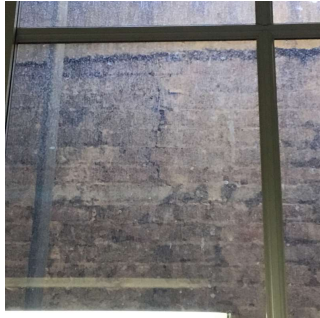
AREAWAY WALLS: CRACKS AND SPALLING

REPAIR

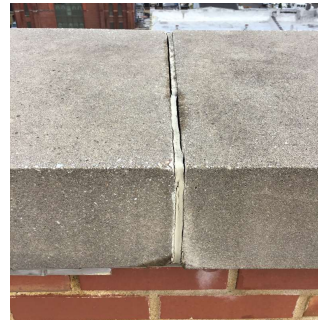
Roof 1
No violations recorded.

150
L.F.
MAINTENANCE
PRIORITY 3
LEVEL 2

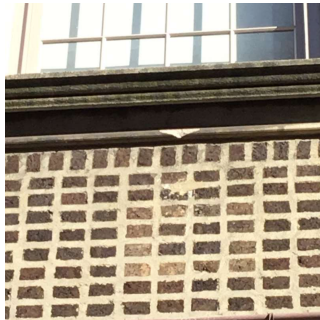
STONE: MINOR CRACKS, SPALLING

10
S.F.
REPAIR
PRIORITY 3
LEVEL 2

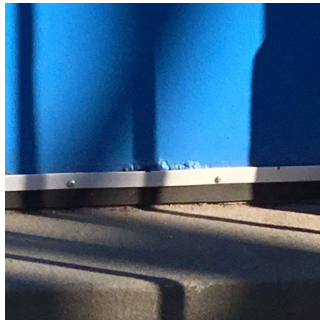
Violations	Facade A No violations recorded.
DOORS	Inspected
DOORS AND FRAMES	Inspected
Condition	4 - Between Fair and Poor
Deficiency	METAL: DETERIORATED DOOR - MINOR DETERIORATION
Roof Plan reference	<p>K660</p>

Deficiency Quantity	1
Quantity Uom	EACH
Potential Action	MAINTENANCE
Urgency of Action	PRIORITY 3
Purpose of Action	LEVEL 2
Deficiency Photo1

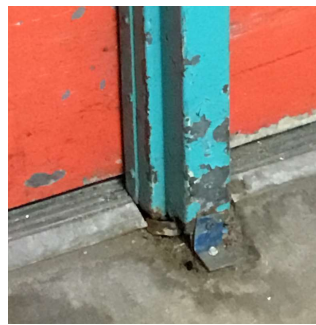
Facade M

Violations	Facade A No violations recorded.
Deficiency	METAL: DETERIORATED DOOR AND FRAME - MAJOR DETERIORATION

4
 EACH
 REPLACE
 PRIORITY 4
 LEVEL 2

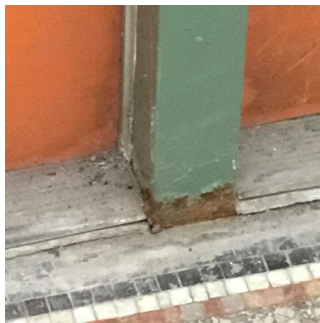
METAL: DETERIORATED DOOR AND FRAME - MINOR DETERIORATION

2
 EACH
 MAINTENANCE
 PRIORITY 3
 LEVEL 2

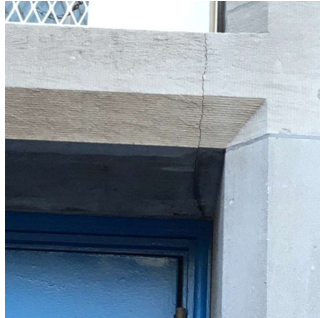
Violations	Facade H - Exit 11 No violations recorded.
DOOR HARDWARE	Inspected
Condition	3 - Fair
Deficiency	No deficiencies recorded
LINTELS	Inspected
Condition	2 - Between Good and Fair
Deficiency	STONE: CHIPPED/SPALLED/BROKEN PIECES
Roof Plan reference

Deficiency Quantity	20
Quantity Uom	S.F.
Potential Action	REPAIR
Urgency of Action	PRIORITY 3
Purpose of Action	LEVEL 2
Deficiency Photo1

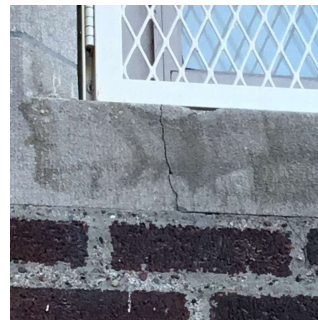
Facade C

Question	Response
EXTERIOR	
EXTERIOR WALLS	
Material Type(s)	Masonry, Steel
Replacement Quantity	65,000
Replacement Uom	S.F.
Instance on All Facades	Inspected
Instance Condition	3 - Fair
Instance Quantity	65,000
Instance Quantity Uom	S.F.
Deficiency	BRICK: DETERIORATED CONTROL/EXPANSION JOINTS
Roof Plan reference	 
Elevation	 
Deficiency Quantity	15
Quantity Uom	L.F.
Potential Action	MAINTENANCE
Urgency of Action	PRIORITY 3
Purpose of Action	LEVEL 2
Deficiency Photo1	 
Violations	Facade P No violations recorded.
Deficiency	BRICK: DETERIORATED MASONRY SILLS - MINOR

REPAIR

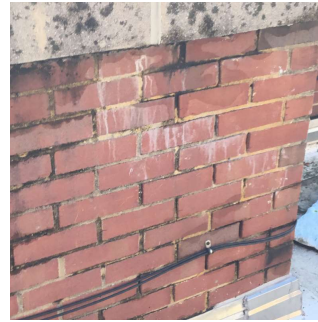
Roof 5

Violations	Roof 4 No violations recorded.
Deficiency	BRICK: DETERIORATED JOINTS
Roof Plan reference

Deficiency Quantity	80
Quantity Uom	S.F.
Potential Action	REPOINT
Urgency of Action	PRIORITY 3
Purpose of Action	LEVEL 2

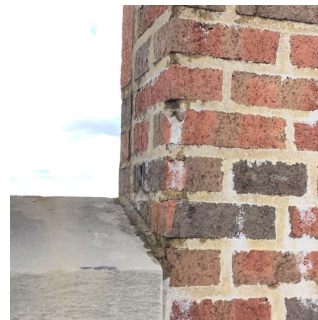
Roof 1

BRICK: MINOR CRACKS, SPALLING

REPAIR

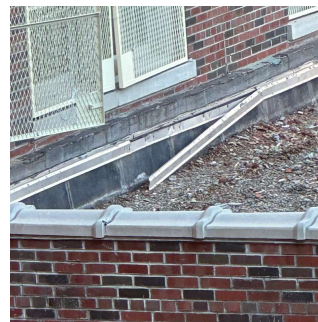
Roof 2
No violations recorded.

Installation Year	1998
Source of Installation	Inspector Estimate
Deficiency	IRMA: FLASHING: CAP FLASHING DAMAGED

20
L.F.
REPLACE
PRIORITY 4
LEVEL 2

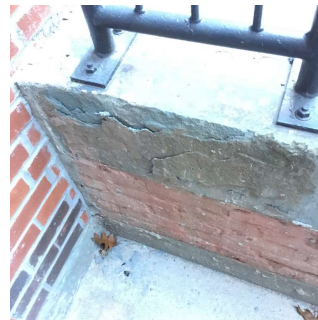
Facade L

BRICK: DETERIORATED COPING STONE

35
S.F.
REPLACE
PRIORITY 4
LEVEL 2

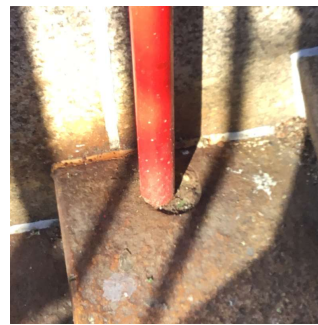
Facade A
No violations recorded.

RUST - MAJOR

15
L.F.
REPLACE
PRIORITY 4
LEVEL 2

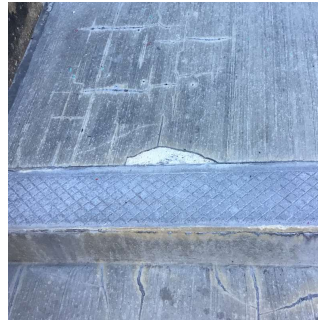
Facade C

CONCRETE: CRACKS/SPALLING - MINOR

25
S.F.
REPAIR
PRIORITY 3
LEVEL 2

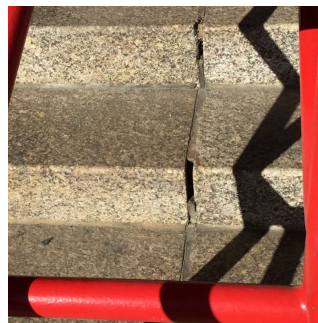
Facade A

STONE: DETERIORATED JOINTS

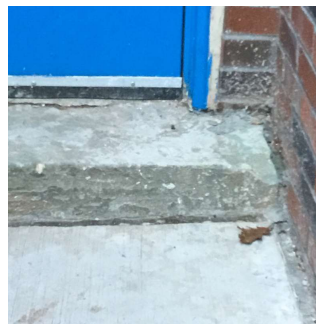
Facade L

STONE: CRACKS/SPALLING - MAJOR

20
S.F.
REPLACE
PRIORITY 4
LEVEL 2

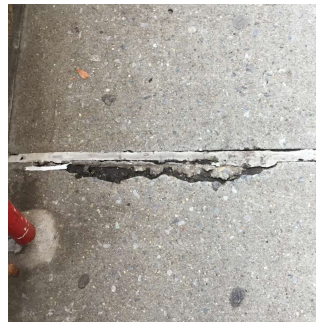
Facade A

CONCRETE: CRACKS/SPALLING - MAJOR

10
S.F.
REPLACE
PRIORITY 4
LEVEL 2

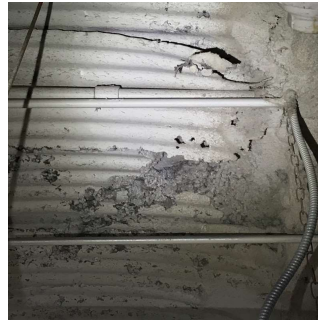
Basement Storage Area

CINDER CONCRETE ARCH: METAL PAN DETERIORATED, SPALLED

REPAIR

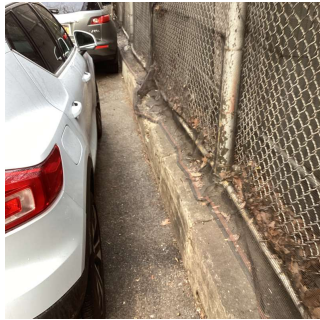
Violations	Pennsylvania Avenue No violations recorded.

Violations	Near Exit 13 No violations recorded.
Deficiency	CONCRETE CURB: DAMAGED/DETERIORATED
Deficiency Location/Instance	New Jersey Avenue, Glenmore Avenue, Pennsylvania Avenue
Deficiency Quantity	200
Quantity Uom	S.F.
Potential Action	REPLACE
Urgency of Action	PRIORITY 3
Purpose of Action	LEVEL 2
Deficiency Photo1

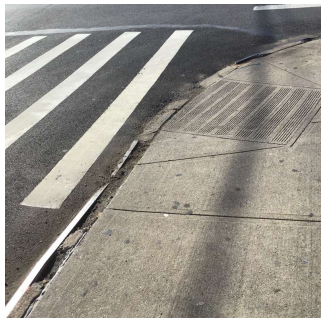
Violations	Near Exit 5 No violations recorded.
Pavers	Does not Exist
DOT Sidewalk	Inspected
Asphalt	Does not Exist
Concrete	Inspected
Condition	4 - Between Fair and Poor
Deficiency	DAMAGED CURBS
Deficiency Location/Instance	Pennsylvania Avenue, Glenmore Avenue
Deficiency Quantity	90
Quantity Uom	L.F.
Potential Action	REPLACE
Urgency of Action	PRIORITY 4
Purpose of Action	LEVEL 4
Deficiency Photo1

Violations	Pennsylvania Avenue, Glenmore Avenue 94334
Deficiency	HEAVING
Deficiency Location/Instance	New Jersey Avenue
Deficiency Quantity	25
Quantity Uom	S.F.
Potential Action	REPLACE
Urgency of Action	PRIORITY 4
Purpose of Action	LEVEL 4
