NYC Department of Education
Building Condition Assessment Survey 2023 - 2024

Architectural Inspection

Asset: **PRE-K CENTER @ 219 25TH STREET - BROOKLYN, 219 25TH STREET, New York, 11232**

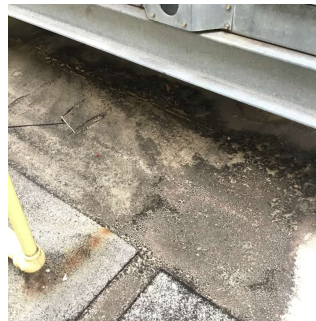
Roof 1 - near RTU

Deficiency	MODIFIED BITUMEN: ROOFING: DELAMINATION
------------	---

Deficiency Quantity	60
---------------------	----

Urgency of Action	PRIORITY 4
-------------------	------------

Potential Action	REPLACE ROOFING WITHOUT MAJOR EQUIPMENT REMOVAL
------------------	---

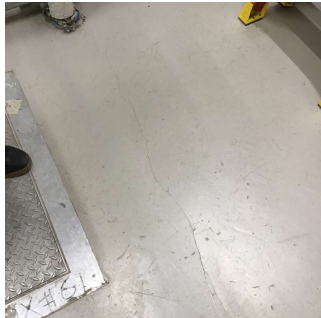
Deficiency	No deficiencies recorded
INTERIOR	Inspected
POOLS	Does not Exist
STRUCTURAL	Inspected
COLUMNS/BEAMS/BEARING WALLS	Inspected
Condition	2 - Between Good and Fair
Deficiency	No deficiencies recorded
FLOOR STRUCTURE	Inspected
Condition	3 - Fair
Deficiency	CONCRETE SLAB ON GRADE: THRU CRACKS
Deficiency Location/Instance	Boiler Room, Electrical Panel Room
Deficiency Quantity	50
Quantity Uom	S.F.
Potential Action	REPAIR
Urgency of Action	PRIORITY 3

Question	Response
INTERIOR	
STRUCTURAL	
FLOOR STRUCTURE	
Purpose of Action	LEVEL 5
Deficiency Photo1

Violations	Boiler Room, Electrical Panel Room No violations recorded.
FOUNDATION WALLS	
Material Type(s)	Inspected Concrete
Condition	2 - Between Good and Fair
Deficiency	No deficiencies recorded
ROOF STRUCTURE	
Condition	Inspected 2 - Between Good and Fair
Deficiency	No deficiencies recorded
VAULTS-BUNKERS	
Does not Exist	
AUDITORIUM	
Does not Exist	
CAFETERIA	
Does not Exist	
CLASSROOMS/CORRIDORS/ADMIN SPACES	
Inspected	
Ceiling	
Condition	Inspected 2 - Between Good and Fair
Deficiency	No deficiencies recorded
Door(s)	
Condition	Inspected 2 - Between Good and Fair
Deficiency	No deficiencies recorded
Floor Finish	
Condition	Inspected 2 - Between Good and Fair
Deficiency	No deficiencies recorded
Walls	
Condition	Inspected 2 - Between Good and Fair
Deficiency	GYPSUM BOARD: DETERIORATED
Deficiency Location/Instance	Corridor near Rooms 102, 105, 115

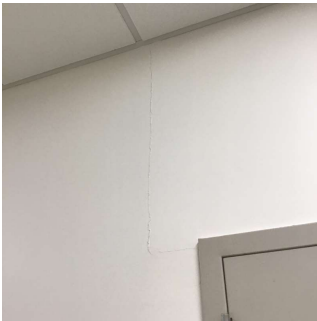
Deficiency Quantity	30
Quantity Uom	S.F.
Potential Action	REPLACE
Urgency of Action	PRIORITY 3
Purpose of Action	LEVEL 2

Violations	Corridor near Room 105 No violations recorded.
Specialties	Does not Exist
GYMNASIUM	Does not Exist
INTERIOR DOOR HARDWARE	Inspected
Condition	2 - Between Good and Fair
Deficiency	No deficiencies recorded
INTERIOR GUARDS	Does not Exist
KITCHEN	Inspected
Instance on 1st Floor	Inspected
Ceiling	
Instance on 1st Floor	Inspected
Condition	2 - Between Good and Fair
Deficiency	No deficiencies recorded
Door(s)	
Instance on 1st Floor	Inspected
Condition	2 - Between Good and Fair
Deficiency	No deficiencies recorded
Floor Finish	
Instance on 1st Floor	Inspected
Condition	2 - Between Good and Fair
Deficiency	No deficiencies recorded
Walls	
Instance on 1st Floor	Inspected
Condition	2 - Between Good and Fair
Deficiency	No deficiencies recorded
LIBRARY	Does not Exist
LOCKER ROOM	Does not Exist
MULTI-PURPOSE ROOM	Inspected
Instance on 1st Floor	Inspected

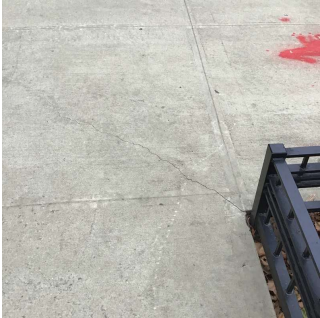
DOT Sidewalk	Inspected
Asphalt	Does not Exist
Concrete	Inspected
Condition	3 - Fair
Deficiency	DAMAGED/DETERIORATED/MISSING SECTIONS
Deficiency Location/Instance	25th Street

Question	Response
SITE	
PAVING	
DOT Sidewalk	
Concrete	
Deficiency Quantity	125
Quantity Uom	S.F.
Potential Action	REPLACE
Urgency of Action	PRIORITY 3
Purpose of Action	LEVEL 2
Deficiency Photo1

Violations	25th Street No violations recorded.
Pavers	Does not Exist
PLAYGROUNDS	Does not Exist
PLAYING SURFACE	Does not Exist
RETAINING WALLS	Does not Exist
SEATING	Does not Exist
SITE WALLS (NOT RETAINING WALLS)	Does not Exist
STAIRS/RAMPS: EXTERIOR	Does not Exist
ARTWORK	Does not Exist
