**NYC Department of Education
Building Condition Assessment Survey 2023 - 2024**

Architectural Inspection

K662

Asset: PRE-K CENTER @ 385 AVENUE W - BROOKLYN, 385 AVENUE W, New York, 11223

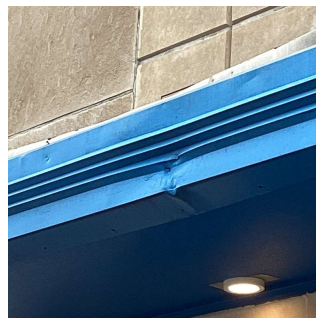
Question	Response
Architectural	
EXTERIOR	Inspected
AREAWAY	Not Required
AWNINGS AND CANOPIES	Inspected
Condition	3 - Fair
Deficiency	METAL: DETERIORATION/DAMAGED/MISSING PIECES
Roof Plan reference

25
S.F.
REPLACE
PRIORITY 4
LEVEL 2

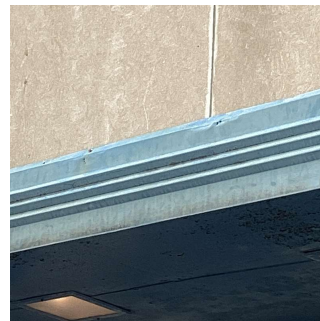
Facade A

METAL: DETERIORATION/DAMAGED/MISSING PIECES

50

REPAIR

PRIORITY 3

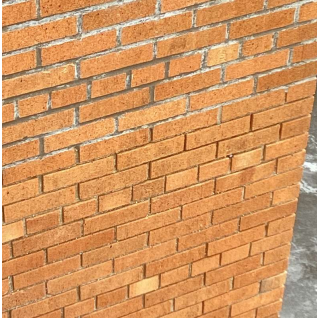
BRICK: DETERIORATED JOINTS

60

REPOINT

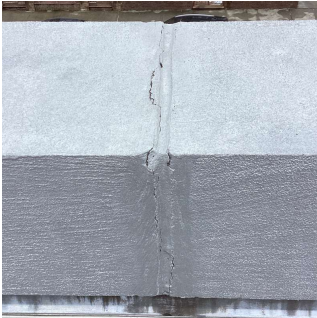
Violations	Chimney No violations recorded.
COPING	
Condition	Inspected 3 - Fair
Deficiency	CAST STONE: DETERIORATED TRANSVERSE JOINTS
Roof Plan reference

Deficiency Quantity	100
Quantity Uom	L.F.
Potential Action	MAINTENANCE
Urgency of Action	PRIORITY 3
Purpose of Action	LEVEL 2
Deficiency Photo1

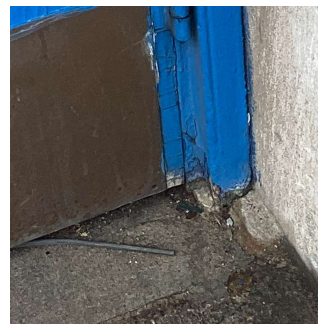
Violations	Roof 1 No violations recorded.
CORNICE	
Does not Exist	
DOORS	
Inspected	
DOORS AND FRAMES	
Inspected	
Condition	4 - Between Fair and Poor
Deficiency	WOOD: DETERIORATED DOOR AND FRAME - MAJOR DETERIORATION

2
EACH
REPLACE
PRIORITY 4
LEVEL 2

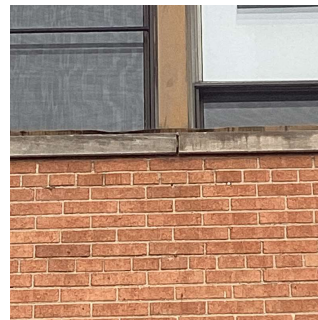
Facade A

BRICK: MASONRY SILLS - DETERIORATED JOINTS

20

REPOINT

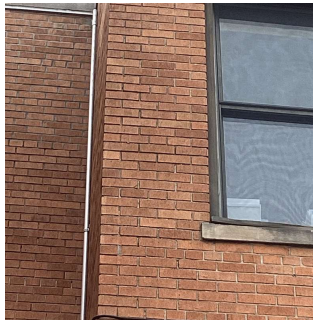
Facade E

BRICK: DETERIORATED JOINTS

1,000

REPOINT

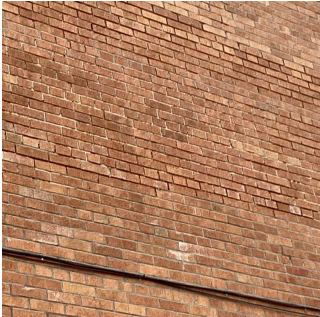
BRICK: DETERIORATED JOINTS

560

REPOINT

Question	Response
EXTERIOR	
EXTERIOR WALLS	
Urgency of Action	PRIORITY 4
Purpose of Action	LEVEL 2
Deficiency Photo1

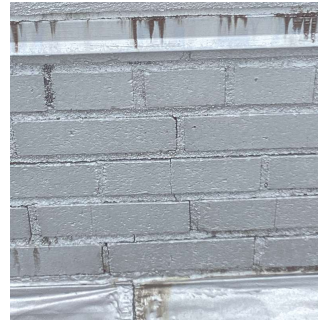
Roof 2

Violations	Facade H No violations recorded.
EXTERIOR SOFFITS	Does not Exist
LOADING DOCK	Does not Exist
LOUVER	Does not Exist
PARAPETS	Inspected
Material Type(s)	Masonry
Replacement Quantity	1,750
Replacement Uom	C.F.
Instance on All Roofs	Inspected
Instance Condition	5 - Poor
Instance Quantity	1,750
Instance Quantity Uom	C.F.
Deficiency	BRICK: MINOR CRACKS, SPALLING
Roof Plan reference

Deficiency Quantity	70
Quantity Uom	S.F.
Potential Action	REPAIR
Urgency of Action	PRIORITY 3
Purpose of Action	LEVEL 2

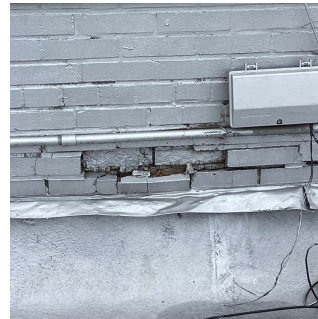
Roof 2

BRICK: MAJOR DETERIORATION/CRACKS

80

REMOVE AND REBUILD

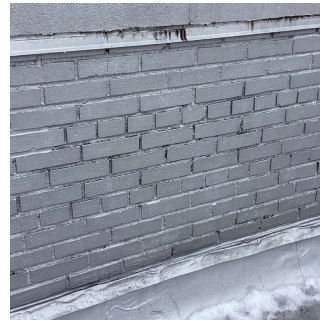
Roof 2

BRICK: DETERIORATED JOINTS

120

REPOINT

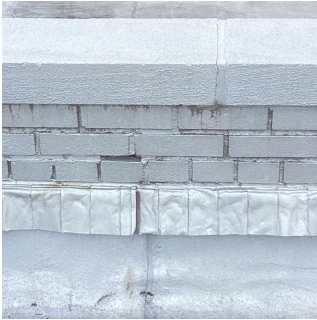
BRICK: DETERIORATED JOINTS

120

REPOINT

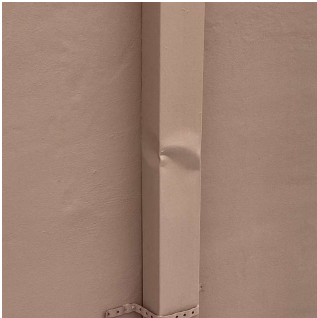
Violations	Roof 1 No violations recorded.
PLAZA DECK	Does not Exist
ROOF	Inspected
Roofing	Inspected
Replacement Quantity	24,000
Replacement Uom	S.F.
ROOF HATCH/SMOKE HATCH	Does not Exist
LEADERS, GUTTERS, DOWNSPOUTS, SCUPPERS	Inspected
Condition	3 - Fair
Deficiency	DAMAGED/MISSING
Roof Plan reference

Deficiency Quantity	10
Quantity Uom	L.F.
Potential Action	REPLACE
Urgency of Action	PRIORITY 4
Purpose of Action	LEVEL 2
Deficiency Photo1

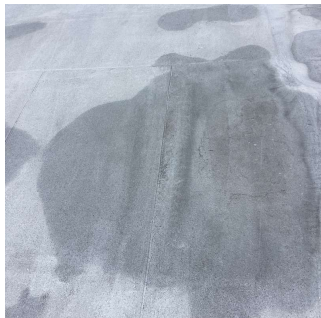
Roof 1
Instance Quantity	24,000
Instance Quantity Uom	S.F.
Does the roof have major mechanical equipment sitting on Dunnage Steel less than 18" above the Roofing?	Yes
Does this roof instance have a Sustainable Roof System?	No
Do solar panels exist on these roofs?	No
Is/Are the roof(s) suitable for Solar Panel installation?	Yes
Installation Year	1990
Source of Installation	Custodial Staff
Deficiency	MODIFIED BITUMEN: ROOFING: DELAMINATION
Roof Plan reference

Deficiency Quantity	170
Quantity Uom	S.F.
Potential Action	REPLACE ROOFING WITH MAJOR EQUIPMENT REMOVAL
Urgency of Action	PRIORITY 4
Purpose of Action	LEVEL 2
Deficiency Photo1

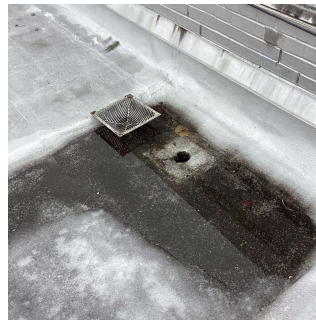
Condition	5 - Poor
-----------	----------

Deficiency	DETERIORATED
Roof Plan reference

3
EACH
REPLACE
PRIORITY 4
LEVEL 2

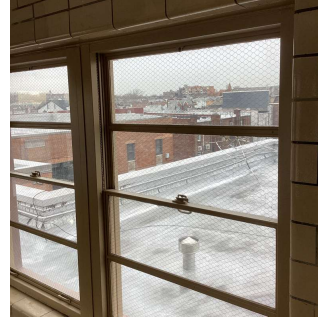
BH2

Deficiency	BULKHEAD/PENTHOUSE WINDOWS: DAMAGED, DETERIORATED WINDOWS
------------	---

30
S.F.
REPLACE
PRIORITY 4

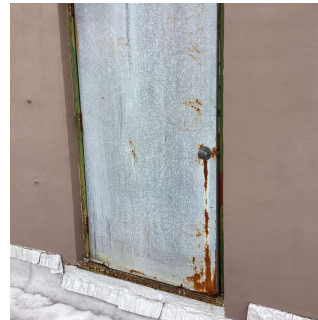
BH1

BULKHEAD/PENTHOUSE DOORS: DETERIORATED DOOR

2

REPLACE DOOR

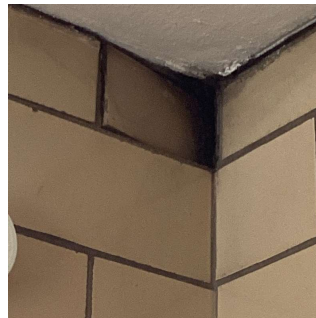
BH1
No violations recorded.

**BULKHEAD/PENTHOUSE WALLS/INTERIOR: GLAZED BLOCK
CRACKS/SPALLING**

10
S.F.
REPLACE
PRIORITY 4
LEVEL 2

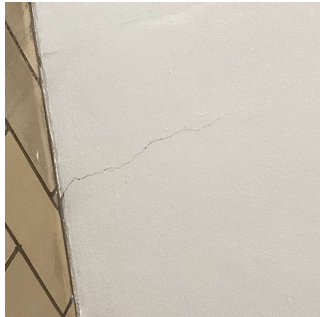
BULKHEAD/PENTHOUSE CEILING: PLASTER DAMAGED/DETERIORATED

15
S.F.
REPLACE
PRIORITY 3
LEVEL 2

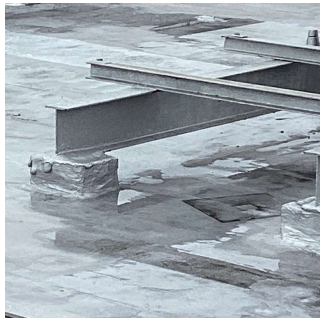
Violations	BH1 No violations recorded.
CUPOLA/ SPIRES/ TOWERS	Does not Exist
DORMER	Does not Exist
DUNNAGE STEEL	Inspected
Condition	3 - Fair
Deficiency	HEIGHT LESS THAN 18"
Roof Plan reference

Deficiency Quantity	80
Quantity Uom	L.F.
Potential Action	REPLACE
Urgency of Action	PRIORITY 3
Purpose of Action	LEVEL 2
Deficiency Photo1

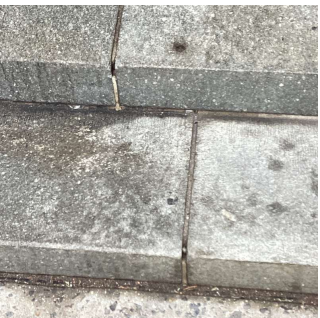
Question	Response
EXTERIOR	
ROOF	Inspected
Specialties	Inspected
ROOF/GRAVITY TANK	Does not Exist
STAIRS/RAMPS: EXTERIOR	Inspected
BUILDING CHEEK/FLANK WALLS	Does not Exist
RAILINGS	Does not Exist
STAIRS/RAMPS	Inspected
Condition	3 - Fair
Deficiency	STONE: DETERIORATED JOINTS
Roof Plan reference

Deficiency Quantity	10
Quantity Uom	L.F.
Potential Action	REPOINT
Urgency of Action	PRIORITY 4
Purpose of Action	LEVEL 2
Deficiency Photo1

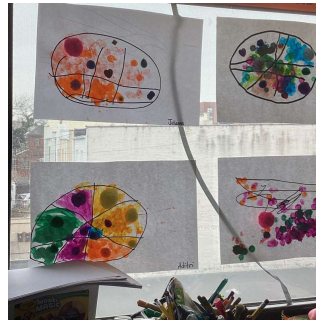
Facade A - Room 17

Question	Response
EXTERIOR	
STAIRS/RAMPS: EXTERIOR	Inspected
STAIRS/RAMPS	
Urgency of Action	PRIORITY 3
Purpose of Action	LEVEL 2
Deficiency Photo1	 
	Facade A
Violations	No violations recorded.
WINDOWS	Inspected
Replacement Quantity	4,000
Replacement Uom	S.F.
EXTERIOR GUARDS	Inspected
Condition	2 - Between Good and Fair
Deficiency	No deficiencies recorded
LINTELS	Inspected
Condition	2 - Between Good and Fair
Deficiency	No deficiencies recorded
WINDOWS	Inspected
Material Type(s)	Aluminum
Instance on Aluminum - Double Hung: All Facades	Inspected
Instance Condition	3 - Fair
Instance Quantity	2,500
Instance Quantity Uom	S.F.
Are these windows insulated	No
Installation Year	1951
Source of Installation	Custodial Staff
Deficiency	ALUMINUM - DOUBLE HUNG: BROKEN PANE
Roof Plan reference

30
S.F.
MAINTENANCE
PRIORITY 3
LEVEL 2

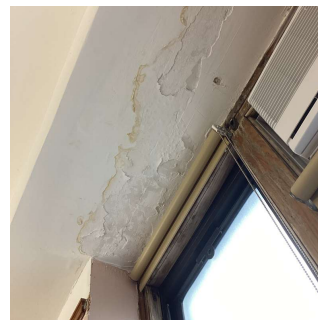
Facade H - Room 15

ALUMINUM - DOUBLE HUNG: AIR/WATER INFILTRATION

30
L.F.
REPLACE TRIM, SILLS OR WEATHERSTRIPPING
PRIORITY 5
LEVEL 2

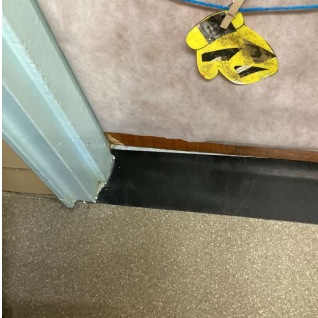
Violations	Room 15 No violations recorded.
Door(s)	Inspected
Condition	5 - Poor
Deficiency	WOOD: DETERIORATED DOOR
Deficiency Location/Instance	Room 20
Deficiency Quantity	1
Quantity Uom	EACH
Potential Action	MAINTENANCE

Question	Response
INTERIOR	Inspected
CLASSROOMS/CORRIDORS/ADMIN SPACES	
Door(s)	
Urgency of Action	PRIORITY 3
Purpose of Action	LEVEL 2
Deficiency Photo1

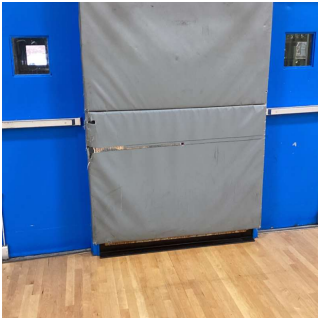
Walls	
Instance on 1st Floor	Inspected
Condition	2 - Between Good and Fair
Deficiency	WALL PADDING: DETERIORATED
Deficiency Location/Instance	Near Entrance

Question	Response
INTERIOR	
GYMNASIUM	
Walls	
Deficiency Quantity	20
Quantity Uom	S.F.
Potential Action	REPLACE
Urgency of Action	PRIORITY 3
Purpose of Action	LEVEL 2
Deficiency Photo1
