NYC Department of Education
Building Condition Assessment Survey 2023 - 2024

Architectural Inspection

K664

Asset: **PRE-K CENTER @ 140A 58TH STREET - BROOKLYN, 140A 58 STREET, New York, 11220**

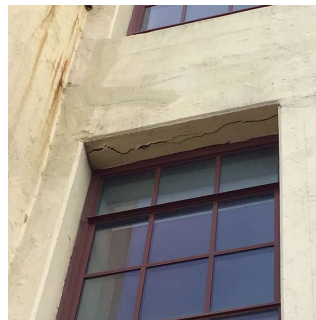
Question	Response
Architectural	
EXTERIOR	Inspected
AREAWAY	Does not Exist
AWNINGS AND CANOPIES	Not Required
CHIMNEY	Not Required
COPING	Not Required
CORNICE	Does not Exist
DOORS	Inspected
DOORS AND FRAMES	Inspected
Condition	2 - Between Good and Fair
Deficiency	No deficiencies recorded
DOOR HARDWARE	Inspected
Condition	2 - Between Good and Fair
Deficiency	No deficiencies recorded
LINTELS	Does not Exist
TRANSOM/SIDE LIGHT	Inspected
Condition	2 - Between Good and Fair
Deficiency	No deficiencies recorded
EXTERIOR WALLS	Inspected
Material Type(s)	Concrete, Masonry
Replacement Quantity	1,400
Replacement Uom	S.F.
Instance on Facade B	Inspected
Instance Condition	3 - Fair
Instance Quantity	1,400
Instance Quantity Uom	S.F.
Deficiency	CAST IN PLACE / PRE-CAST CONCRETE: MAJOR CRACKS/SPALLING

REPLACE

PRIORITY 4

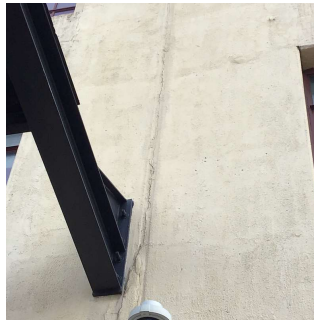
Facade B

CAST IN PLACE / PRE-CAST CONCRETE: DETERIORATED CONTROL/EXPANSION JOINTS

MAINTENANCE

PRIORITY 3

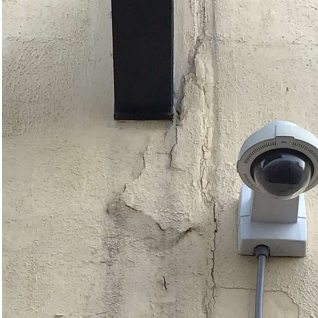
CAST IN PLACE / PRE-CAST CONCRETE: MINOR
CRACKS/SPALLING

Question	Response
EXTERIOR	
EXTERIOR WALLS	
Potential Action	REPAIR
Urgency of Action	PRIORITY 3
Purpose of Action	LEVEL 2
Deficiency Photo1

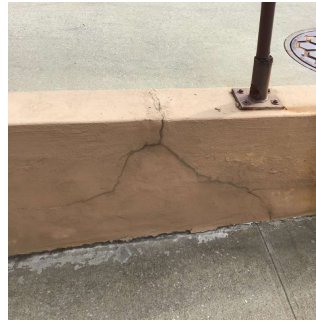
Facade A - HC Ramp

Violations	Facade B No violations recorded.
EXTERIOR SOFFITS	Does not Exist
LOADING DOCK	Not Required
LOUVER	Not Required
PARAPETS	Not Required
PLAZA DECK	Does not Exist
ROOF	Inspected
Roofing	Not Required
Specialties	Inspected
BULKHEAD/PENTHOUSE	Not Required
CUPOLA/ SPIRES/ TOWERS	Does not Exist
DORMER	Does not Exist
DUNNAGE STEEL	Not Required
SKYLIGHT/ROOF VENT	Not Required
ROOF/GRAVITY TANK	Not Required
STAIRS/RAMPS: EXTERIOR	Inspected
BUILDING CHEEK/FLANK WALLS	Inspected
Condition	4 - Between Fair and Poor
Deficiency	CAST IN PLACE CONCRETE: CRACKS/SPALLING - MINOR
Roof Plan reference

Deficiency Quantity	40
Quantity Uom	S.F.
Potential Action	REPAIR
Urgency of Action	PRIORITY 3
Purpose of Action	LEVEL 2

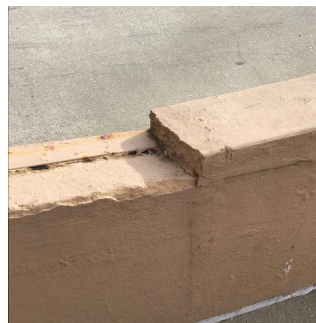
Facade A - HC Ramp

CAST IN PLACE CONCRETE: CRACKS/SPALLING - MAJOR

REPLACE

PRIORITY 4

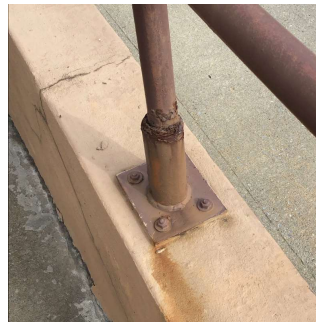
Facade A - HC Ramp
No violations recorded.

RUST - MAJOR

25
L.F.
REPLACE
PRIORITY 4
LEVEL 2

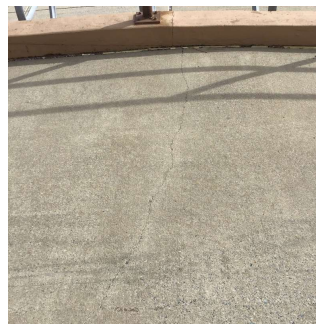
Facade A - HC Ramp
No violations recorded.

Deficiency Quantity	50
Quantity Uom	S.F.
Potential Action	REPLACE
Urgency of Action	PRIORITY 4
Purpose of Action	LEVEL 2
Deficiency Photo1	 
Violations	Facade A No violations recorded.
Deficiency	CONCRETE: CRACKS/SPALLING - MINOR

40
S.F.
REPAIR
PRIORITY 3
LEVEL 2

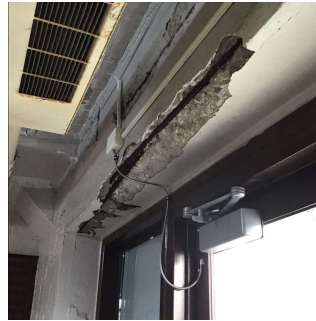
Priority Condition Exist Last Year?	Priority Category	Condition Description	Component Affected	Location Description	Person(s) Notified	Person(s) Title	PhotoImage
No	Potential Falling Debris	Deteriorated concrete beam fireproofing is a potential falling debris hazard.	INTERIOR STRUCTURAL COLUMNS/BEAMS/BEARING WALLS	1st Floor - Main Entrance Vestibule	Kevin Rodriguez	Cleaner

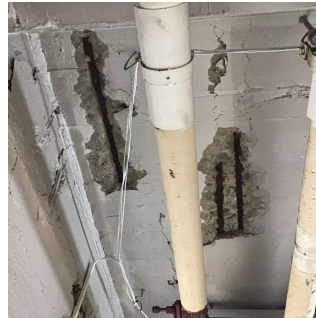
1st Floor - Main Entrance Vestibule

CONCRETE: CRACKS/SPALLED/REINFORCEMENT EXPOSED

REPAIR

PRIORITY 4

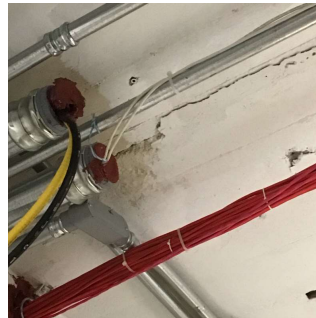
CONCRETE: CRACKS/SPALLED/REINFORCEMENT EXPOSED

1st Floor - Boiler Room, Telecom Room

REPAIR

PRIORITY 3

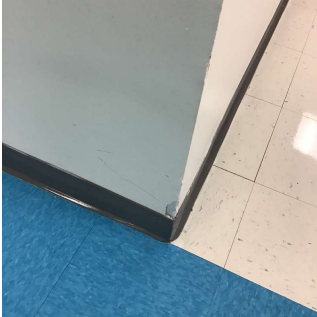
Question	Response
INTERIOR	
CLASSROOMS/CORRIDORS/ADMIN SPACES	
Floor Finish	Inspected
Violations	No violations recorded.
Walls	Inspected
Condition	2 - Between Good and Fair
Deficiency	GYPSUM BOARD: DETERIORATED
Deficiency Location/Instance	Room 102, Corridor near Room 115
Deficiency Quantity	30
Quantity Uom	S.F.
Potential Action	REPLACE
Urgency of Action	PRIORITY 3
Purpose of Action	LEVEL 2
Deficiency Photo1
