NYC Department of Education
Building Condition Assessment Survey 2023 - 2024

Architectural Inspection

K672

Asset: PRE-K CENTER @ 1223 CONEY ISLAND AVENUE - BROOKLYN, 1223 CONEY ISLAND AVENUE, New York, 11230

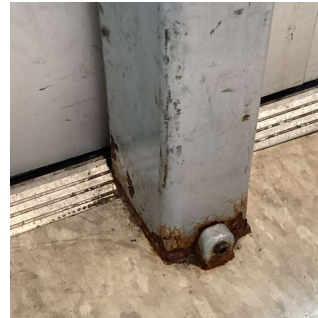
Facade A

Question	Response
Architectural	
EXTERIOR	Inspected
AREAWAY	Does not Exist
AWNINGS AND CANOPIES	Does not Exist
CHIMNEY	Inspected
Material Type(s)	Masonry
Condition	2 - Between Good and Fair
Deficiency	No deficiencies recorded
COPING	Inspected
Condition	2 - Between Good and Fair
Deficiency	No deficiencies recorded
CORNICE	Does not Exist
DOORS	Inspected
DOORS AND FRAMES	Inspected
Condition	3 - Fair
Deficiency	METAL: DETERIORATED DOOR AND FRAME - MINOR DETERIORATION
Roof Plan reference

Deficiency Quantity
Quantity Uom
Potential Action
Urgency of Action

3
EACH
MAINTENANCE
PRIORITY 3

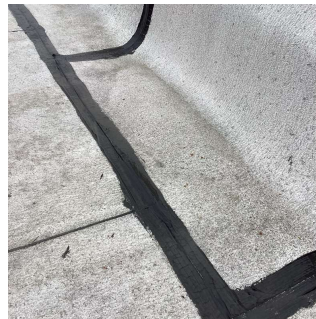
Roof 1
No violations recorded.

Question	Response
EXTERIOR	
ROOF	
Roofing	
ROOFING	
Instance Photo	 
	Roof 1
Instance Quantity	10,000
Instance Quantity Uom	S.F.
Does the roof have major mechanical equipment sitting on Dunnage Steel less than 18" above the Roofing?	No
Does this roof instance have a Sustainable Roof System?	Yes
Sustainable Roof Type	White Roof
Sustainable Roof Location (Roof Number)	Roof 1
Do solar panels exist on these roofs?	No
Is/Are the roof(s) suitable for Solar Panel installation?	Yes
Installation Year	2016
Source of Installation	Custodial Staff
Deficiency	MODIFIED BITUMEN: FLASHING: BASE FLASHING DETERIORATED
Roof Plan reference	<p align="center">K672</p>   <p align="center">Coney Island Avenue</p>
Deficiency Quantity	10
Quantity Uom	S.F.
Potential Action	REPLACE
Urgency of Action	PRIORITY 4
Purpose of Action	LEVEL 2
Deficiency Photo1	 
	Roof 1
Violations	No violations recorded.
Deficiency	MODIFIED BITUMEN: ROOFING: DELAMINATION

10
S.F.
REPLACE ROOFING WITHOUT MAJOR EQUIPMENT
REMOVAL
PRIORITY 4
LEVEL 2

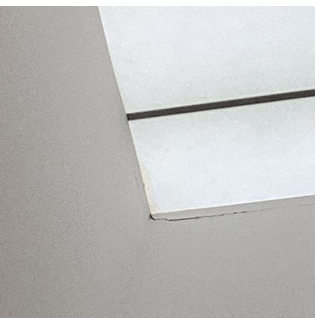
WATER INFILTRATION

Deficiency Quantity	50
Quantity Uom	S.F.
Potential Action	MAINTENANCE
Urgency of Action	PRIORITY 3
Purpose of Action	LEVEL 2
Deficiency Photo1

Violations	SK9 - Room 122 No violations recorded.
ROOF/GRAVITY TANK	Does not Exist
STAIRS/RAMPS: EXTERIOR	Does not Exist
WINDOWS	Inspected
Replacement Quantity	250
Replacement Uom	S.F.
EXTERIOR GUARDS	Does not Exist
LINTELS	Inspected
Condition	2 - Between Good and Fair
Deficiency	No deficiencies recorded
WINDOWS	Inspected
Material Type(s)	Aluminum
Instance on Aluminum - Other: Facade A	Inspected
Instance Condition	1 - Good
Instance Quantity	250
Instance Quantity Uom	S.F.
Are these windows insulated	Yes
Installation Year	2016
Source of Installation	Custodial Staff
Deficiency	No deficiencies recorded
INTERIOR	Inspected

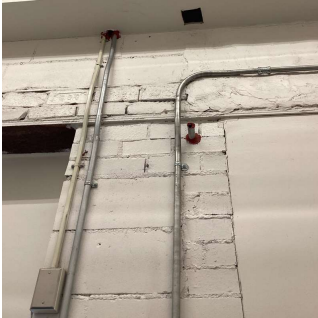
Question	Response
INTERIOR	
POOLS	Does not Exist
STRUCTURAL	Inspected
COLUMNS/BEAMS/BEARING WALLS	Inspected
Condition	3 - Fair
Deficiency	MASONRY BEARING WALL: CRACKED/SPALLED
Deficiency Location/Instance	1st Floor- Storage Room
Deficiency Quantity	20
Quantity Uom	S.F.
Potential Action	RESTITCH
Urgency of Action	PRIORITY 4
Purpose of Action	LEVEL 5
Deficiency Photo1

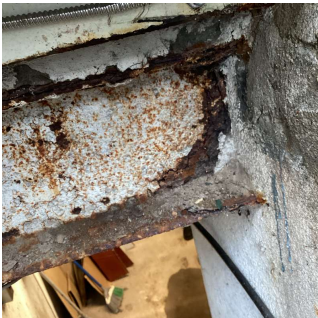
Violations	1st Floor- Storage Room No violations recorded.
Deficiency	STEEL COLUMNS/BEAMS: MAJOR RUSTING
Deficiency Location/Instance	Basement - Electrical and Gas Meter Room
Deficiency Quantity	30
Quantity Uom	S.F.
Potential Action	REPLACE
Urgency of Action	PRIORITY 4
Purpose of Action	LEVEL 5
Deficiency Photo1

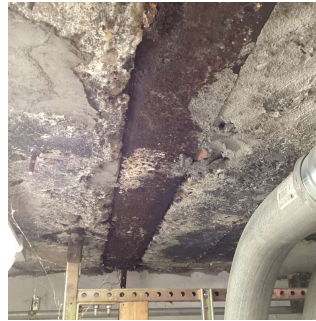
Violations	Basement - Electrical and Gas Meter Room No violations recorded.
Deficiency	STEEL COLUMNS/BEAMS: DETERIORATED CONCRETE FIREPROOFING
Deficiency Location/Instance	Basement - Electrical and Gas Meter Room
Deficiency Quantity	30

Quantity Uom	S.F.
Potential Action	REPLACE
Urgency of Action	PRIORITY 4
Purpose of Action	LEVEL 5

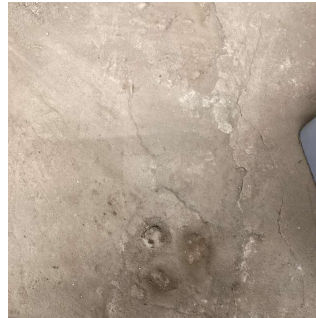
4 - Between Fair and Poor

CONCRETE SLAB ON GRADE: THRU CRACKS

Basement - Electrical and Gas Meter Room

30

REPAIR

PRIORITY 3

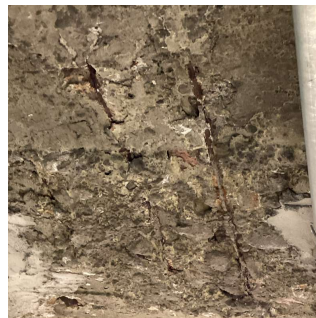
CONCRETE: CRACKS/SPALLED/REINFORCEMENT EXPOSED

Basement - Electrical and Gas Meter Room, 1st Floor Storage

100

REPAIR

PRIORITY 4

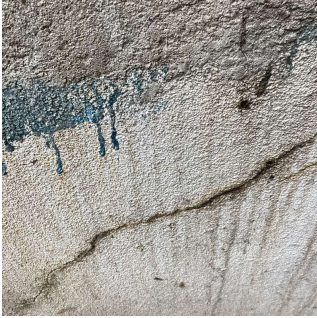
Question	Response
INTERIOR	
STRUCTURAL	
FLOOR STRUCTURE	Inspected
Violations	Basement - Electrical and Gas Meter Room No violations recorded.
FOUNDATION WALLS	Inspected
Material Type(s)	Concrete
Condition	3 - Fair
Deficiency	CONCRETE: CRACKED/SPALLED/REINFORCEMENT EXPOSED
Deficiency Location/Instance	Basement - Electrical and Gas Meter Room
Deficiency Quantity	30
Quantity Uom	S.F.
Potential Action	REPAIR
Urgency of Action	PRIORITY 4
Purpose of Action	LEVEL 5
Deficiency Photo1

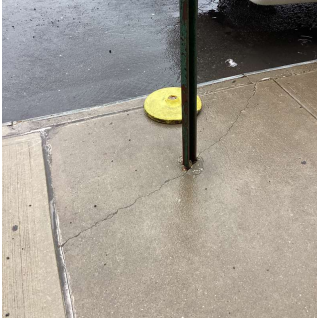
Question	Response
SITE	
PAVING	
DOT Sidewalk	Inspected
Asphalt	Does not Exist
Concrete	Inspected
Condition	3 - Fair
Deficiency	DAMAGED/DETERIORATED/MISSING SECTIONS
Deficiency Location/Instance	Coney Island Avenue
Deficiency Quantity	50
Quantity Uom	S.F.
Potential Action	REPLACE
Urgency of Action	PRIORITY 3
Purpose of Action	LEVEL 2
Deficiency Photo1
