NYC Department of Education
Building Condition Assessment Survey 2023 - 2024

Architectural Inspection

Asset: P.S. 677 - BROOKLYN, 139 MENAHAN STREET, New York, 11221

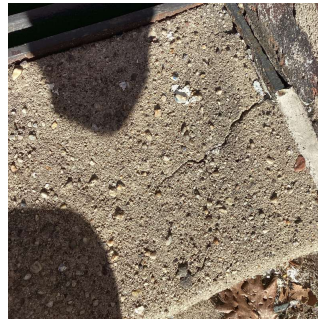
AW1

AREAWAY WALLS: CRACKS AND SPALLING

20
S.F.
REPLACE
PRIORITY 4
LEVEL 2

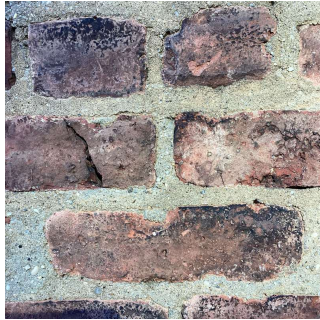
Violations	CH No violations recorded.
Deficiency	BRICK: DETERIORATED JOINTS
Roof Plan reference

Deficiency Quantity	50
Quantity Uom	S.F.
Potential Action	REPOINT
Urgency of Action	PRIORITY 3
Purpose of Action	LEVEL 2
Deficiency Photo1

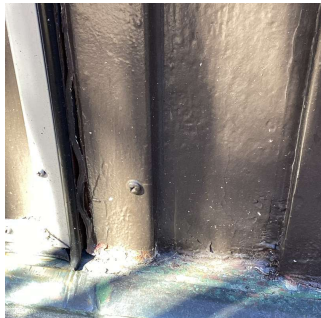
Question	Response
EXTERIOR	
DOORS	
DOORS AND FRAMES	
Deficiency	METAL CLAD: DETERIORATED DOOR AND FRAME - MINOR DETERIORATION
Roof Plan reference

Violations	Facade A No violations recorded.
DOOR HARDWARE	Inspected
Condition	3 - Fair
Deficiency	No deficiencies recorded
LINTELS	Inspected
Condition	2 - Between Good and Fair
Deficiency	No deficiencies recorded
TRANSOM/SIDE LIGHT	Inspected
Condition	2 - Between Good and Fair
Deficiency	No deficiencies recorded
EXTERIOR WALLS	Inspected
Material Type(s)	Masonry
Replacement Quantity	20,000
Replacement Uom	S.F.
Instance on All Facades	Inspected
Instance Condition	3 - Fair
Instance Quantity	20,000
Instance Quantity Uom	S.F.
Deficiency	BRICK: EFFLORESCENCE

Deficiency Quantity	2
Quantity Uom	EACH
Potential Action	MAINTENANCE
Urgency of Action	PRIORITY 3
Purpose of Action	LEVEL 2
Deficiency Photo1

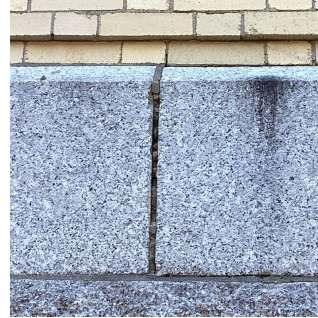
Facade A

STONE: DETERIORATED JOINTS

REPOINT
PRIORITY 3
LEVEL 2

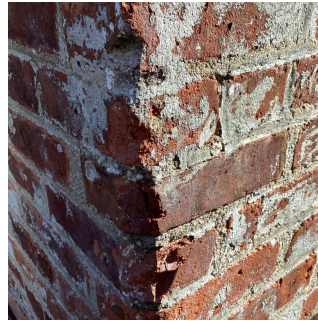
Facade C

BRICK: CRACKS/DISPLACED/SPALLED BRICK AT BUILDING CORNERS

10
S.F.
REMOVE AND REBUILD
PRIORITY 4
LEVEL 2

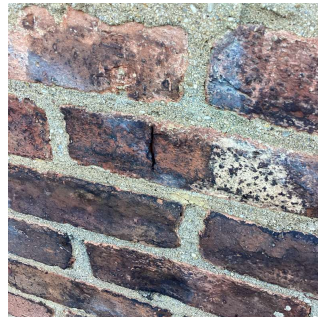
Facade C

BRICK: MINOR CRACKS AND SPALLING

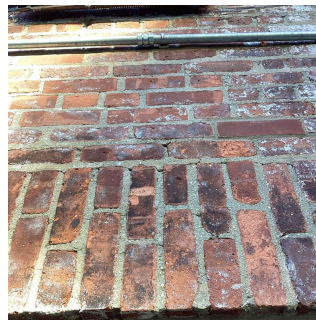
BRICK: DETERIORATED JOINTS

Facade C
No violations recorded.

300
S.F.
REPOINT
PRIORITY 3
LEVEL 2

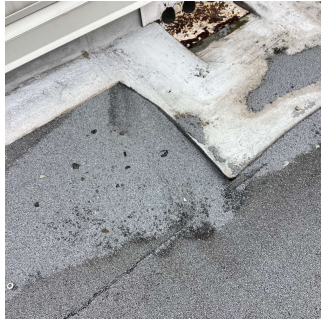
Is/Are the roof(s) suitable for Solar Panel installation?	Yes
Installation Year	2017
Source of Installation	Custodial Staff
Deficiency	MODIFIED BITUMEN: ROOFING: DELAMINATION
Roof Plan reference

Deficiency Quantity	10
Quantity Uom	S.F.
Potential Action	REPLACE ROOFING WITHOUT MAJOR EQUIPMENT REMOVAL

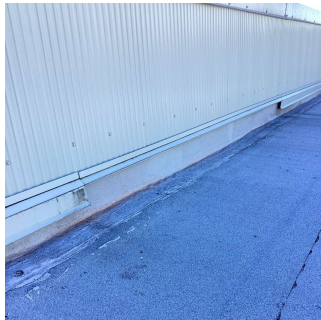
Violations	Roof 1 No violations recorded.
Deficiency	MODIFIED BITUMEN: FLASHING: CAP FLASHING DAMAGED
Roof Plan reference

Deficiency Quantity	10
Quantity Uom	L.F.
Potential Action	REPLACE
Urgency of Action	PRIORITY 4
Purpose of Action	LEVEL 2
Deficiency Photo1

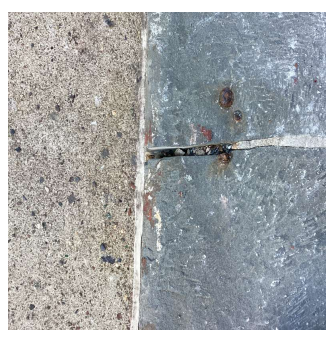
Question	Response
EXTERIOR	
ROOF	
Specialties	
DORMER	Does not Exist
DUNNAGE STEEL	Does not Exist
SKYLIGHT/ROOF VENT	Inspected
Material Type(s)	Glass
Condition	2 - Between Good and Fair
Deficiency	No deficiencies recorded
ROOF/GRAVITY TANK	Does not Exist
STAIRS/RAMPS: EXTERIOR	Inspected
BUILDING CHEEK/FLANK WALLS	Does not Exist
RAILINGS	Does not Exist
STAIRS/RAMPS	Inspected
Condition	3 - Fair
Deficiency	STONE: DETERIORATED JOINTS
Roof Plan reference

Deficiency Quantity	10
Quantity Uom	L.F.
Potential Action	REPOINT
Urgency of Action	PRIORITY 3
Purpose of Action	LEVEL 2
Deficiency Photo1

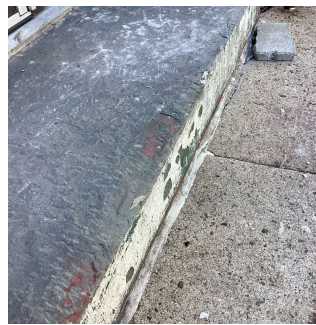
Violations	Facade C No violations recorded.
Deficiency	STONE: CRACKS/SPALLING - MINOR

20
S.F.
REPAIR
PRIORITY 3
LEVEL 2

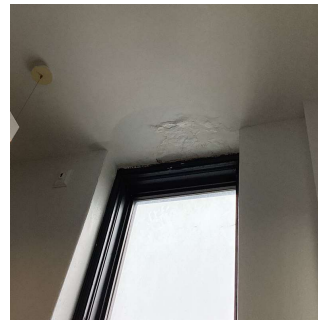
Deficiency	ALUMINUM - DOUBLE HUNG: AIR/WATER INFILTRATION
------------	--

Facade D - 2nd Floor Boys Toilet Room shown, Facade D - Corridor near Stair B/2 similar

REPLACE TRIM, SILLS OR WEATHERSTRIPPING

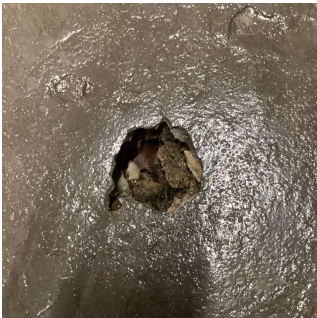
Question	Response
INTERIOR	
STRUCTURAL	
COLUMNS/BEAMS/BEARING WALLS	Inspected
Deficiency	No deficiencies recorded
FLOOR STRUCTURE	Inspected
Condition	3 - Fair
Deficiency	CONCRETE SLAB ON GRADE: THRU CRACKS
Deficiency Location/Instance	Basement - Boiler Room
Deficiency Quantity	10
Quantity Uom	S.F.
Potential Action	REPLACE
Urgency of Action	PRIORITY 4
Purpose of Action	LEVEL 5
Deficiency Photo1

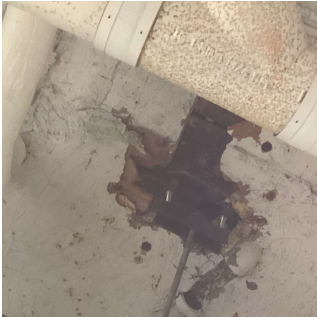
Basement - Boiler Room
Violations	No violations recorded.
Deficiency	CINDER CONCRETE FLAT SLAB: CRACKED/SPALLED/REINFORCEMENT EXPOSED
Deficiency Location/Instance	Basement - Boiler Room
Deficiency Quantity	10
Quantity Uom	S.F.
Potential Action	REPAIR
Urgency of Action	PRIORITY 4
Purpose of Action	LEVEL 5
Deficiency Photo1

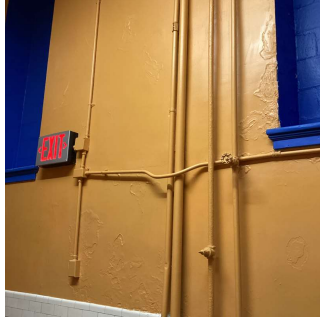
Basement - Boiler Room
Violations	No violations recorded.
FOUNDATION WALLS	Inspected
Material Type(s)	Concrete, Masonry
Condition	4 - Between Fair and Poor
Deficiency	CONCRETE: WATER INFILTRATION IN INSTRUCTIONAL SPACE

Deficiency Location/Instance	Stair C/Basement
Deficiency Quantity	100
Quantity Uom	S.F.

Question	Response
INTERIOR	
STRUCTURAL	
FOUNDATION WALLS	
Potential Action	INSTALL WATERPROOFING
Urgency of Action	PRIORITY 5
Purpose of Action	LEVEL 5
Deficiency Photo1

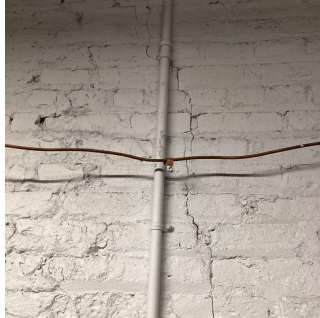
Stair C/Basement
Violations	No violations recorded.
Deficiency	BRICK: CRACKED/SPALLED
Deficiency Location/Instance	Basement - Boiler Room
Deficiency Quantity	50
Quantity Uom	S.F.
Potential Action	RESTITCH
Urgency of Action	PRIORITY 4
Purpose of Action	LEVEL 5
Deficiency Photo1

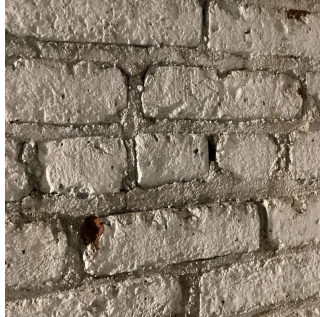
Basement - Boiler Room
Violations	No violations recorded.
ROOF STRUCTURE	
Condition	Inspected
Deficiency	2 - Between Good and Fair
VAULTS-BUNKERS	
Condition	Inspected
Foundation Walls	
Condition	Inspected
Deficiency	3 - Fair
Deficiency	DETERIORATED JOINTS
Deficiency Location/Instance	Basement - Vault
Deficiency Quantity	20
Quantity Uom	S.F.
Potential Action	REPOINT
Urgency of Action	PRIORITY 3
Purpose of Action	LEVEL 5

Violations	Basement - Vault No violations recorded.
Deficiency	CRACKS, SPALLING
Deficiency Location/Instance	Basement - Vault
Deficiency Quantity	20
Quantity Uom	S.F.
Potential Action	REPAIR
Urgency of Action	PRIORITY 3
Purpose of Action	LEVEL 5
Deficiency Photo1

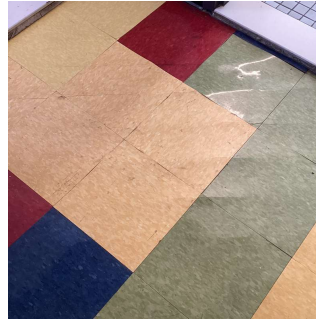
Corridor near Students Toilets Rooms - 3rd Floor

Question	Response
INTERIOR	
STRUCTURAL	
VAULTS-BUNKERS	
Slab Structure	Inspected
Deficiency Photo1	 
Violations	Basement - Vault No violations recorded.
Vault/Ash Hoist Doors and Framing	Inspected
Condition	2 - Between Good and Fair
Deficiency	No deficiencies recorded
AUDITORIUM	Does not Exist
CAFETERIA	Does not Exist
CLASSROOMS/CORRIDORS/ADMIN SPACES	Inspected
Ceiling	Inspected
Condition	2 - Between Good and Fair
Deficiency	No deficiencies recorded
Door(s)	Inspected
Condition	5 - Poor
Deficiency	WOOD: DETERIORATED DOOR AND FRAME
Deficiency Location/Instance	Rooms 308, 307, 203, 202, 201 and others
Deficiency Quantity	6
Quantity Uom	EACH
Potential Action	MAINTENANCE
Urgency of Action	PRIORITY 3
Purpose of Action	LEVEL 2
Deficiency Photo1	 
Violations	Room 308 No violations recorded.
Floor Finish	Inspected
Condition	2 - Between Good and Fair
Deficiency	VINYL TILES: DETERIORATED SUBSTRATE
Deficiency Location/Instance	Corridor near Rooms 304, 104, by Students Toilet Rooms - 3rd, 2nd Floor

Quantity Uom	S.F.
Potential Action	REPLACE
Urgency of Action	PRIORITY 3
Purpose of Action	LEVEL 2
Deficiency Photo1

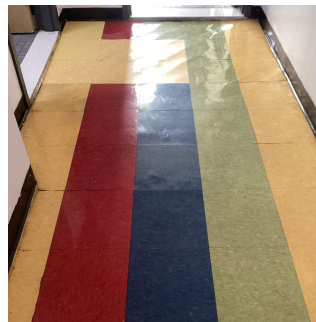
Corridor near Girls Toilet Room - 3rd Floor

Deficiency	VINYL TILES: BROKEN/DETERIORATED/MISSING TILES
Deficiency Location/Instance	Corridor near Girls Toilet Room - 3rd Floor, by Rooms 202, 107, 104
Deficiency Quantity	50
Quantity Uom	S.F.
Potential Action	REPLACE
Urgency of Action	PRIORITY 3
Purpose of Action	LEVEL 2
Deficiency Photo1

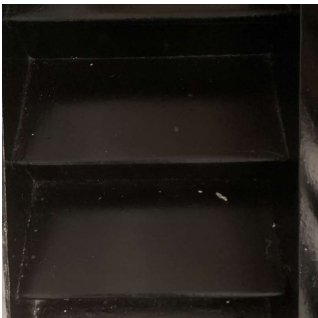
Question	Response
INTERIOR	
MULTI-PURPOSE ROOM	
Stage	
Stage	Inspected
Instance on Basement	Inspected
Condition	3 - Fair
Deficiency	DAMAGED STEPS
Deficiency Location/Instance	Right and Left Side
Deficiency Quantity	20
Quantity Uom	S.F.
Potential Action	REPLACE
Urgency of Action	PRIORITY 3
Purpose of Action	LEVEL 2
Deficiency Photo1

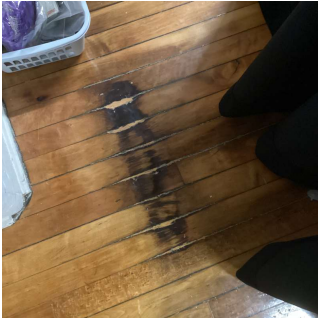
Right Side
Violations	No violations recorded.
Deficiency	DAMAGED FLOOR
Deficiency Location/Instance	Right and Left Side
Deficiency Quantity	30
Quantity Uom	S.F.
Potential Action	REPLACE
Urgency of Action	PRIORITY 3
Purpose of Action	LEVEL 2
Deficiency Photo1

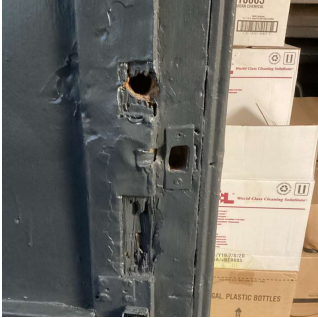
Question	Response
INTERIOR	
MULTI-PURPOSE ROOM	
Walls	
Purpose of Action	LEVEL 2
Deficiency Photo1	 
Violations	Near Students Toilet Rooms No violations recorded.
Window Curtains/Shades/Blinds	
Instance on Basement	Inspected
Condition	2 - Between Good and Fair
Deficiency	No deficiencies recorded
SCIENCE DEMO ROOM	Does not Exist
SCIENCE LAB	Does not Exist
SCIENCE PREP ROOM	Does not Exist
SHOWER ROOM	Does not Exist
STAIRS/RAMPS: INTERIOR	
Do Letter Stair Signs Exist?	Yes
Ceiling	
Condition	2 - Between Good and Fair
Deficiency	PLASTER: CRACKS/SPALLING - ACTIVE LEAK
Deficiency Location/Instance	Stair C/Basement
Deficiency Quantity	30
Quantity Uom	S.F.
Potential Action	REPLACE
Urgency of Action	PRIORITY 5
Purpose of Action	LEVEL 2
Deficiency Photo1	 
Violations	Stair C/Basement No violations recorded.
Door(s)	
Condition	Inspected
Deficiency	3 - Fair
Deficiency Location/Instance	METAL: DETERIORATED DOOR AND FRAME Stairs A/Basement, B/3

Question	Response
INTERIOR	
STAIRS/RAMPS: INTERIOR	
Door(s)	
Quantity Uom	EACH
Potential Action	MAINTENANCE
Urgency of Action	PRIORITY 3
Purpose of Action	LEVEL 2
Deficiency Photo1

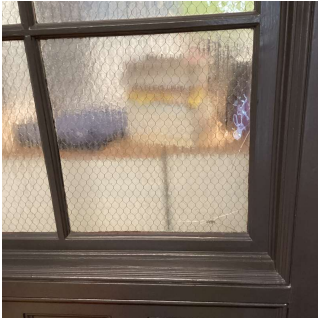
Violations	Stair A/Basement No violations recorded.
Partition	Inspected
Condition	2 - Between Good and Fair
Deficiency	GLASS PANEL: DAMAGED/DETERIORATED
Deficiency Location/Instance	Stair A/Mezzanine
Deficiency Quantity	10
Quantity Uom	S.F.
Potential Action	REPLACE
Urgency of Action	PRIORITY 3
Purpose of Action	LEVEL 2
Deficiency Photo1

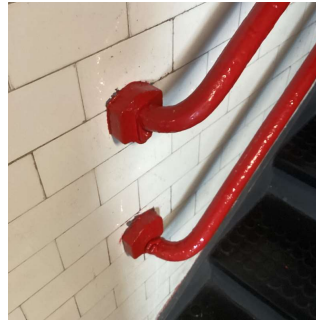
Violations	Stair A/Mezzanine No violations recorded.
Railings	Inspected
Condition	5 - Poor
Deficiency	METAL: BROKEN BRACKET
Deficiency Location/Instance	Stair B/1
Deficiency Quantity	1
Quantity Uom	EACH
Potential Action	REPLACE
Urgency of Action	PRIORITY 3
Purpose of Action	LEVEL 2

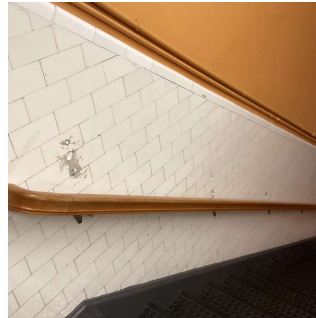
Stair C/1

WOOD: MISSING

REPLACE

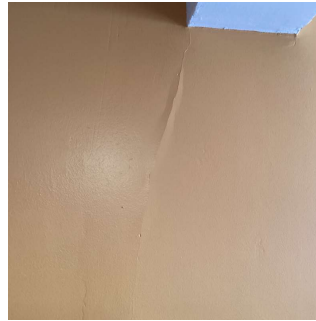
Stair A/2

Violations	Stair A/Bulkhead No violations recorded.
Walls	Inspected
Condition	2 - Between Good and Fair
Deficiency	PLASTER: CRACKS/SPALLING
Deficiency Location/Instance	Stairs A/2, 1, B/1
Deficiency Quantity	40
Quantity Uom	S.F.
Potential Action	REPLACE
Urgency of Action	PRIORITY 3
Purpose of Action	LEVEL 2

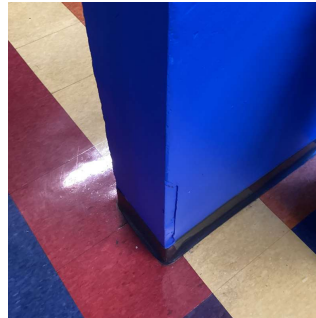
Stair B/2

GYPSUM BOARD: DETERIORATED

REPLACE

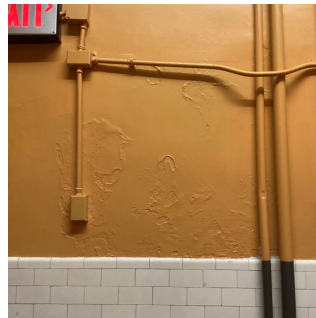
Stair C/Basement

PLASTER: CRACKS/SPALLING - ACTIVE LEAK

REPLACE

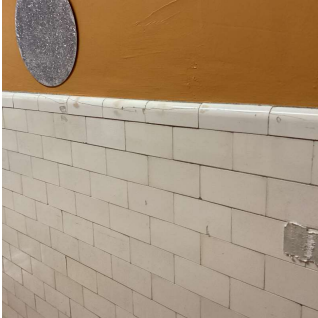
Question	Response
INTERIOR	
STAIRS/RAMPS: INTERIOR	
Walls	
Deficiency	CERAMIC TILE: BROKEN/ MISSING
Deficiency Location/Instance	Stairs A/3, 2, 1, B/3, C/Basement
Deficiency Quantity	100
Quantity Uom	S.F.
Potential Action	REPLACE
Urgency of Action	PRIORITY 3
Purpose of Action	LEVEL 2
Deficiency Photo1

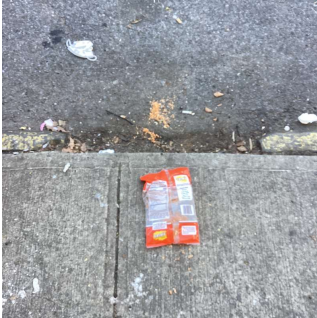
Menahan Street
Violations	No violations recorded.
Deficiency	DAMAGED CURBS
Deficiency Location/Instance	Menahan Street
Deficiency Quantity	160
Quantity Uom	L.F.
Potential Action	REPLACE
Urgency of Action	PRIORITY 3
Purpose of Action	LEVEL 2
Deficiency Photo1

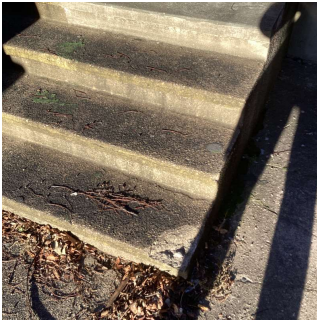
Violations	Near Exit 3 No violations recorded.
Stairs/ramps	Inspected
Condition	2 - Between Good and Fair
Deficiency	CAST IN PLACE CONCRETE: CRACKS/SPALLING - MAJOR
Deficiency Location/Instance	Near Exit 3
Deficiency Quantity	10
Quantity Uom	S.F.
Potential Action	REPLACE
Urgency of Action	PRIORITY 3
Purpose of Action	LEVEL 2
Deficiency Photo1
