**NYC Department of Education**  
**Building Condition Assessment Survey 2023 - 2024**

Architectural Inspection

**K682**

**Asset:** P.S. @ 736 48TH STREET - BROOKLYN, 736 48TH STREET, New York, 11220

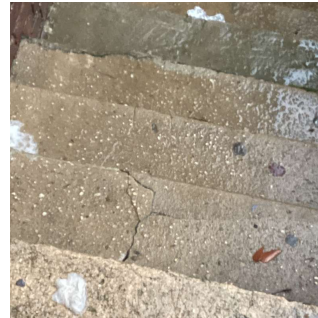
AW1

Urgency of Action  
Purpose of Action  
Deficiency Photo1

PRIORITY 3  
LEVEL 2

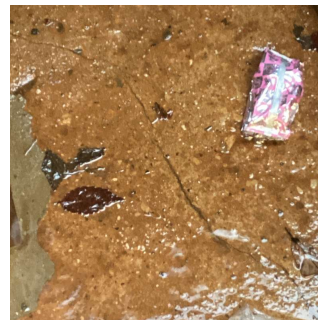
AW1

AREAWAY SLAB: CRACKS AND SPALLING

10  
S.F.  
REPLACE  
PRIORITY 4  
LEVEL 2

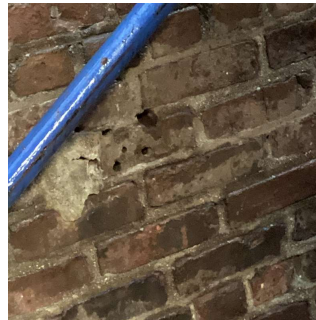
AW1  
No violations recorded.

AREAWAY WALLS: CRACKS AND SPALLING

20  
S.F.  
REPAIR  
PRIORITY 3  
LEVEL 2

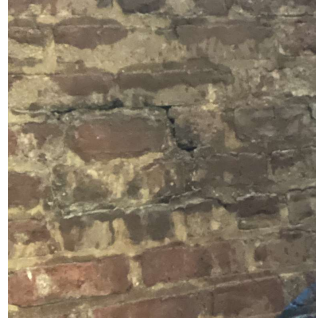
AW1

AREAWAY WALLS: DETERIORATED JOINTS

30  
S.F.  
REPAIR  
PRIORITY 4  
LEVEL 2

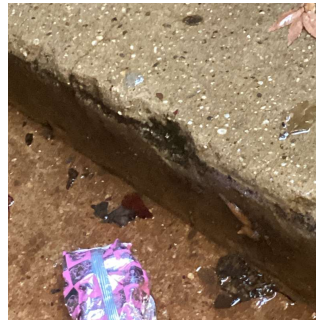
AW1

AREAWAY STAIRS: DETERIORATED  
TREADS/RISERS/NOSINGS

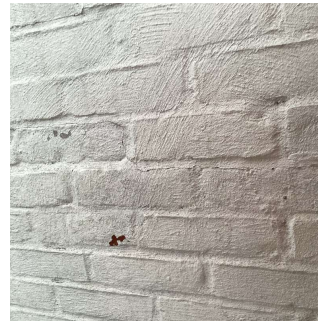
CH  
 No violations recorded.

BRICK: MINOR CRACKS AND SPALLING

10  
 S.F.  
 RESTITCH  
 PRIORITY 3  
 LEVEL 2

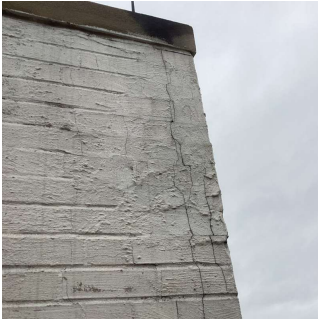
BRICK: MAJOR / THRU CRACKS

20  
 S.F.  
 REMOVE AND REBUILD  
 PRIORITY 4  
 LEVEL 2

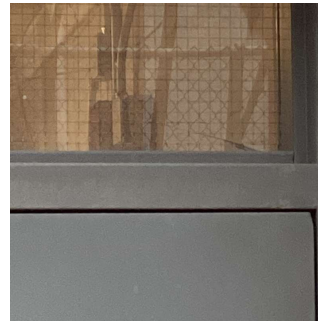
Facade C

METAL: BROKEN GLASS

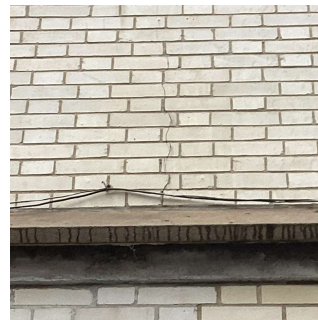
Facade C

BRICK: MAJOR / THRU CRACKS

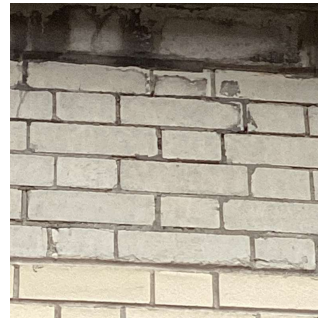
Facade A

BRICK: DETERIORATED JOINTS

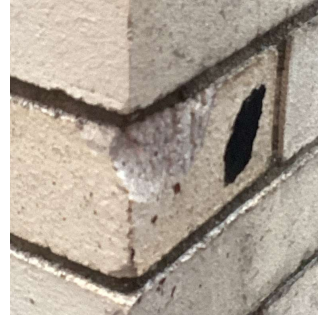
Facade A

BRICK: CRACKS/DISPLACED/SPALLED BRICK AT BUILDING CORNERS

REMOVE AND REBUILD  
PRIORITY 4  
LEVEL 2

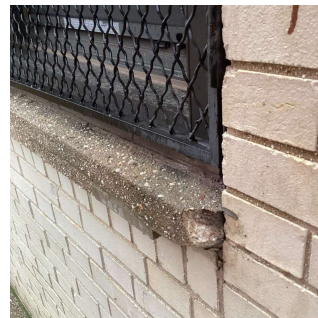
BRICK: DETERIORATED MASONRY SILLS - MAJOR

60  
L.F.  
REMOVE AND REPLACE  
PRIORITY 4  
LEVEL 2

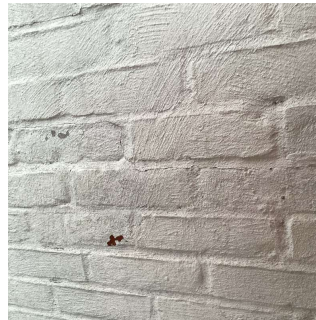
Roof 1  
No violations recorded.

Question	Response
<b>EXTERIOR</b>	
<b>EXTERIOR WALLS</b>	Inspected
	Facade C
Violations	No violations recorded.
<b>EXTERIOR SOFFITS</b>	Does not Exist
<b>LOADING DOCK</b>	Does not Exist
<b>LOUVER</b>	Does not Exist
<b>PARAPETS</b>	Inspected
Material Type(s)	Masonry
Replacement Quantity	3,600
Replacement Uom	C.F.
Instance on All Facades	Inspected
Instance Condition	4 - Between Fair and Poor
Instance Quantity	3,600
Instance Quantity Uom	C.F.
Deficiency	<b>BRICK: MAJOR DETERIORATION/CRACKS</b>
Roof Plan reference	  <p>K682</p> <p>48TH STREET</p> <p>Main Entrance HC Accessible</p> <p>A</p> <p>BH1</p> <p>⊙ 2</p> <p>BH2</p> <p>B</p> <p>MT</p> <p>G</p> <p>E</p> <p>F</p> <p>⊙ 1</p> <p>D</p> <p>OH</p> <p>C</p>
Deficiency Quantity	60
Quantity Uom	S.F.
Potential Action	REMOVE AND REBUILD
Urgency of Action	PRIORITY 4
Purpose of Action	LEVEL 2
Deficiency Photo1	 
	Roof 1
Violations	No violations recorded.
Deficiency	<b>BRICK: MINOR CRACKS, SPALLING</b>

50  
S.F.  
REPAIR  
PRIORITY 3  
LEVEL 2

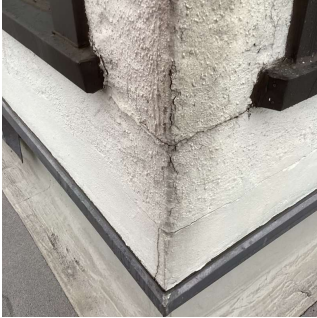
Violations	BH2 No violations recorded.
Deficiency	BULKHEAD/PENTHOUSE WALLS/EXTERIOR: CRACKS/SPALLING - MAJOR
Roof Plan reference

Deficiency Quantity	40
Quantity Uom	S.F.
Potential Action	REPLACE
Urgency of Action	PRIORITY 4
Purpose of Action	LEVEL 2
Deficiency Photo1

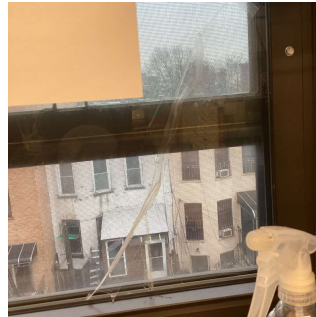
Facade C - Room 301

ALUMINUM - DOUBLE HUNG: BROKEN PANE

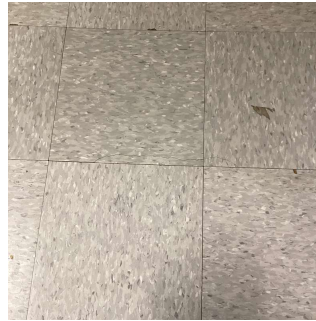
<b>Ceiling</b>	
Condition	2 - Between Good and Fair
Deficiency	No deficiencies recorded
<b>Door(s)</b>	
Condition	1 - Good
Deficiency	No deficiencies recorded
<b>Floor Finish</b>	
Condition	2 - Between Good and Fair
Deficiency	VINYL TILES: BROKEN/DETERIORATED/MISSING TILES
Deficiency Location/Instance	Room 114
Deficiency Quantity	10
Quantity Uom	S.F.
Potential Action	REPLACE
Urgency of Action	PRIORITY 3
Purpose of Action	LEVEL 2

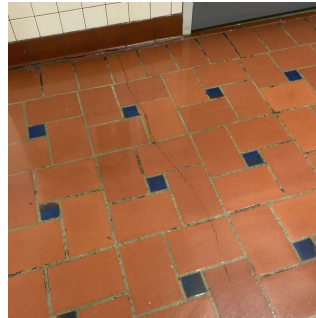
Corridor near Room 114

QUARRY TILE: DETERIORATED SUBSTRATE

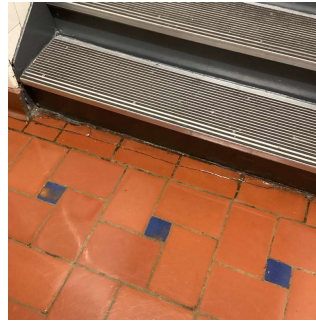
Stair B/1

Violations	Stair B/Bulkhead No violations recorded.
Deficiency	QUARRY TILE: BROKEN/MISSING
Deficiency Location/Instance	Stairs A/3,1, B/1
Deficiency Quantity	40
Quantity Uom	S.F.
Potential Action	REPLACE
Urgency of Action	PRIORITY 3
Purpose of Action	LEVEL 2

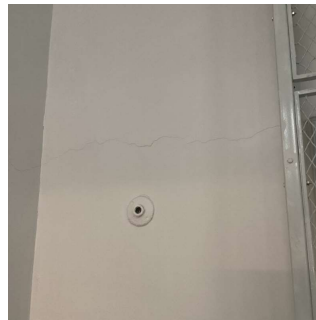
Stair A/3

PLASTER: CRACKS/SPALLING
