NYC Department of Education
Building Condition Assessment Survey 2023 - 2024

Architectural Inspection

Asset: P.S. 188 GYM - BROOKLYN, 2815 WEST 35 STREET, New York, 11224

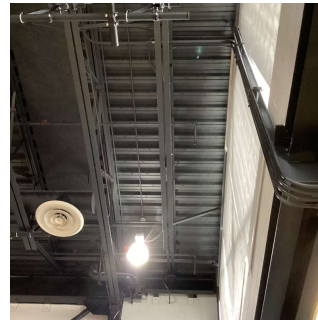
Roof 1 - Gymnasium

IRMA: ROOFING: MAJOR ACTIVE ROOF LEAKS IN INSTRUCTIONAL SPACE

Deficiency Quantity

100

REPLACE ROOFING WITHOUT MAJOR EQUIPMENT REMOVAL

PRIORITY 5

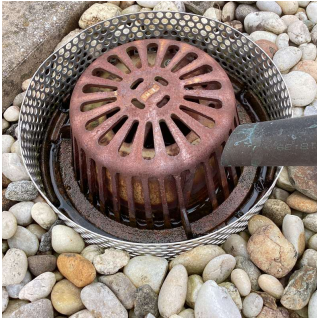
Condition

3 - Fair

DETERIORATED

Question	Response
EXTERIOR	
ROOF	
Roofing	
ROOFING DRAINS	
Quantity Uom	EACH
Potential Action	REPLACE
Urgency of Action	PRIORITY 4
Purpose of Action	LEVEL 2
Deficiency Photo1

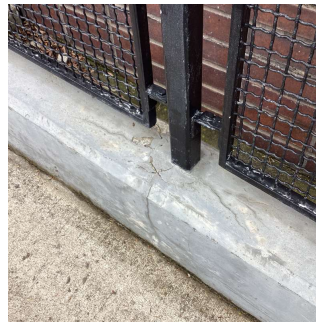
Facade A - HC Ramp

Violations	Roof 1 No violations recorded.
Specialties	Inspected
BULKHEAD/PENTHOUSE	Does not Exist
CUPOLA/ SPIRES/ TOWERS	Does not Exist
DORMER	Does not Exist
DUNNAGE STEEL	Inspected
Condition	2 - Between Good and Fair
Deficiency	No deficiencies recorded
SKYLIGHT/ROOF VENT	Does not Exist
ROOF/GRAVITY TANK	Does not Exist
STAIRS/RAMPS: EXTERIOR	Inspected
BUILDING CHEEK/FLANK WALLS	Inspected
Condition	5 - Poor
Deficiency	CAST IN PLACE CONCRETE: CRACKS/SPALLING - MINOR
Roof Plan reference	K684

Deficiency Quantity	100
Quantity Uom	S.F.
Potential Action	REPAIR
Urgency of Action	PRIORITY 3
Purpose of Action	LEVEL 2

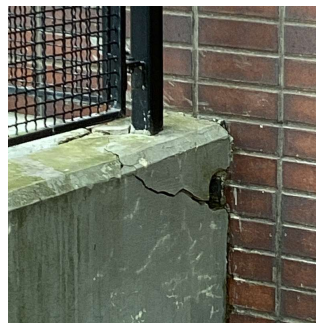
Facade A - HC Ramp

CAST IN PLACE CONCRETE: CRACKS/SPALLING - MAJOR
K684

60

REPLACE

PRIORITY 4

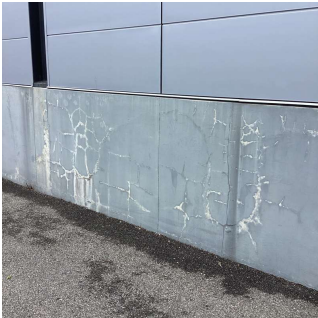
Question	Response
EXTERIOR	
WINDOWS	
EXTERIOR GUARDS	Inspected
Condition	2 - Between Good and Fair
Deficiency	No deficiencies recorded
LINTELS	Inspected
Condition	2 - Between Good and Fair
Deficiency	No deficiencies recorded
WINDOWS	Inspected
Material Type(s)	Aluminum
Instance on Aluminum - Double Hung: Facade A	Inspected
Instance Condition	2 - Between Good and Fair
Instance Quantity	30
Instance Quantity Uom	S.F.
Are these windows insulated	Yes
Installation Year	2012
Source of Installation	Custodial Staff
Deficiency	No deficiencies recorded
INTERIOR	Inspected
POOLS	Does not Exist
STRUCTURAL	Inspected
COLUMNS/BEAMS/BEARING WALLS	Inspected
Condition	2 - Between Good and Fair
Deficiency	No deficiencies recorded
FLOOR STRUCTURE	Inspected
Condition	2 - Between Good and Fair
Deficiency	No deficiencies recorded
FOUNDATION WALLS	Inspected
Material Type(s)	Concrete
Condition	3 - Fair
Deficiency	CONCRETE: CRACKED/SPALLED/REINFORCEMENT EXPOSED

Deficiency Location/Instance	Facades B, C, D
Deficiency Quantity	200
Quantity Uom	S.F.
Potential Action	REPAIR
Urgency of Action	PRIORITY 3
Purpose of Action	LEVEL 5
Deficiency Photo1
