NYC Department of Education
Building Condition Assessment Survey 2023 - 2024

Architectural Inspection

Asset: **PRE-K CENTER @ 10 BOUCK COURT - BROOKLYN, 10 BOUCK COURT, New York, 11223**

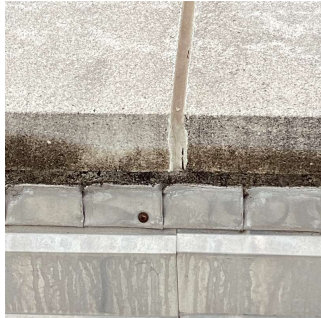
Question	Response
Architectural	
EXTERIOR	Inspected
AREAWAY	Does not Exist
AWNINGS AND CANOPIES	Inspected
Condition	2 - Between Good and Fair
Deficiency	No deficiencies recorded
CHIMNEY	Inspected
Material Type(s)	Metal
Condition	2 - Between Good and Fair
Deficiency	No deficiencies recorded
COPING	Inspected
Condition	2 - Between Good and Fair
Deficiency	CAST STONE: DETERIORATED TRANSVERSE JOINTS
Roof Plan reference	K687

10
L.F.
MAINTENANCE
PRIORITY 3
LEVEL 2

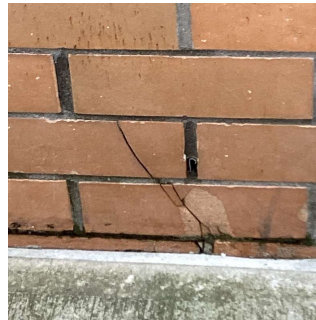
Facade B

Violations	Roof 1 No violations recorded.
CORNICE	Does not Exist
DOORS	Inspected
DOORS AND FRAMES	Inspected
Condition	2 - Between Good and Fair
Deficiency	No deficiencies recorded
DOOR HARDWARE	Inspected
Condition	2 - Between Good and Fair
Deficiency	No deficiencies recorded
LINTELS	Inspected
Condition	2 - Between Good and Fair
Deficiency	No deficiencies recorded
TRANSOM/SIDE LIGHT	Does not Exist
EXTERIOR WALLS	Inspected
Material Type(s)	Masonry
Replacement Quantity	6,300
Replacement Uom	S.F.
Instance on All Facades	Inspected
Instance Condition	4 - Between Fair and Poor
Instance Quantity	6,300
Instance Quantity Uom	S.F.
Deficiency	BRICK: MAJOR / THRU CRACKS
Roof Plan reference	K687

40

REMOVE AND REBUILD

PRIORITY 4

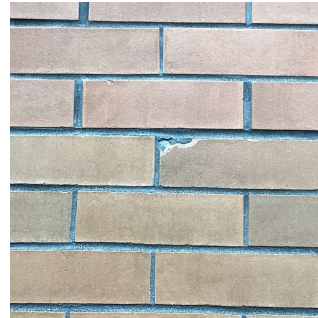
Facade D

BRICK: MINOR CRACKS AND SPALLING

50

RESTITCH

PRIORITY 3
LEVEL 2

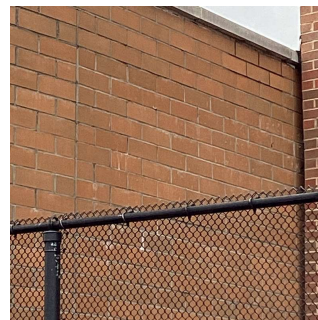
Facade C

BRICK: EFFLORESCENCE

20

MAINTENANCE

PRIORITY 1

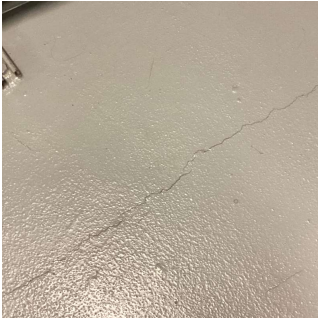
Question	Response
EXTERIOR	Inspected
WINDOWS	Inspected
WINDOWS	
Installation Year	2016
Source of Installation	Custodial Staff
Deficiency	No deficiencies recorded
INTERIOR	Inspected
POOLS	Does not Exist
STRUCTURAL	Inspected
COLUMNS/BEAMS/BEARING WALLS	Inspected
Condition	2 - Between Good and Fair
Deficiency	No deficiencies recorded
FLOOR STRUCTURE	Inspected
Condition	3 - Fair
Deficiency	CONCRETE SLAB ON GRADE: THRU CRACKS
Deficiency Location/Instance	1st Floor
Deficiency Quantity	50
Quantity Uom	S.F.
Potential Action	REPAIR
Urgency of Action	PRIORITY 3
Purpose of Action	LEVEL 5
Deficiency Photo1

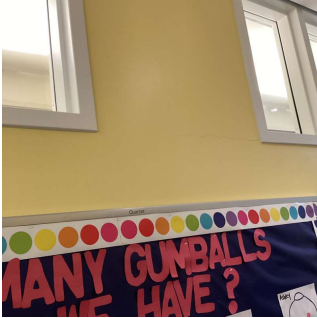
Question	Response
INTERIOR	Inspected
STRUCTURAL	
ROOF STRUCTURE	
Deficiency Photo1	 
Violations	Room 101 No violations recorded.
VAULTS-BUNKERS	Does not Exist
AUDITORIUM	Does not Exist
CAFETERIA	Does not Exist
CLASSROOMS/CORRIDORS/ADMIN SPACES	Inspected
Ceiling	Inspected
Condition	2 - Between Good and Fair
Deficiency	GYPSUM BOARD: DAMAGED/DETERIORATED
Deficiency Location/Instance	Main Lobby
Deficiency Quantity	15
Quantity Uom	S.F.
Potential Action	REPLACE
Urgency of Action	PRIORITY 3
Purpose of Action	LEVEL 2
Deficiency Photo1	 
Violations	Main Lobby No violations recorded.
Door(s)	Inspected
Condition	2 - Between Good and Fair
Deficiency	No deficiencies recorded
Floor Finish	Inspected
Condition	2 - Between Good and Fair
Deficiency	No deficiencies recorded
Walls	Inspected
Condition	2 - Between Good and Fair
Deficiency	GYPSUM BOARD: DETERIORATED
Deficiency Location/Instance	Corridor near rooms 114, 111
Deficiency Quantity	15

Question	Response
INTERIOR	
CLASSROOMS/CORRIDORS/ADMIN SPACES	
Walls	
Potential Action	REPLACE
Urgency of Action	PRIORITY 3
Purpose of Action	LEVEL 2
Deficiency Photo1

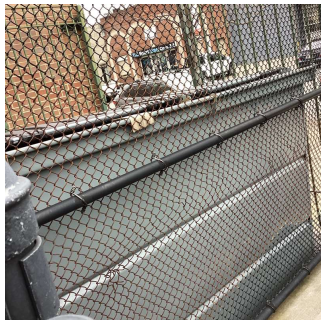
Question	Response
INTERIOR	
TOILET ROOMS - STUDENTS	
Floor Finish	Inspected
Deficiency	No deficiencies recorded
Stalls	Does not Exist
Walls	Inspected
Condition	2 - Between Good and Fair
Deficiency	No deficiencies recorded
LIFE SAFETY	Inspected
F.D. HOLDING AREA	Does not Exist
STEEL STAIRS	Does not Exist
SITE	Inspected
CONTAINERIZATION	Does not Exist
Drainage System for Asphalt	Does not Exist
Drainage System for Concrete	Inspected
Catch Basins/Manhole - Surrounded by concrete	Inspected
Condition	2 - Between Good and Fair
Deficiency	No deficiencies recorded
Culverts - Concrete Covering	Does not Exist
Drainage System for Soil	Does not Exist
DRINKING FOUNTAINS	Does not Exist
FENCES	Inspected
Condition	3 - Fair
Deficiency	CHAIN LINK: RUST - MAJOR
Deficiency Location/Instance	Near generator
Deficiency Quantity	100
Quantity Uom	S.F.
Potential Action	REPLACE
Urgency of Action	PRIORITY 3
Purpose of Action	LEVEL 2
Deficiency Photo1

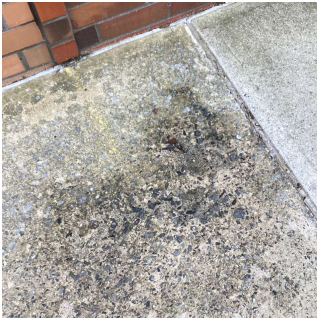
Question	Response
SITE	
PAVING	
DOT Sidewalk	
Concrete	
Violations	No violations recorded.
Deficiency	DAMAGED/DETERIORATED/MISSING SECTIONS
Deficiency Location/Instance	Bouck Court, Shell Road
Deficiency Quantity	300
Quantity Uom	S.F.
Potential Action	REPLACE
Urgency of Action	PRIORITY 3
Purpose of Action	LEVEL 2
Deficiency Photo1
