**NYC Department of Education  
Building Condition Assessment Survey 2023 - 2024**

Architectural Inspection

**K692**

**Asset: PRE-K CENTER @ 305-307 THIRD AVENUE - BROOKLYN, 305-307 THIRD AVENUE,  
New York, 11215**

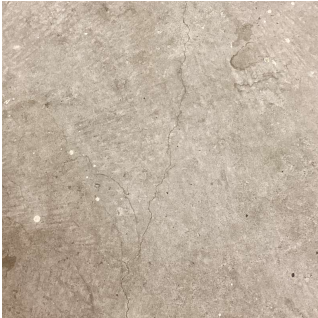
Question	Response
<b>INTERIOR</b>	
<b>STRUCTURAL</b>	Inspected
<b>COLUMNS/BEAMS/BEARING WALLS</b>	Inspected
Condition	2 - Between Good and Fair
Deficiency	No deficiencies recorded
<b>FLOOR STRUCTURE</b>	Inspected
Condition	3 - Fair
Deficiency	CONCRETE: CRACKS/SPALLED/REINFORCEMENT EXPOSED
Deficiency Location/Instance	Mezzanine - Room 204
Deficiency Quantity	10
Quantity Uom	S.F.
Potential Action	REPAIR
Urgency of Action	PRIORITY 3
Purpose of Action	LEVEL 5
Deficiency Photo1

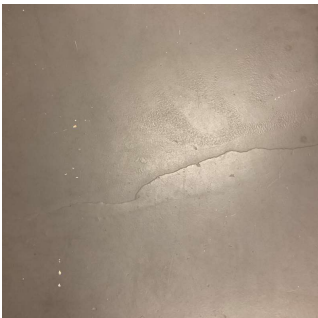
Violations	Mezzanine - Room 204 No violations recorded.
Deficiency	CONCRETE SLAB ON GRADE: THRU CRACKS
Deficiency Location/Instance	1st Floor - Room 115
Deficiency Quantity	20
Quantity Uom	S.F.
Potential Action	REPAIR
Urgency of Action	PRIORITY 3
Purpose of Action	LEVEL 5
Deficiency Photo1

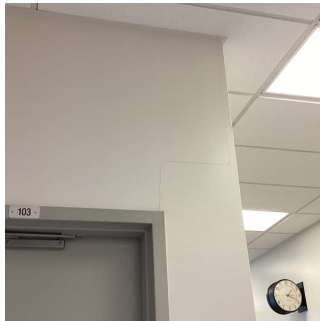
Question	Response
<b>INTERIOR</b>	
<b>STRUCTURAL</b>	
<b>ROOF STRUCTURE</b>	
Deficiency	CONCRETE: CRACKED/SPALLED/REINFORCEMENT EXPOSED
Deficiency Location/Instance	Roof 1 - Mezzanine - Room 202
Deficiency Quantity	20
Quantity Uom	S.F.
Potential Action	REPAIR
Urgency of Action	PRIORITY 4
Purpose of Action	LEVEL 5
Deficiency Photo1	 
	Roof 1 - Mezzanine - Room 202
Violations	No violations recorded.
<b>VAULTS-BUNKERS</b>	
	Does not Exist
<b>AUDITORIUM</b>	
	Does not Exist
<b>CAFETERIA</b>	
	Does not Exist
<b>CLASSROOMS/CORRIDORS/ADMIN SPACES</b>	
<b>Ceiling</b>	Inspected
Condition	2 - Between Good and Fair
Deficiency	No deficiencies recorded
<b>Door(s)</b>	Inspected
Condition	2 - Between Good and Fair
Deficiency	No deficiencies recorded
<b>Floor Finish</b>	Inspected
Condition	2 - Between Good and Fair
Deficiency	No deficiencies recorded
<b>Walls</b>	Inspected
Condition	2 - Between Good and Fair
Deficiency	GYPSON BOARD: DETERIORATED

Deficiency Location/Instance	Corridor near Room 103, 114, 118
Deficiency Quantity	20
Quantity Uom	S.F.
Potential Action	REPLACE
Urgency of Action	PRIORITY 3
Purpose of Action	LEVEL 2

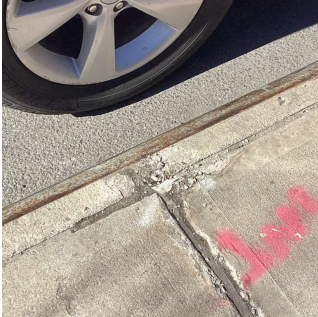
<b>F.D. HOLDING AREA</b>	Does not Exist
<b>STEEL STAIRS</b>	Does not Exist
<b>SITE</b>	
	Inspected
<b>CONTAINERIZATION</b>	
	Does not Exist
<b>Drainage System for Asphalt</b>	Does not Exist
<b>Drainage System for Concrete</b>	Does not Exist
<b>Drainage System for Soil</b>	Does not Exist
<b>DRINKING FOUNTAINS</b>	
	Does not Exist
<b>FENCES</b>	
	Does not Exist
<b>IRRIGATION SYSTEM</b>	
	Does not Exist
<b>PAVING</b>	
	Inspected
<b>Student Non-Use</b>	Does not Exist
<b>Student Use</b>	Does not Exist
<b>Site Sidewalks &amp; Walkways</b>	Does not Exist
<b>DOT Sidewalk</b>	Inspected
<b>Asphalt</b>	Does not Exist
<b>Concrete</b>	Inspected
Condition	3 - Fair
Deficiency	DAMAGED CURBS
Deficiency Location/Instance	Along 3rd Avenue

Question	Response
<b>SITE</b>	
<b>PAVING</b>	
<b>DOT Sidewalk</b>	
<b>Concrete</b>	
Deficiency Quantity	20
Quantity Uom	L.F.
Potential Action	REPLACE
Urgency of Action	PRIORITY 3
Purpose of Action	LEVEL 2
Deficiency Photo1

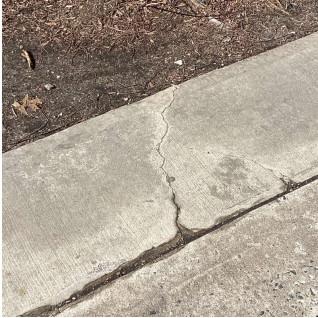
Violations	Along 3rd Avenue No violations recorded.
Deficiency	DAMAGED/DETERIORATED/MISSING SECTIONS
Deficiency Location/Instance	Along 3rd Avenue
Deficiency Quantity	100
Quantity Uom	S.F.
Potential Action	REPLACE
Urgency of Action	PRIORITY 3
Purpose of Action	LEVEL 2
Deficiency Photo1
