**NYC Department of Education**  
**Building Condition Assessment Survey 2023 - 2024**

Architectural Inspection

K695

**Asset:** PRE-K CENTER @ 1258 65TH STREET - BROOKLYN, 1258 65TH STREET, New York, 11219

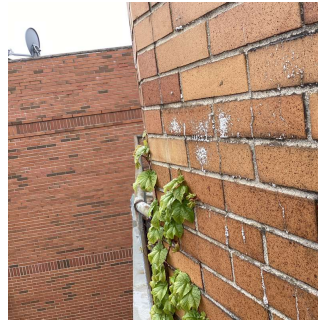
CH

BRICK: MINOR CRACKS AND SPALLING

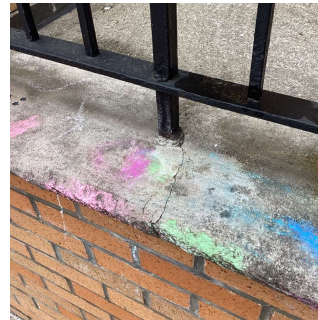
Roof 5

CAST STONE: CRACKED/BROKEN PIECES

REPLACE-IN-KIND

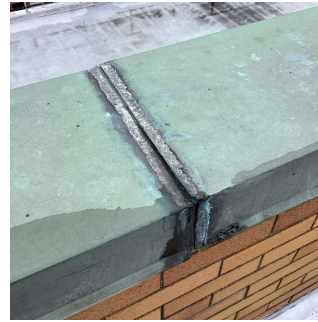
Roof 1

METAL: DETERIORATED TRANSVERSE JOINTS

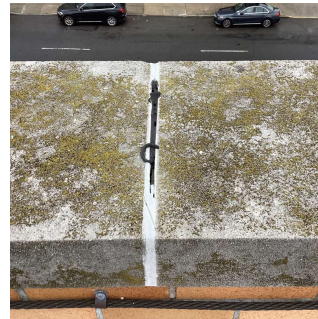
Roof 1

CAST STONE: DETERIORATED TRANSVERSE JOINTS

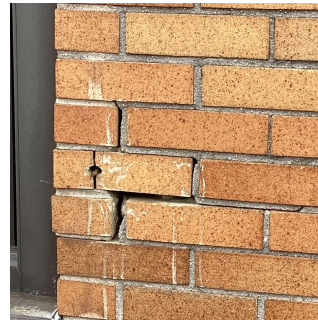
Facade B

Deficiency BRICK: DETERIORATED JOINTS

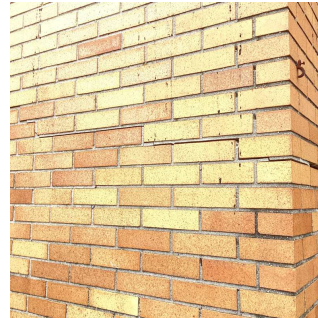
Facade B

BRICK: MAJOR / THRU CRACKS

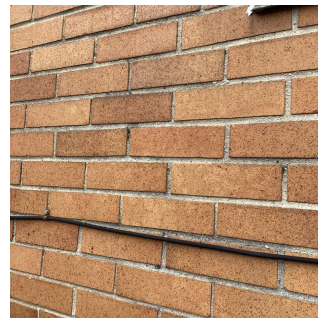
Facade B

BRICK: DETERIORATED JOINTS

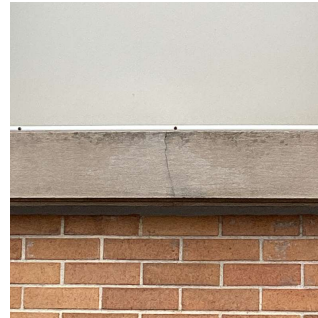
Facade A

BRICK: DETERIORATED MASONRY SILLS - MINOR

REPAIR

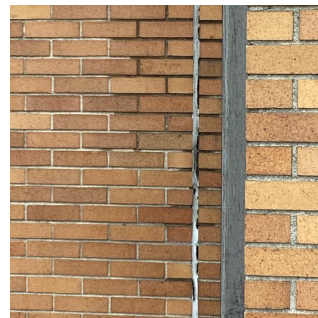
Facade F

BRICK: DETERIORATED CONTROL/EXPANSION JOINTS

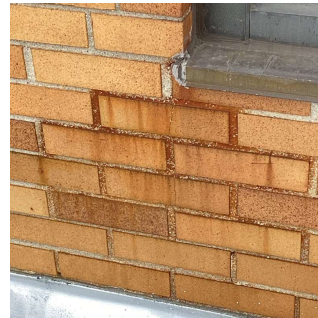
Roof 2

BRICK: MINOR CRACKS AND SPALLING

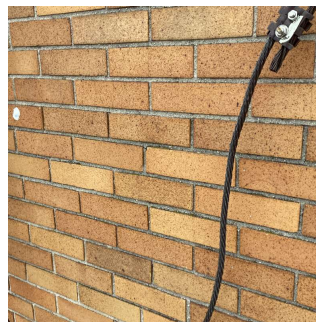
BH2  
No violations recorded.

Deficiency	BULKHEAD/PENTHOUSE WALLS/EXTERIOR: DETERIORATED JOINTS
------------	--

120  
S.F.  
REPOINT  
PRIORITY 3  
LEVEL 2

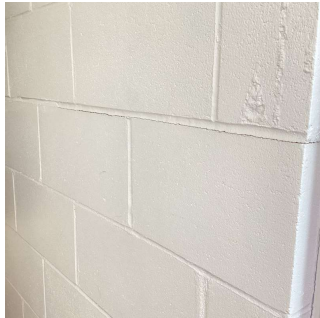
**BULKHEAD/PENTHOUSE WALLS/INTERIOR: CMU  
CRACKS/SPALLING**

Violations	BH2 No violations recorded.
Deficiency	BULKHEAD/PENTHOUSE WALLS/INTERIOR: CMU CRACKS/SPALLING
Roof Plan reference

20  
S.F.  
REPLACE  
PRIORITY 3  
LEVEL 2

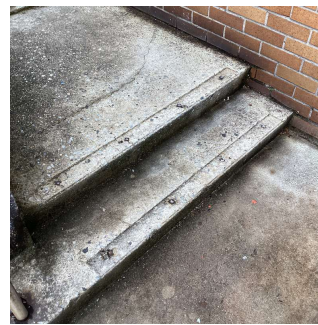
Facade B

CONCRETE: WORN-OUT TREAD/RISER/NOSING

20  
S.F.  
REPLACE  
PRIORITY 4  
LEVEL 2

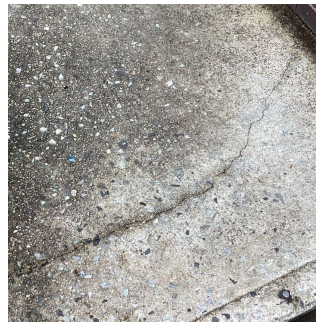
Facade B

CONCRETE: CRACKS/SPALLING - MINOR

25  
S.F.  
REPAIR  
PRIORITY 3  
LEVEL 2

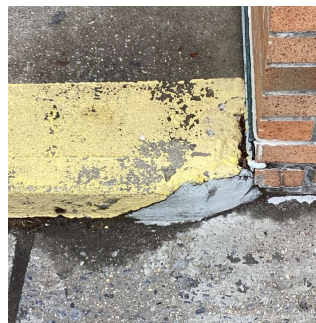
Facade A

**CONCRETE: CRACKS/SPALLING - MAJOR**

REPLACE

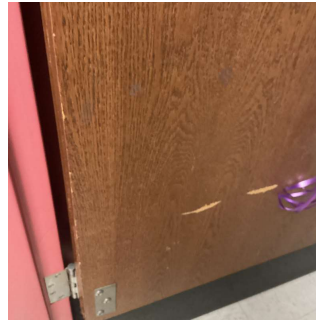
Violations	Corridor near Room 010 No violations recorded.
<b>Door(s)</b>	Inspected
Condition	5 - Poor
Deficiency	WOOD: DETERIORATED DOOR
Deficiency Location/Instance	Room 308
Deficiency Quantity	1
Quantity Uom	EACH
Potential Action	MAINTENANCE
Urgency of Action	PRIORITY 3

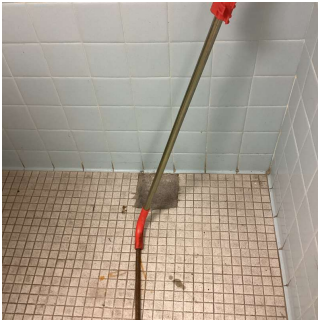
Question	Response
<b>INTERIOR</b>	
<b>SHOWER ROOM</b>	
<b>Floor Finish</b>	
Instance on Room 017	Inspected
Condition	3 - Fair
Deficiency	CERAMIC TILE: BROKEN/MISSING TILES
Deficiency Location/Instance	Near Toilet
Deficiency Quantity	10
Quantity Uom	S.F.
Potential Action	REPLACE
Urgency of Action	PRIORITY 3
Purpose of Action	LEVEL 2
Deficiency Photo1

Violations	Near Toilet No violations recorded.
<b>Walls</b>	
Instance on Room 017	Inspected
Condition	3 - Fair
Deficiency	MASONRY: CRACKS/SPALLING
Deficiency Location/Instance	Near Sink
Deficiency Quantity	10
Quantity Uom	S.F.
Potential Action	REPLACE
Urgency of Action	PRIORITY 3
Purpose of Action	LEVEL 2
Deficiency Photo1

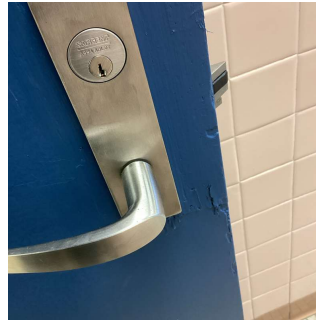
Room 113

Violations	Room 305 No violations recorded.
<b>Door(s)</b>	Inspected
Condition	5 - Poor
Deficiency	WOOD: DETERIORATED DOOR
Deficiency Location/Instance	Rooms 105, 113, 305, 309
Deficiency Quantity	4
Quantity Uom	EACH
Potential Action	MAINTENANCE
Urgency of Action	PRIORITY 3
Purpose of Action	LEVEL 2
