NYC Department of Education
Building Condition Assessment Survey 2023 - 2024

Architectural Inspection

K705

Asset: MIDWOOD HS ADDITION - BROOKLYN, 2886 BEDFORD AVENUE, New York, 11210

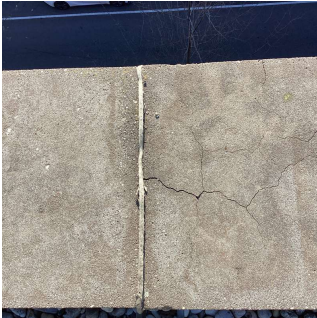
Question	Response
EXTERIOR	
COPING	
Deficiency Photo1

Violations	Roof 1 No violations recorded.
Deficiency	CAST STONE: DISINTEGRATING / FREEZE THAW
Roof Plan reference	K705

Deficiency Quantity	100
Quantity Uom	L.F.
Potential Action	REPLACE-IN-KIND
Urgency of Action	PRIORITY 4
Purpose of Action	LEVEL 2
Deficiency Photo1

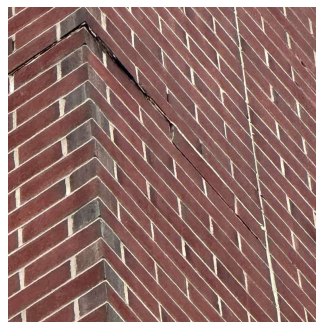
Facade C

Deficiency	BRICK: MAJOR / THRU CRACKS
------------	-----------------------------------

Deficiency Quantity

10

Potential Action

REMOVE AND REBUILD

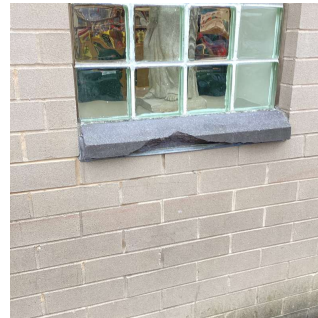
Facade D

BRICK: DETERIORATED MASONRY SILLS - MAJOR

Potential Action

REMOVE AND REPLACE

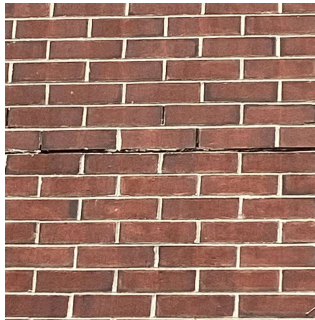
Facade B

BRICK: DETERIORATED JOINTS

Potential Action

REPOINT

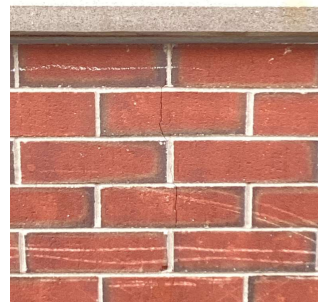
Facade B

BRICK: MINOR CRACKS AND SPALLING

Potential Action

RESTITCH

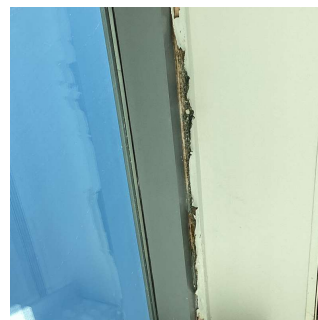
METAL/GLASS CURT WALL: WATER INFILTRATION IN INSTRUCTIONAL SPACE

200
S.F.
REPAIR
PRIORITY 5
LEVEL 2

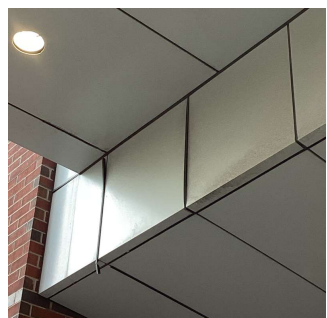
Question	Response
EXTERIOR	
EXTERIOR WALLS	Inspected
Violations	3rd Floor Bridge (2nd Floor Bridge similar) No violations recorded.
EXTERIOR SOFFITS	Inspected
Condition	3 - Fair
Deficiency	METAL: DETERIORATION/DAMAGED/MISSING PIECES
Roof Plan reference	K705

Deficiency Quantity	40
Quantity Uom	S.F.
Potential Action	REPLACE
Urgency of Action	PRIORITY 4
Purpose of Action	LEVEL 2
Deficiency Photo1

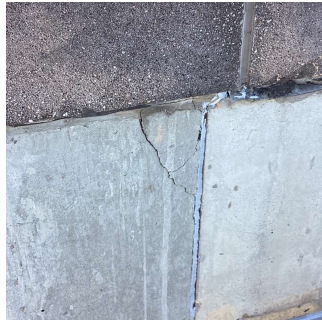
Deficiency	CONCRETE: MAJOR DETERIORATION/CRACKS
Roof Plan reference	K705

Deficiency Quantity	10
Quantity Uom	S.F.
Potential Action	REMOVE AND REBUILD
Urgency of Action	PRIORITY 4
Purpose of Action	LEVEL 2
Deficiency Photo1

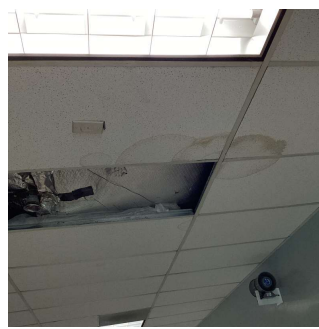
Is/Are the roof(s) suitable for Solar Panel installation?	No
Installation Year	2008
Source of Installation	Custodial Staff
Deficiency	IRMA: ROOFING: MAJOR ACTIVE ROOF LEAKS IN INSTRUCTIONAL SPACE

Deficiency Quantity	300
Quantity Uom	S.F.
Potential Action	REPLACE ROOFING WITHOUT MAJOR EQUIPMENT REMOVAL
Urgency of Action	PRIORITY 5
Purpose of Action	LEVEL 2
Deficiency Photo1

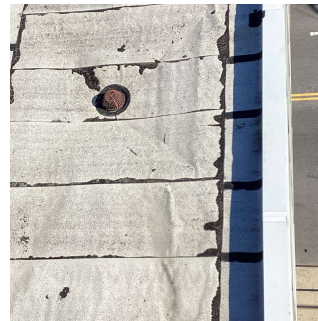
Violations	No violations recorded.
Instance on Modified Bitumen: Roofs 2, 3	Inspected
Instance Condition	5 - Poor
Instance Photo	
	Roof 2
Instance Quantity	1,500
Instance Quantity Uom	S.F.
Does the roof have major mechanical equipment sitting on Dunnage Steel less than 18" above the Roofing?	No
Does this roof instance have a Sustainable Roof System?	No
Do solar panels exist on these roofs?	No
Is/Are the roof(s) suitable for Solar Panel installation?	No
Installation Year	2008
Source of Installation	Custodial Staff
Deficiency	MODIFIED BITUMEN: ROOFING: DELAMINATION

90
S.F.
REPLACE ROOFING WITHOUT MAJOR EQUIPMENT
REMOVAL
PRIORITY 4
LEVEL 2

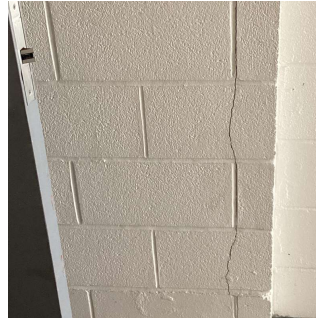
BH/PH
No violations recorded.

BULKHEAD/PENTHOUSE WALLS/INTERIOR: CMU
CRACKS/SPALLING

REPLACE
PRIORITY 4
LEVEL 2

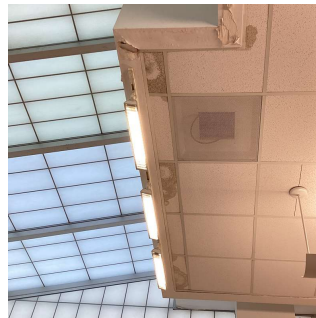
Skylight - Room 100A

WATER INFILTRATION

200
S.F.
MAINTENANCE
PRIORITY 3
LEVEL 2

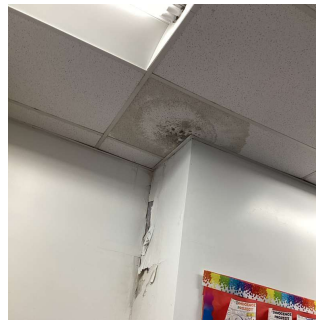
GYP SUM BOARD: DETERIORATED - ACTIVE LEAK

Room 320

REPLACE

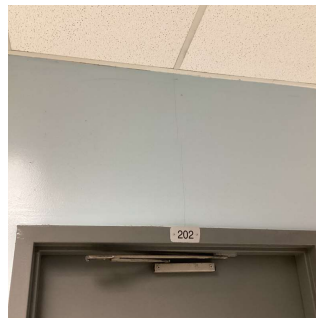
GYP SUM BOARD: DETERIORATED

Corridor near rooms 202, 204, 206, 215, 218 and others

REPLACE

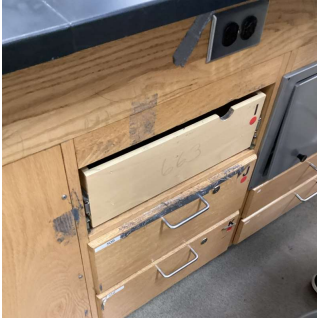
Question	Response
INTERIOR	
SCIENCE LAB	
Fixed Equipment	
Condition	3 - Fair
Deficiency	CABINETRY: MISSING/DAMAGED
Deficiency Location/Instance	Rooms 313, 215
Deficiency Quantity	10
Quantity Uom	L.F.
Potential Action	REPLACE
Urgency of Action	PRIORITY 3
Purpose of Action	LEVEL 2
Deficiency Photo1
