NYC Department of Education
Building Condition Assessment Survey 2023 - 2024

Architectural Inspection

Asset: P.S. 721 OTC - BROOKLYN, 64 AVENUE X, New York, 11223

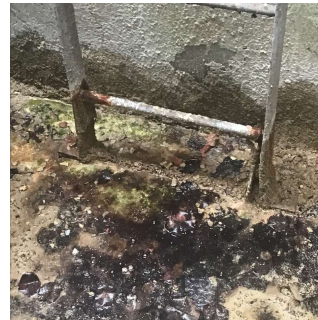
Question	Response
Architectural	
EXTERIOR	Inspected
AREAWAY	Inspected
Instance on AW1	Inspected
Instance Condition	3 - Fair
Instance Quantity	1
Instance Quantity Uom	EACH
Deficiency	AREAWAY LADDER: DETERIORATED

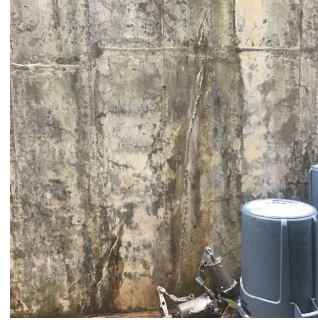
AW1

AREAWAY WALLS: CRACKS AND SPALLING

REPAIR

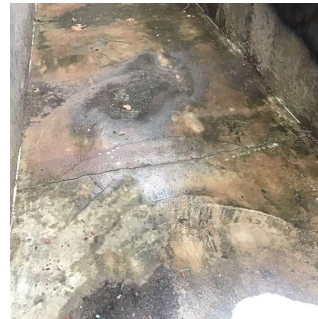
AW1

AREAWAY SLAB: CRACKS AND SPALLING

REPAIR

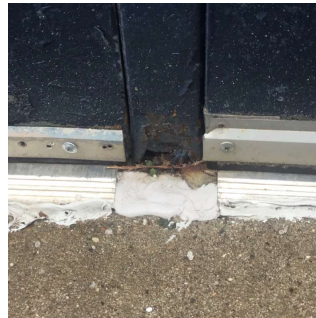
Facade C - Exit 1

METAL: DETERIORATED DOOR AND FRAME - MAJOR DETERIORATION

REPLACE

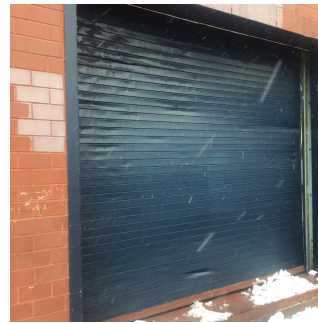
Facade D

ROLL-UP DOOR: DETERIORATED DOOR - MINOR DETERIORATION

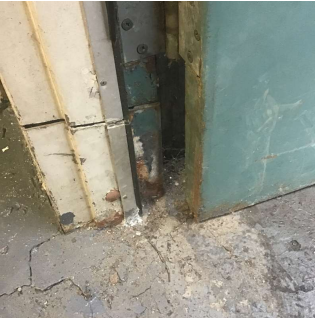
METAL: DETERIORATED DOOR AND FRAME - MINOR DETERIORATION

Deficiency Quantity	1
Quantity Uom	EACH
Potential Action	MAINTENANCE
Urgency of Action	PRIORITY 3
Purpose of Action	LEVEL 2
Deficiency Photo1

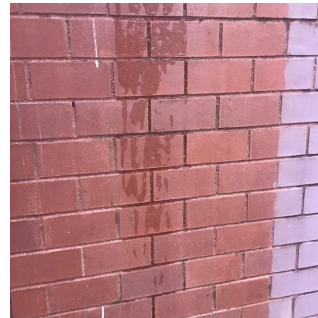
Facade C

Violations	No violations recorded.
DOOR HARDWARE	Inspected
Condition	3 - Fair
Deficiency	No deficiencies recorded
LINTELS	Inspected
Condition	2 - Between Good and Fair
Deficiency	No deficiencies recorded
TRANSOM/SIDE LIGHT	Inspected
Condition	2 - Between Good and Fair
Deficiency	No deficiencies recorded
EXTERIOR WALLS	Inspected
Material Type(s)	Masonry
Replacement Quantity	28,000
Replacement Uom	S.F.
Instance on All Facades	Inspected
Instance Condition	3 - Fair
Instance Quantity	28,000
Instance Quantity Uom	S.F.
Deficiency	BRICK: DETERIORATED JOINTS

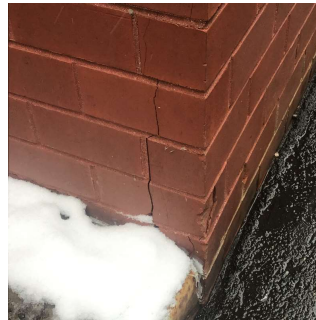
Facade C

BRICK: CRACKS/DISPLACED/SPALLED BRICK AT BUILDING CORNERS

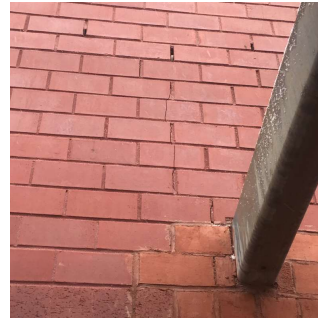
Facade C

BRICK: MAJOR / THRU CRACKS

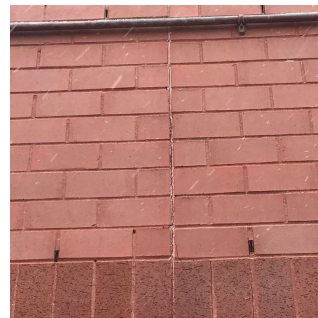
Facade D

BRICK: DETERIORATED CONTROL/EXPANSION JOINTS

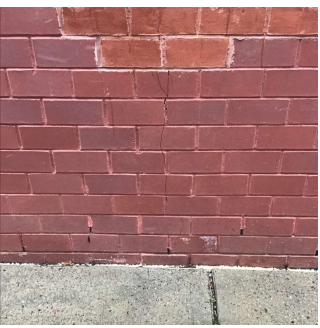
Question	Response
EXTERIOR	
EXTERIOR WALLS	
Violations	No violations recorded.
Deficiency	BRICK: MINOR CRACKS AND SPALLING
Roof Plan reference	<p>K722</p>

Deficiency Quantity	60
Quantity Uom	S.F.
Potential Action	RESTITCH
Urgency of Action	PRIORITY 3
Purpose of Action	LEVEL 2
Deficiency Photo1

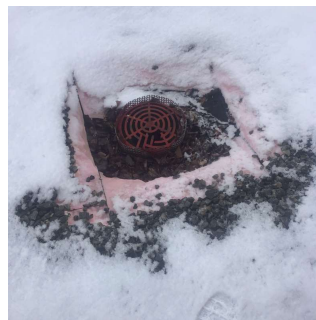
Roof 3
No violations recorded.

Does this roof instance have a Sustainable Roof System?	No
Do solar panels exist on these roofs?	No
Is/Are the roof(s) suitable for Solar Panel installation?	No
Installation Year	1997
Source of Installation	Custodial Staff
Deficiency	IRMA: ROOFING: DAMAGED INSULATION

20
S.F.
REPLACE
PRIORITY 4
LEVEL 2

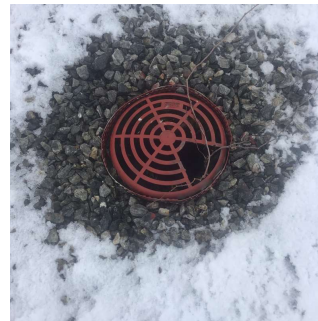
Roof 6

DETERIORATED

REPLACE

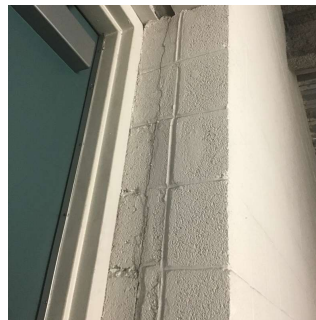
Stair B/Bulkhead

Deficiency	BULKHEAD/PENTHOUSE WALLS/INTERIOR: CMU CRACKS/SPALLING
------------	--

Deficiency Quantity	20
Quantity Uom	S.F.
Potential Action	REPLACE
Urgency of Action	PRIORITY 3
Purpose of Action	LEVEL 2
Deficiency Photo1

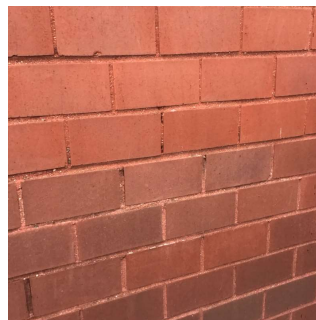
Stair B/Bulkhead

Deficiency	BULKHEAD/PENTHOUSE WALLS/EXTERIOR: DETERIORATED JOINTS
------------	--

20
 S.F.
 REPOINT
 PRIORITY 3
 LEVEL 2

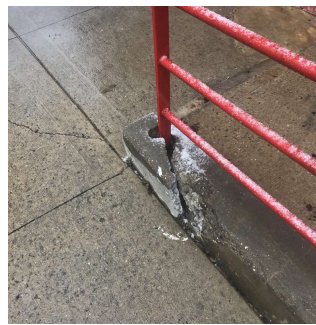
Facade D - Service Ramp
 No violations recorded.

CUPOLA/ SPIRES/ TOWERS	Does not Exist
DORMER	Does not Exist
DUNNAGE STEEL	Inspected
Condition	2 - Between Good and Fair
Deficiency	No deficiencies recorded
SKYLIGHT/ROOF VENT	Does not Exist
ROOF/GRAVITY TANK	Does not Exist
STAIRS/RAMPS: EXTERIOR	Inspected
BUILDING CHEEK/FLANK WALLS	Inspected
Condition	4 - Between Fair and Poor
Deficiency	CAST IN PLACE CONCRETE: CRACKS/SPALLING - MAJOR

20
 S.F.
 REPLACE
 PRIORITY 4
 LEVEL 2

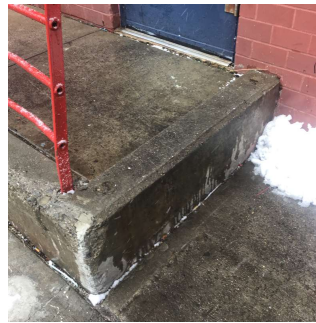
Facade D - Service Ramp

MISSING RAILING

10
 L.F.
 REPLACE
 PRIORITY 5
 LEVEL 6

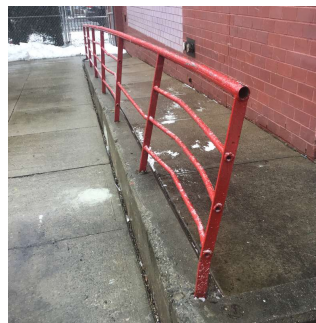
Facade D - Service Ramp

DAMAGED

REPLACE

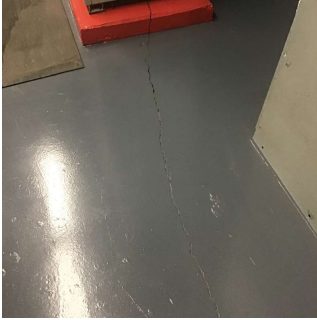
Violations	Attic - Mechanical Equipment Room No violations recorded.
Deficiency	CONCRETE SLAB ON GRADE: THRU CRACKS
Deficiency Location/Instance	Basement - Rooms 1C3, 1C4, 1C5, 1C14, Boiler Room
Deficiency Quantity	200
Quantity Uom	S.F.
Potential Action	REPAIR
Urgency of Action	PRIORITY 3
Purpose of Action	LEVEL 5
Deficiency Photo1

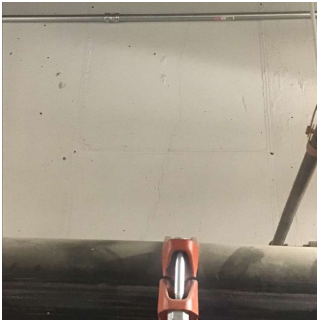
Violations	Room 1C14 No violations recorded.
FOUNDATION WALLS	
	Inspected
Material Type(s)	Concrete
Condition	4 - Between Fair and Poor
Deficiency	CONCRETE: CRACKED/SPALLED/REINFORCEMENT EXPOSED
Deficiency Location/Instance	Basement - Boiler Room, Water Meter Room
Deficiency Quantity	100
Quantity Uom	S.F.
Potential Action	REPAIR
Urgency of Action	PRIORITY 3
Purpose of Action	LEVEL 5

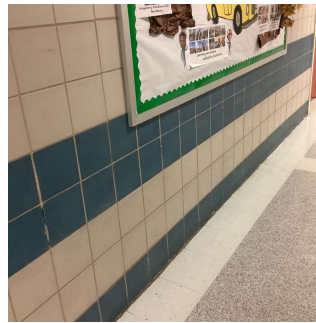
Room 211

Potential Action	REPLACE
Urgency of Action	PRIORITY 5
Purpose of Action	LEVEL 6

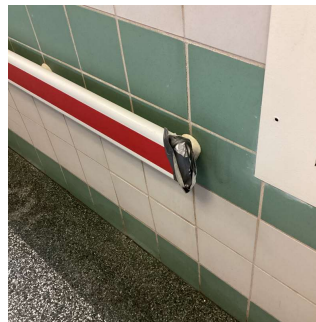
Corridor near room 131

METAL: DAMAGED

REPLACE

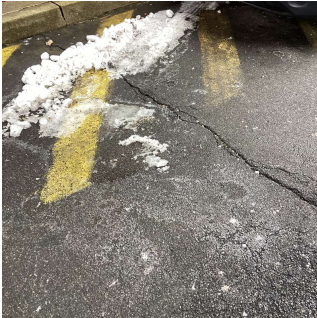
Violations	Service Road No violations recorded.
Deficiency	CRACKS - MAJOR
Deficiency Location/Instance	Rear Service Road, Both Service Entrances from Avenue X
Deficiency Quantity	3,500
Quantity Uom	S.F.
Potential Action	REPLACE
Urgency of Action	PRIORITY 3
Purpose of Action	LEVEL 2
Deficiency Photo1

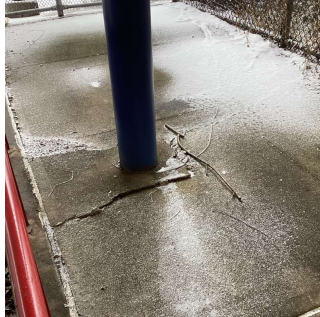
Violations	Rear Service Road No violations recorded.
Concrete	
Condition	Inspected 3 - Fair
Deficiency	CRACKS - MAJOR
Deficiency Location/Instance	Near Schoolyard Entrance
Deficiency Quantity	100
Quantity Uom	S.F.
Potential Action	REPLACE
Urgency of Action	PRIORITY 3
Purpose of Action	LEVEL 2
