NYC Department of Education
Building Condition Assessment Survey 2023 - 2024

Architectural Inspection

Asset: LIBERATION DIPLOMA PLUS H.S. - K, 2865 WEST 19TH STREET, New York, 11224

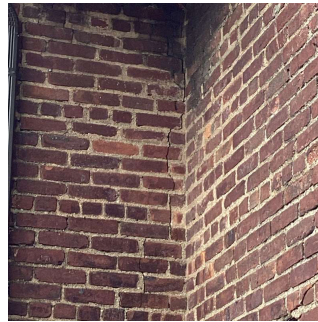
Facade G - CH

| Question | Response |
|---|---|
| Deficiency | BRICK: MAJOR / THRU CRACKS |

K728
 10
 S.F.
 REMOVE AND REBUILD
 PRIORITY 4
 LEVEL 2

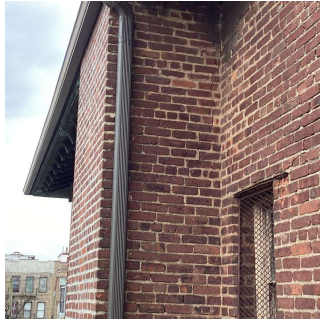
| Question | Response |
|---|---|
| Violations | Facade G - CH No violations recorded. |

BRICK: DETERIORATED JOINTS

K728
 100
 S.F.
 REPOINT
 PRIORITY 3
 LEVEL 2

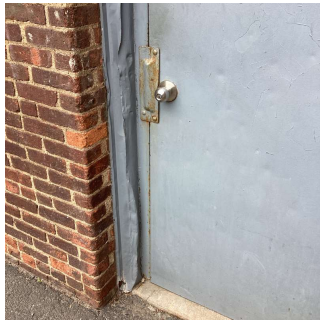
| Question | Response |
|---|---|
| Violations | Facade G No violations recorded. |

| Question | Response |
|---|---|
| Condition | 4 - Between Fair and Poor |
| Deficiency | METAL: DETERIORATED DOOR AND FRAME - MAJOR DETERIORATION |

| Question | Response |
|---|---|
| Deficiency Quantity | 1 |
| Potential Action | REPLACE |
| Urgency of Action | PRIORITY 4 |

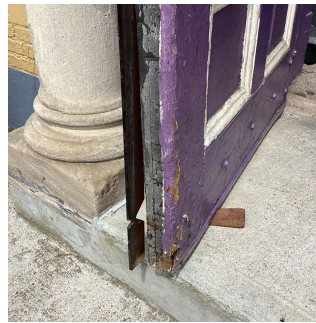
Facade A - Main Entrance
No violations recorded.

| Question | Response |
|---|---|
| Deficiency | WOOD: DETERIORATED DOOR - MAJOR DETERIORATION |

K728
2
EACH
REPLACE
PRIORITY 4
LEVEL 2

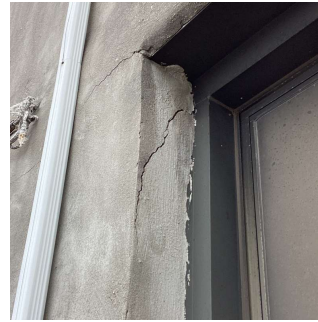
Facade C

| Question | Response |
|---|--|
| Deficiency | STUCCO CEMENT SURFACE: CRACKS, SPALLING |

| Question | Response |
|---|--|
| Potential Action | REPLACE |

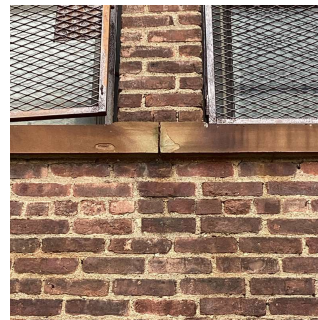
Facade G

BRICK: MASONRY SILLS - DETERIORATED JOINTS

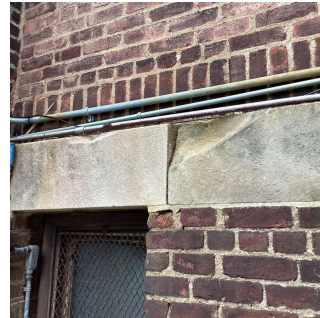
Facade G

STONE: CHIPPED/SPALLED/BROKEN PIECES - MAJOR

REPLACE

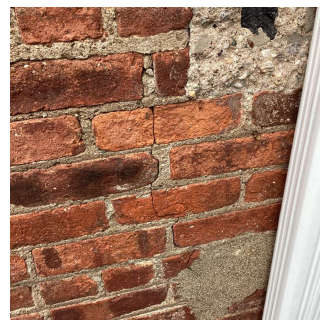
Facade F

BRICK: MINOR CRACKS AND SPALLING

50
S.F.
RESTITCH
PRIORITY 3
LEVEL 2

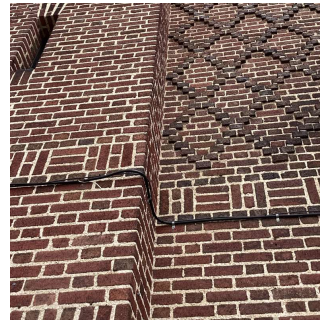
Facade A

BRICK: DETERIORATED JOINTS

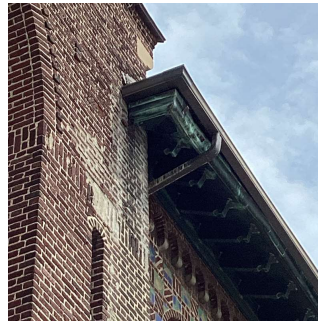
Roof 1 - Facade A

METAL: DETERIORATION/DAMAGED/MISSING PIECES

| Potential Action | REPLACE |

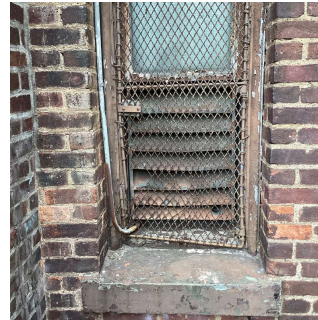
Facade G

| Deficiency | BROKEN/ DENTED BLADES |

| Potential Action | REPLACE |

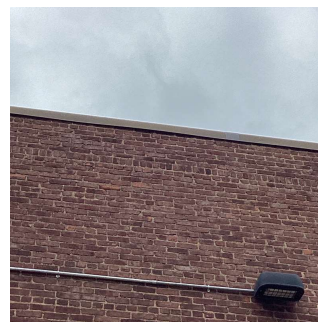
Roof 2 - Facade F

BRICK: DETERIORATED JOINTS

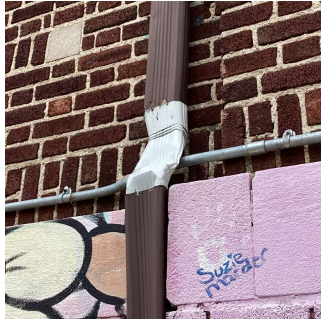
| Question | Response |
|---|--|
| Violations | Facade H No violations recorded. |

| Deficiency | DAMAGED/MISSING |

K728
 20
 L.F.
 REPLACE

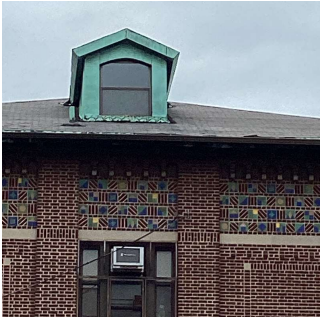
| Question | Response |
|---|---|
| Violations | Roof 1 - Facade H No violations recorded. |

| Question | Response |
|---|--|
| Deficiency | ASPHALT SHINGLE: ROOFING: DAMAGED, WORN-OUT OR MISSING SHINGLES CURLING UP |

| Question | Response |
|---|---|
| Potential Action | REPLACE |

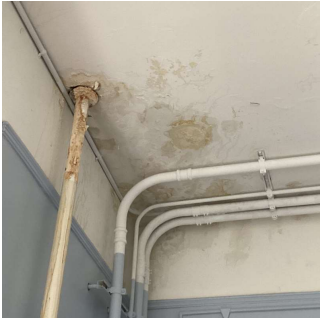
| Question | Response |
|---|---|
| Violations | Roof 1 - Room 303 No violations recorded. |

| Question | Response |
|---|---|
| Deficiency | ASPHALT SHINGLE: ROOFING: MAJOR ACTIVE ROOF LEAKS IN INSTRUCTIONAL SPACE |

| Question | Response |
|---|---|
| Potential Action | REPLACE ROOFING |
| Urgency of Action | PRIORITY 5 |

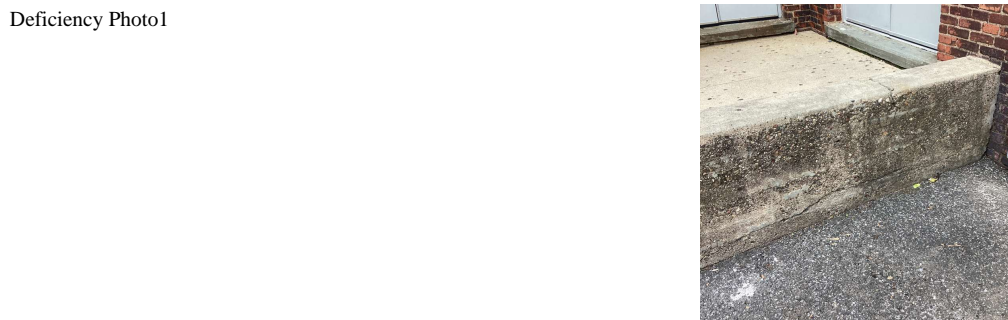
Facade F

| Condition | 4 - Between Fair and Poor |

| Deficiency | CAST IN PLACE CONCRETE: CRACKS/SPALLING - MAJOR |

| Potential Action | REPLACE |

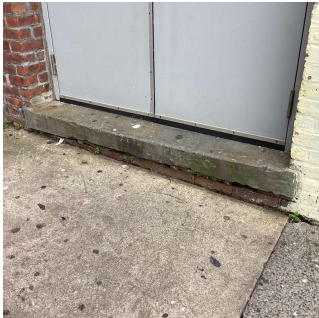
| Question | Response |
|---|--|
| Violations | Facade C No violations recorded. |

| Question | Response |
|---|--|
| Deficiency | STONE: WORN-OUT TREAD/RISER/NOSING |

| Question | Response |
|---|--|
| Potential Action | REPLACE |

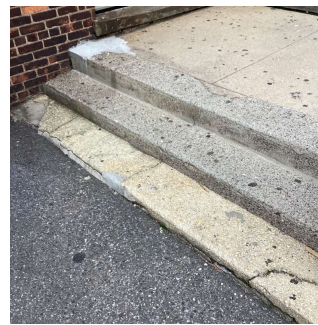
Facade G

| Question | Response |
|---|--|
| Deficiency | CONCRETE: CRACKS/SPALLING - MAJOR |

K728
 30
 S.F.
 REPLACE
 PRIORITY 4
 LEVEL 2

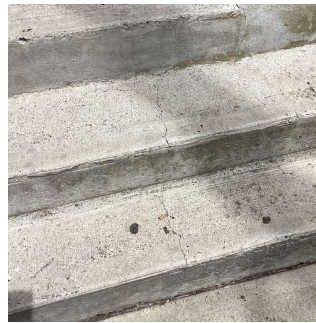
Facade A - Main Entrance

CONCRETE: CRACKS/SPALLING - MINOR

K728
 30
 S.F.
 REPAIR
 PRIORITY 3
 LEVEL 2

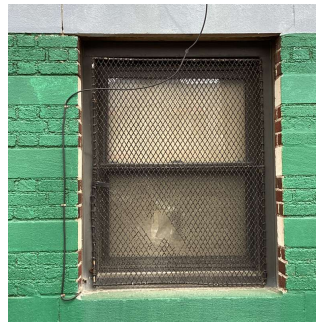
Facade A

DETERIORATED/TORN-OUT/MISSING

REPLACE

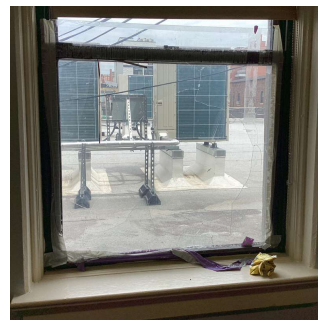
Facade C - Room 307

ALUMINUM - DOUBLE HUNG: BROKEN PANE

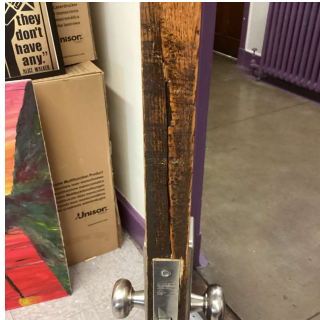
| Question | Response |
|--|--|
| | Room 203 |

| Question | Response |
|--|--|
| Condition | 5 - Poor |
| Deficiency | WOOD: DETERIORATED DOOR |

| Question | Response |
|--|--|
| Urgency of Action | PRIORITY 3 |

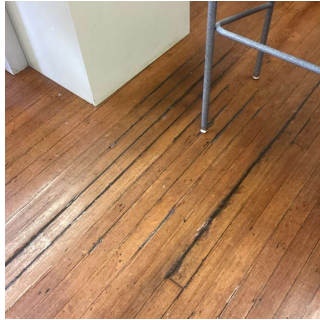
| Question | Response |
|--|--|
| | Room 304 |

| Question | Response |
|--|--|
| Condition | 5 - Poor |
| Deficiency | WOOD: DAMAGED/DETERIORATED |

| Question | Response |
|--|--|
| Potential Action | REPLACE |
| Urgency of Action | PRIORITY 3 |

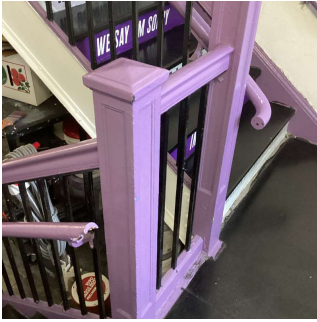
| Question | Response |
|---|--|
| Violations | Stair B/1 No violations recorded. |

| Question | Response |
|---|--|
| Deficiency | WOOD: DAMAGED |

| Question | Response |
|---|--|
| Urgency of Action | PRIORITY 3 |
