NYC Department of Education
Building Condition Assessment Survey 2023 - 2024

Architectural Inspection

Asset: P.S. 207 ANNEX - BROOKLYN, 3874 FLATLANDS AVENUE, New York, 11234

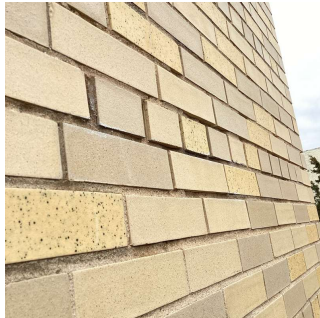
Question	Response
Architectural	
EXTERIOR	Inspected
AREAWAY	Does not Exist
AWNINGS AND CANOPIES	Does not Exist
CHIMNEY	Inspected
Material Type(s)	Masonry
Condition	2 - Between Good and Fair
Deficiency	BRICK: DETERIORATED JOINTS
Roof Plan reference

Deficiency Quantity	20
Quantity Uom	S.F.
Potential Action	REPOINT

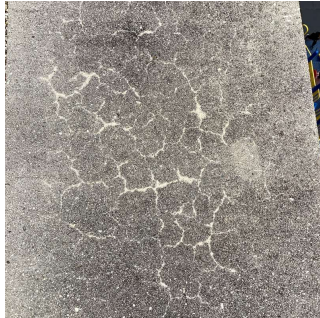
Violations	Roof 1 No violations recorded.
Deficiency	CAST STONE: DETERIORATED TRANSVERSE JOINTS

Violations	CH No violations recorded.
COPING	
Condition	Inspected 3 - Fair
Deficiency	CAST STONE: DISINTEGRATING / FREEZE THAW
Roof Plan reference

Deficiency Quantity	10
Quantity Uom	L.F.
Potential Action	REPLACE-IN-KIND
Urgency of Action	PRIORITY 4
Purpose of Action	LEVEL 2
Deficiency Photo1

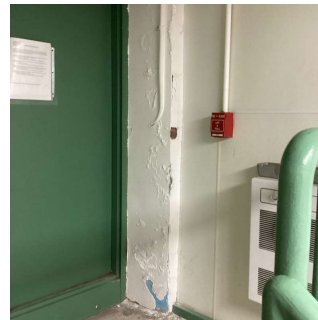
Facade D - Kitchen Exit

BRICK: WATER INFILTRATION IN INSTRUCTIONAL SPACE

REPAIR

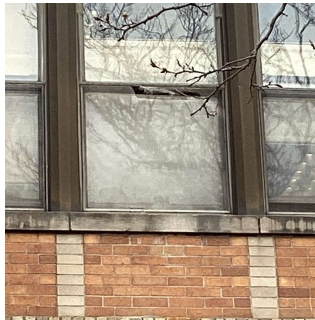
Facade H

BRICK: MASONRY SILLS - DETERIORATED JOINTS

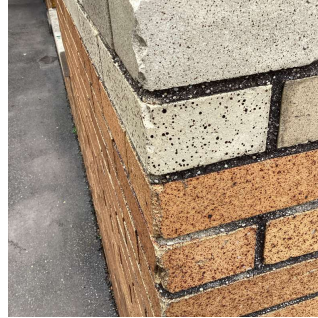
Facade D

BRICK: CRACKS/DISPLACED/SPALLED BRICK AT BUILDING CORNERS

REMOVE AND REBUILD
 PRIORITY 4
 LEVEL 2

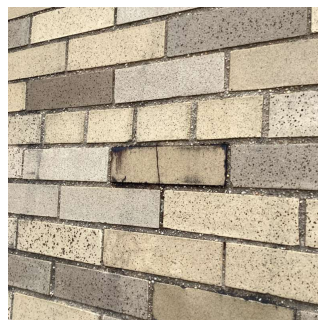
BRICK: MINOR CRACKS AND SPALLING

30
 S.F.
 RESTITCH
 PRIORITY 3
 LEVEL 2

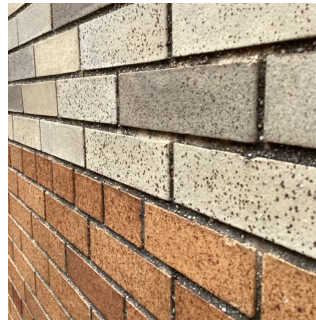
Facade E

BRICK: DETERIORATED JOINTS

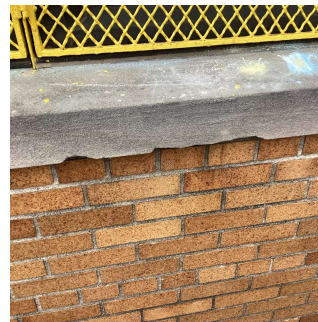
Facade D

BRICK: DETERIORATED MASONRY SILLS - MINOR

REPAIR

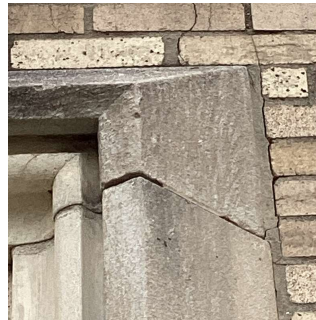
Facade A

STONE: DETERIORATED JOINTS

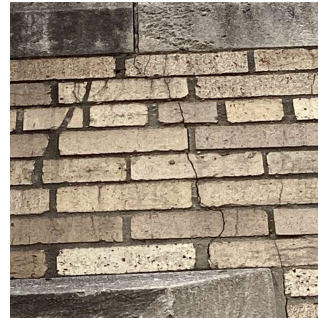
Facade A

BRICK: MAJOR / THRU CRACKS

PRIORITY 4
LEVEL 2

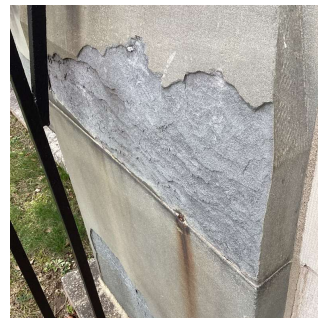
Facade A

STONE: CHIPPED/SPALLED/BROKEN PIECES - MAJOR

REPLACE

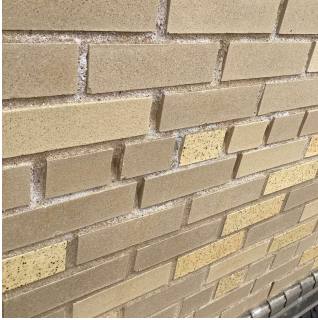
Deficiency	BRICK: DETERIORATED JOINTS
Roof Plan reference

Deficiency Quantity	220
Quantity Uom	S.F.
Potential Action	REPOINT
Urgency of Action	PRIORITY 4
Purpose of Action	LEVEL 2

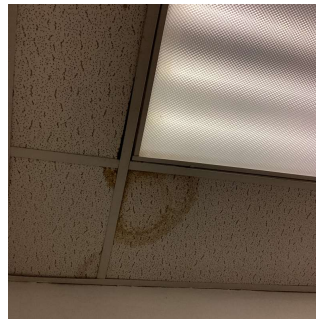
Roof 1 - Room 215
No violations recorded.

Installation Year	2009
Source of Installation	Custodial Staff
Deficiency	BUILT-UP: ROOFING: MAJOR ACTIVE ROOF LEAKS IN INSTRUCTIONAL SPACE

100
S.F.
REPLACE ROOFING WITHOUT MAJOR EQUIPMENT
REMOVAL
PRIORITY 5
LEVEL 2

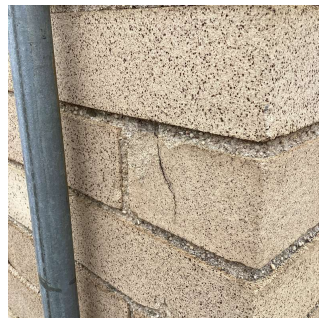
BULKHEAD/PENTHOUSE WALLS/EXTERIOR:
CRACKS/SPALLING - MINOR

Question	Response
EXTERIOR	
ROOF	
Specialties	
BULKHEAD/PENTHOUSE	
Potential Action	REPAIR
Urgency of Action	PRIORITY 3
Purpose of Action	LEVEL 2
Deficiency Photo1

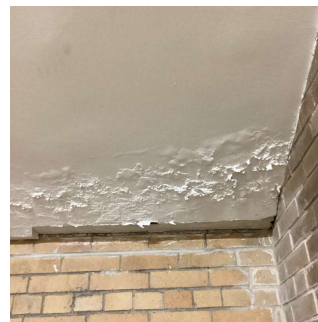
BH2
No violations recorded.

Violations	BH2
Deficiency	No violations recorded.
Deficiency	BULKHEAD/PENTHOUSE CEILING: PLASTER DAMAGED/DETERIORATED

90
S.F.
REPLACE
PRIORITY 3
LEVEL 2

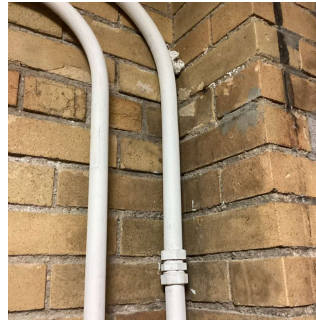
BH2

**BULKHEAD/PENTHOUSE WALLS/INTERIOR: BRICK
DETERIORATED JOINTS**

60
S.F.
REPOINT
PRIORITY 3
LEVEL 2

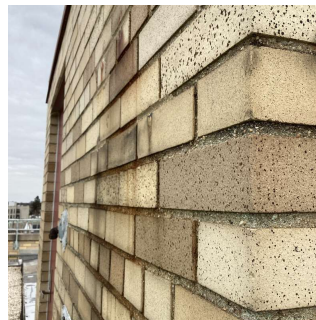
BH1

BULKHEAD/PENTHOUSE WALLS/EXTERIOR: DETERIORATED JOINTS

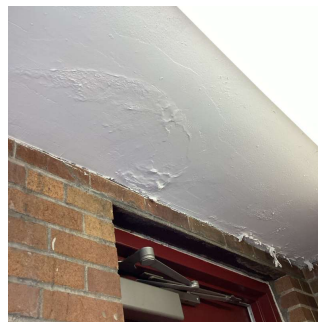
BH1
No violations recorded.

BULKHEAD/PENTHOUSE ROOF: MAJOR LEAKAGE

200
S.F.
REPLACE
PRIORITY 5
LEVEL 2

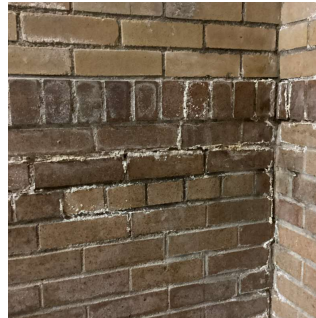
BH2

BULKHEAD/PENTHOUSE WALLS/EXTERIOR: WATER INFILTRATION

200
S.F.
REPAIR
PRIORITY 5
LEVEL 2

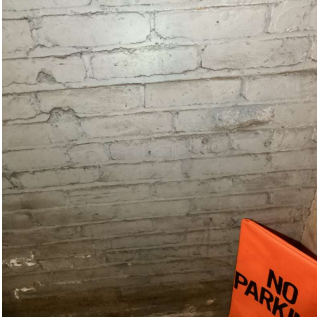
Violations	Basement - Boiler Room No violations recorded.
FOUNDATION WALLS	
Material Type(s)	Inspected Concrete, Masonry
Condition	3 - Fair
Deficiency	BRICK: CRACKED/SPALLED
Deficiency Location/Instance	Basement - Boiler Room
Deficiency Quantity	10
Quantity Uom	S.F.
Potential Action	RESTITCH
Urgency of Action	PRIORITY 3
Purpose of Action	LEVEL 5
Deficiency Photo1

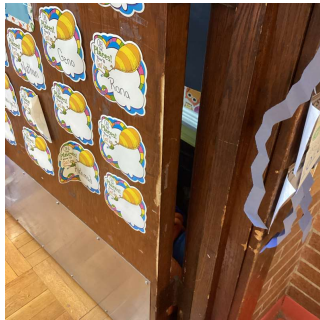
Question	Response
INTERIOR	
CLASSROOMS/CORRIDORS/ADMIN SPACES	
Ceiling	Inspected
Violations	Corridor near Room 318 No violations recorded.
Door(s)	Inspected
Condition	5 - Poor
Deficiency	WOOD: DETERIORATED DOOR
Deficiency Location/Instance	Rooms 129, 203, 204, 206, 305 and others
Deficiency Quantity	12
Quantity Uom	EACH
Potential Action	MAINTENANCE
Urgency of Action	PRIORITY 3
Purpose of Action	LEVEL 2
Deficiency Photo1

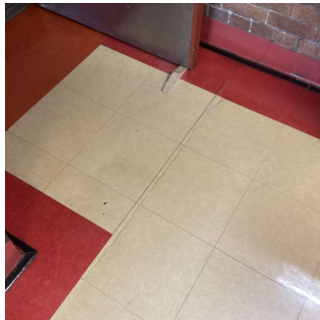
Violations	Room 203 No violations recorded.
Floor Finish	Inspected
Condition	2 - Between Good and Fair
Deficiency	VINYL TILES: DETERIORATED SUBSTRATE
Deficiency Location/Instance	Corridor near Rooms 215, 202, 221, 309, by Stair A/2 and others
Deficiency Quantity	60
Quantity Uom	S.F.
Potential Action	REPLACE
Urgency of Action	PRIORITY 3
Purpose of Action	LEVEL 2
Deficiency Photo1

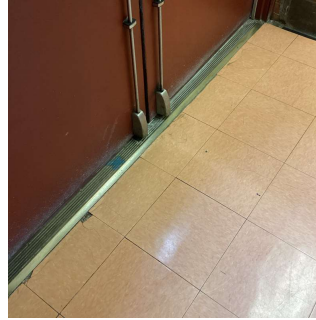
Corridor by Stair A/1

Violations	Corridor near Room 309 No violations recorded.
Deficiency	VINYL TILES: BROKEN/DETERIORATED/MISSING TILES

Deficiency Location/Instance	Rooms 118, 121, Corridor near Rooms 105, 313, by Stair A/1 and others
Deficiency Quantity	80
Quantity Uom	S.F.

Potential Action	REPLACE
Urgency of Action	PRIORITY 3
Purpose of Action	LEVEL 2
Deficiency Photo1

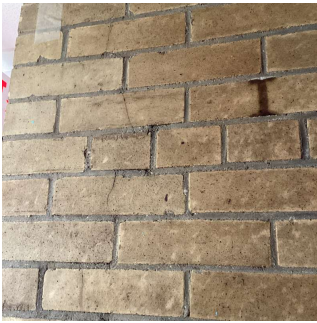
Deficiency	BRICK: CRACKS/SPALLING
Deficiency Location/Instance	Corridor near Rooms 309, 221
Deficiency Quantity	20
Quantity Uom	S.F.
Potential Action	REPLACE
Urgency of Action	PRIORITY 3
Purpose of Action	LEVEL 2

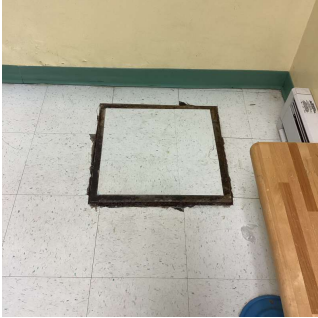
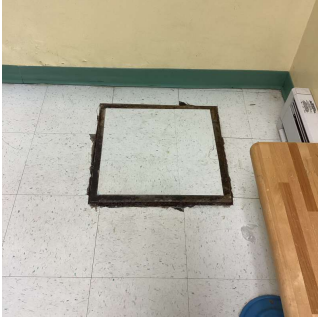
Kitchen Locker Room
No violations recorded.

Instance on 1st Floor	Inspected
Condition	2 - Between Good and Fair
Deficiency	VINYL TILES: BROKEN/DETERIORATED/MISSING TILES
Deficiency Location/Instance	Kitchen Locker Room, Servery
Deficiency Quantity	20
Quantity Uom	S.F.
Potential Action	REPLACE
Urgency of Action	PRIORITY 3
Purpose of Action	LEVEL 2
Deficiency Photo1

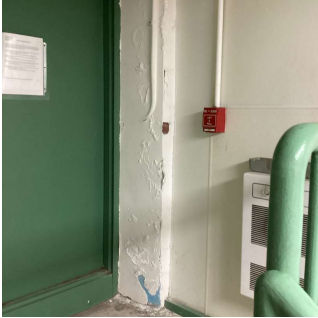
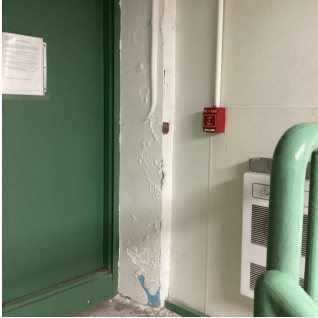
Near Exit Door
No violations recorded.

Instance on 1st Floor	Inspected
Condition	2 - Between Good and Fair
Deficiency	PLASTER: CRACKS/SPALLING - ACTIVE LEAK
Deficiency Location/Instance	Near Exit Door
Deficiency Quantity	30
Quantity Uom	S.F.
Potential Action	REPLACE
Urgency of Action	PRIORITY 5
Purpose of Action	LEVEL 2
Deficiency Photo1

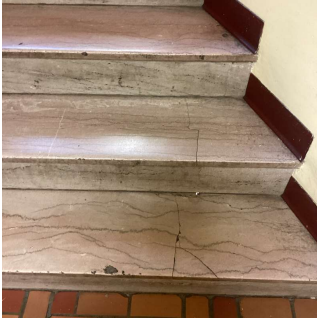
Corridor Near Cafeteria
Violations	No violations recorded.
Walls	Inspected
Condition	2 - Between Good and Fair
Deficiency	No deficiencies recorded
TOILET ROOMS - STAFF

Stair A/Exit - Vestibule
Violations	No violations recorded.
Deficiency	STONE: BROKEN/MISSING
Deficiency Location/Instance	Corridor Near Cafeteria, Main Entrance
Deficiency Quantity	40
Quantity Uom	S.F.
Potential Action	REPLACE
Urgency of Action	PRIORITY 3
Purpose of Action	LEVEL 2
Deficiency Photo1

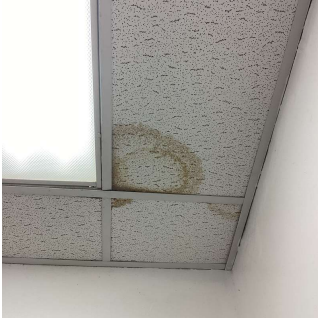
Inspected
Ceiling	Inspected
Condition	4 - Between Fair and Poor
Deficiency	ACOUSTIC TILES: DAMAGED/MISSING - ACTIVE LEAK

Question	Response
INTERIOR	
TOILET ROOMS - STAFF	
Ceiling	
Deficiency Location/Instance	Room 215
Deficiency Quantity	20
Quantity Uom	S.F.
Potential Action	REPLACE
Urgency of Action	PRIORITY 5
Purpose of Action	LEVEL 2
Deficiency Photo1

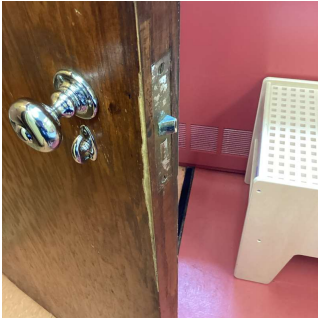
Violations	Room 215 No violations recorded.
Door(s)	Inspected
Condition	5 - Poor
Deficiency	WOOD: DETERIORATED DOOR
Deficiency Location/Instance	Room 108
Deficiency Quantity	1
Quantity Uom	EACH
Potential Action	MAINTENANCE
Urgency of Action	PRIORITY 3
Purpose of Action	LEVEL 2
Deficiency Photo1
