**NYC Department of Education**  
**Building Condition Assessment Survey 2023 - 2024**

Architectural Inspection

**K743**

**Asset: ADULT LRNG CTR (OLD GRLS HS) - K, 475 NOSTRAND AVENUE, New York, 11216**

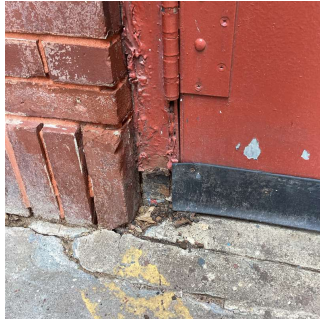
METAL CLAD: DETERIORATED DOOR AND FRAME - MAJOR DETERIORATION

Violations	Facade H - Exit 2 No violations recorded.
Deficiency	METAL: DETERIORATED DOOR AND FRAME - MAJOR DETERIORATION
Roof Plan reference

Question	Response
<b>EXTERIOR</b>	
<b>DOORS</b>	
<b>DOORS AND FRAMES</b>	
Potential Action	REPLACE
Urgency of Action	PRIORITY 4
Purpose of Action	LEVEL 2
Deficiency Photo1

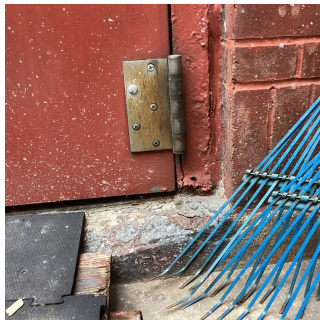
Violations	Facade C - Exit 9 No violations recorded.
<b>DOOR HARDWARE</b>	
Condition	Inspected
Deficiency	3 - Fair
<b>LINTELS</b>	
Condition	Inspected
Deficiency	2 - Between Good and Fair
Deficiency	No deficiencies recorded

Deficiency Quantity	3
Quantity Uom	EACH
Potential Action	REPLACE
Urgency of Action	PRIORITY 4
Purpose of Action	LEVEL 2
Deficiency Photo1

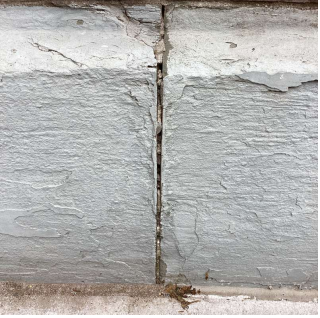
Question	Response
<b>EXTERIOR</b>	
<b>DOORS</b>	Inspected
<b>TRANSOM/SIDE LIGHT</b>	Inspected
Condition	2 - Between Good and Fair
Deficiency	No deficiencies recorded
<b>EXTERIOR WALLS</b>	Inspected
Material Type(s)	Masonry
Replacement Quantity	24,000
Replacement Uom	S.F.
Instance on All Facades	Inspected
Instance Condition	3 - Fair
Instance Quantity	24,000
Instance Quantity Uom	S.F.
Deficiency	STONE: DETERIORATED JOINTS
Roof Plan reference

Violations	Facade C No violations recorded.
Deficiency	BRICK: DETERIORATED JOINTS

Deficiency Quantity	20
Quantity Uom	L.F.
Potential Action	REPOINT
Urgency of Action	PRIORITY 4
Purpose of Action	LEVEL 2
Deficiency Photo1

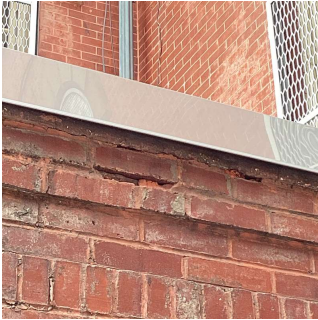
Violations	Roof 2 No violations recorded.
<b>PARAPETS</b>	
Material Type(s)	Inspected Masonry
Replacement Quantity	300
Replacement Uom	C.F.
Instance on Roofs 7-10	Inspected
Instance Condition	4 - Between Fair and Poor
Instance Quantity	300
Instance Quantity Uom	C.F.
Deficiency	<b>BRICK: DETERIORATED JOINTS</b>
Roof Plan reference	K743

Violations	Roof 7 No violations recorded.
Deficiency	<b>BRICK: MINOR CRACKS, SPALLING</b>

Deficiency Quantity	10
Quantity Uom	S.F.
Potential Action	REPOINT
Urgency of Action	PRIORITY 4
Purpose of Action	LEVEL 2
Deficiency Photo1

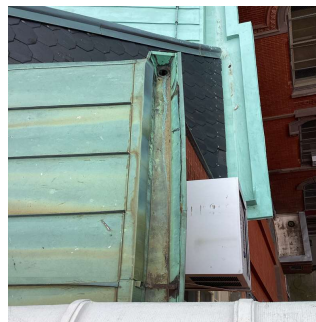
Roof 4  
No violations recorded.

DAMAGED/MISSING

10  
L.F.  
REPLACE  
PRIORITY 4  
LEVEL 2

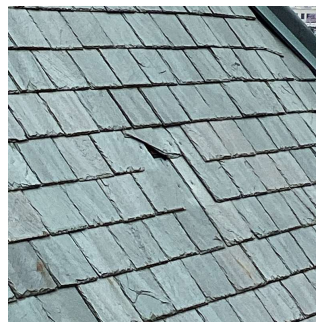
Roof 4  
No violations recorded.

Deficiency	SLATE ROOF: ROOFING: DAMAGED OR MISSING TILES

30  
S.F.  
REPLACE  
PRIORITY 4  
LEVEL 2

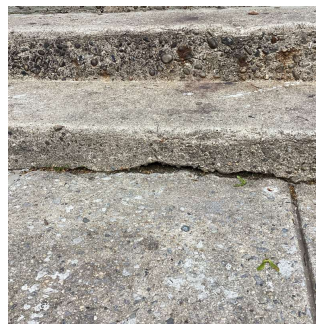
Facade C

Violations	Facade A No violations recorded.
Deficiency	<b>CONCRETE: CRACKS/SPALLING - MAJOR</b>

10  
 S.F.  
 REPLACE  
 PRIORITY 4  
 LEVEL 2

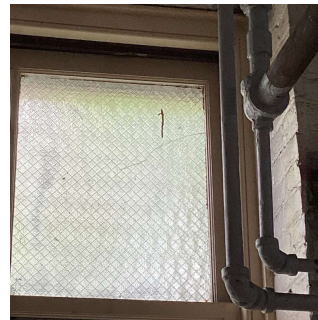
Violations	Facade G - Corridor near Room 304 No violations recorded.
<b>LINTELS</b>	Inspected
Condition	2 - Between Good and Fair
Deficiency	No deficiencies recorded
<b>WINDOWS</b>	Inspected
Material Type(s)	Aluminum, Solid Wood
Instance on Wood: All Facades	Inspected
Instance Condition	3 - Fair
Instance Quantity	7,400
Instance Quantity Uom	S.F.
Are these windows insulated	No
Installation Year	1993
Source of Installation	Custodial Staff
Deficiency	WOOD: BROKEN PANE

Facade D - Room B11  
No violations recorded.

50  
S.F.  
MAINTENANCE  
PRIORITY 3  
LEVEL 2

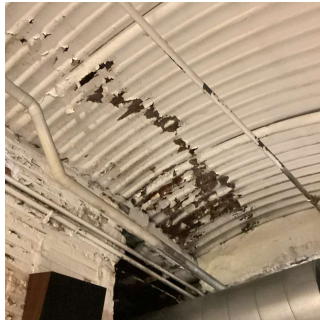
CINDER CONCRETE ARCH: METAL PAN DETERIORATED, SPALLED

Room B5
Violations	No violations recorded.
<b>FOUNDATION WALLS</b>	
Material Type(s)	Inspected Masonry
Condition	3 - Fair
Deficiency	BRICK: DETERIORATED JOINTS
Deficiency Location/Instance	Gas Meter Room, Electrical Panel Room, Boiler Room
Deficiency Quantity	40
Quantity Uom	S.F.
Potential Action	REPOINT
Urgency of Action	PRIORITY 4
Purpose of Action	LEVEL 5
Deficiency Photo1

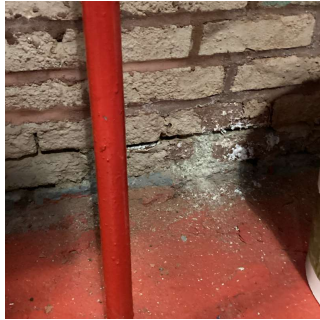
Electrical Panel Room
Violations	No violations recorded.
Deficiency	BRICK: CRACKED/SPALLED
Deficiency Location/Instance	Boiler Room
Deficiency Quantity	20
Quantity Uom	S.F.
Potential Action	RESTITCH
Urgency of Action	PRIORITY 3
Purpose of Action	LEVEL 5

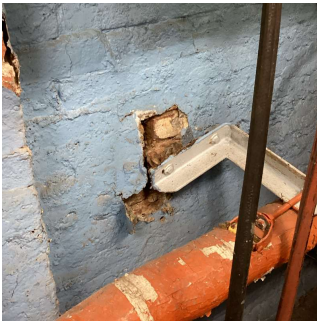
Boiler Room
Violations	No violations recorded.
<b>ROOF STRUCTURE</b>	
Condition	Inspected
	3 - Fair
Deficiency	WOOD COLUMNS AND BEAMS: DETERIORATED
Deficiency Location/Instance	Attic
Deficiency Quantity	20
Quantity Uom	S.F.
Potential Action	REPLACE
Urgency of Action	PRIORITY 4
Purpose of Action	LEVEL 5
Deficiency Photo1

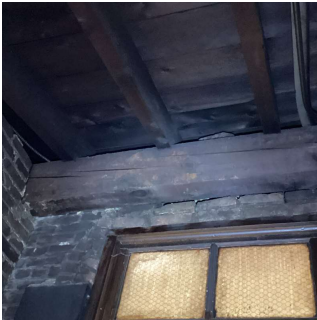
Attic
Violations	No violations recorded.
<b>VAULTS-BUNKERS</b>	
	Inspected
<b>Foundation Walls</b>	Inspected
Condition	2 - Between Good and Fair
Deficiency	No deficiencies recorded
<b>Slab Structure</b>	Inspected
Condition	2 - Between Good and Fair
Deficiency	No deficiencies recorded
<b>Vault/Ash Hoist Doors and Framing</b>	Does not Exist
<b>AUDITORIUM</b>	Does not Exist
<b>CAFETERIA</b>	Does not Exist
<b>CLASSROOMS/CORRIDORS/ADMIN SPACES</b>	Inspected
<b>Ceiling</b>	Inspected
Condition	2 - Between Good and Fair

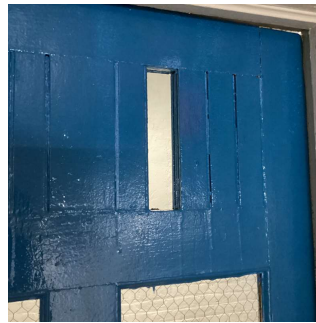
Basement Exit 2 Vestibule

Main Entrance Vestibule
Violations	No violations recorded.
<b>Door(s)</b>	Inspected
Condition	5 - Poor
Deficiency	WOOD: DETERIORATED DOOR
Deficiency Location/Instance	Basement Exit 2 Vestibule, Rooms B8, 204, 309, 403, and others
Deficiency Quantity	13
Quantity Uom	EACH
Potential Action	MAINTENANCE
Urgency of Action	PRIORITY 3
Purpose of Action	LEVEL 2

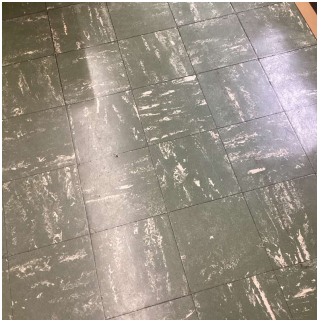
Question	Response
<b>INTERIOR</b>	
<b>CLASSROOMS/CORRIDORS/ADMIN SPACES</b>	
<b>Floor Finish</b>	
Violations	Main Entrance Vestibule No violations recorded.
Deficiency	WOOD: DAMAGED/DETERIORATED
Deficiency Location/Instance	Rooms 202, 326
Deficiency Quantity	20
Quantity Uom	S.F.
Potential Action	REPLACE
Urgency of Action	PRIORITY 5
Purpose of Action	LEVEL 6
Deficiency Photo1	 
Violations	Room 326 No violations recorded.
Deficiency	VINYL TILES: BROKEN/DETERIORATED/MISSING TILES
Deficiency Location/Instance	Rooms 102, 128, 224, 307, 325, and others
Deficiency Quantity	1,900
Quantity Uom	S.F.
Potential Action	REPLACE
Urgency of Action	PRIORITY 3
Purpose of Action	LEVEL 2
Deficiency Photo1

Violations	Room 307 No violations recorded.
Deficiency	WOOD: TRIPPING HAZARD - ELECTRICAL OUTLET
Deficiency Location/Instance	Rooms 209, 228
Deficiency Quantity	30
Quantity Uom	S.F.
Potential Action	REMOVE
Urgency of Action	PRIORITY 5

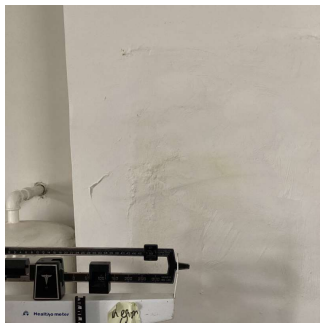
Room 403
Violations	No violations recorded.
Deficiency	PLASTER: CRACKS/SPALLING - ACTIVE LEAK
Deficiency Location/Instance	Corridor near Room 424, Room 424
Deficiency Quantity	20
Quantity Uom	S.F.
Potential Action	REPLACE
Urgency of Action	PRIORITY 5
Purpose of Action	LEVEL 2
Deficiency Photo1

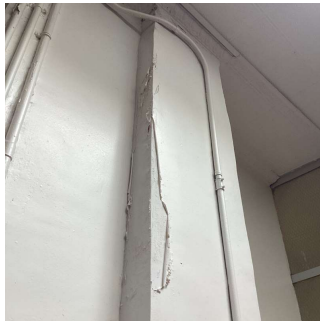
Corridor near Room 424
Violations	No violations recorded.
<b>Specialties</b>	Inspected
<b>Classroom Locker(s)</b>	Inspected
Condition	2 - Between Good and Fair
Deficiency	No deficiencies recorded
<b>Fixed Seating</b>	Does not Exist
<b>GYMNASIUM</b>	Does not Exist
<b>INTERIOR DOOR HARDWARE</b>	Inspected
Condition	3 - Fair
Deficiency	No deficiencies recorded
<b>INTERIOR GUARDS</b>	Inspected
Condition	2 - Between Good and Fair
Deficiency	No deficiencies recorded
<b>KITCHEN</b>	Does not Exist
<b>LIBRARY</b>	Does not Exist

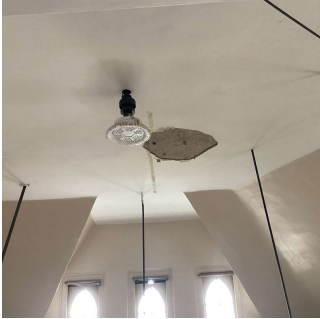
Question	Response
<b>INTERIOR</b>	
<b>MULTI-PURPOSE ROOM</b>	
Instance on 3rd Floor	Inspected
<b>Ceiling</b>	
Instance on 3rd Floor	Inspected
Condition	2 - Between Good and Fair
Deficiency	PLASTER: CRACKS/SPALLING
Deficiency Location/Instance	Right Side
Deficiency Quantity	20
Quantity Uom	S.F.
Potential Action	REPLACE
Urgency of Action	PRIORITY 3
Purpose of Action	LEVEL 2
Deficiency Photo1

Right Side
Violations	No violations recorded.
<b>Door(s)</b>	
Instance on 3rd Floor	Inspected
Condition	2 - Between Good and Fair
Deficiency	No deficiencies recorded
<b>Fixed Equipment</b>	
Instance on 3rd Floor	Does not Exist
<b>Floor Finish</b>	
Instance on 3rd Floor	Inspected
Condition	2 - Between Good and Fair
Deficiency	No deficiencies recorded
<b>Sliding-folding Partition</b>	
Instance on 3rd Floor	Does not Exist
<b>Stage</b>	
Instance on 3rd Floor	Inspected
<b>Stage</b>	
Instance on 3rd Floor	Inspected
Condition	1 - Good
Deficiency	No deficiencies recorded

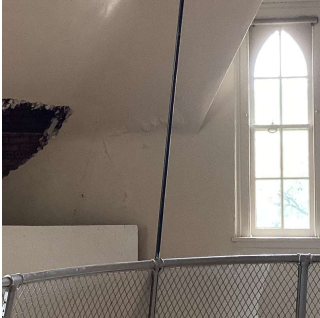
Question	Response
<b>INTERIOR</b>	
<b>MULTI-PURPOSE ROOM</b>	
<b>Walls</b>	
Deficiency Location/Instance	Running Track Near Windows, Near Stage Right
Deficiency Quantity	30
Quantity Uom	S.F.
Potential Action	REPLACE
Urgency of Action	PRIORITY 3
Purpose of Action	LEVEL 2
Deficiency Photo1

Violations	Running Track Near Windows No violations recorded.
<b>Window Curtains/Shades/Blinds</b>	
Instance on 3rd Floor	Does not Exist
<b>SCIENCE DEMO ROOM</b>	
Instance on Room 308	Inspected
Alternative use	Yes
Instance on Room 327	Inspected
Alternative use	Yes
<b>Fixed Equipment</b>	
Instance on Room 308	Inspected
Condition	3 - Fair
Deficiency	CABINETS: MISSING/DAMAGED
Deficiency Location/Instance	Room 308
Deficiency Quantity	10
Quantity Uom	L.F.
Potential Action	REPLACE
Urgency of Action	PRIORITY 3
Purpose of Action	LEVEL 2
Deficiency Photo1	No photo recorded
Violations	No violations recorded.
<b>SCIENCE LAB</b>	
Does not Exist

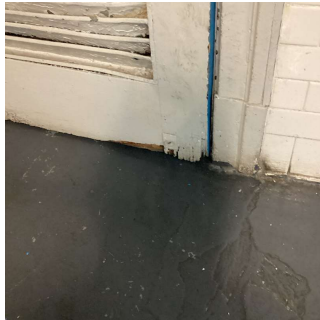
Violations	Basement Boys No violations recorded.
<b>Floor Finish</b>	Inspected
Condition	5 - Poor
Deficiency	CONCRETE: CRACKS
Deficiency Location/Instance	Basement Boys
Deficiency Quantity	20
Quantity Uom	S.F.
Potential Action	REPLACE
Urgency of Action	PRIORITY 3
Purpose of Action	LEVEL 2
Deficiency Photo1

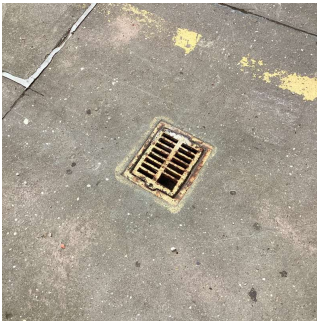
Question	Response
<b>SITE</b>	
<b>Drainage System for Concrete</b>	
<b>Catch Basins/Manhole - Surrounded by concrete</b>	
Deficiency Photo1

Violations	Parking Lot At Exit 2 No violations recorded.
<b>Culverts - Concrete Covering</b>	Does not Exist
<b>Drainage System for Soil</b>	Does not Exist
<b>DRINKING FOUNTAINS</b>	Does not Exist
<b>FENCES</b>	Inspected
Condition	4 - Between Fair and Poor
Deficiency	CHAIN LINK: DAMAGED/DETERIORATED
Deficiency Location/Instance	Halsey Street
Deficiency Quantity	40
Quantity Uom	S.F.
Potential Action	REPLACE
Urgency of Action	PRIORITY 3
Purpose of Action	LEVEL 2
Deficiency Photo1

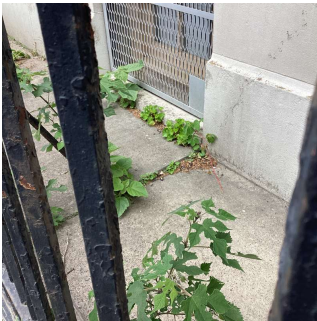
Macon Street
Violations	No violations recorded.
Deficiency	DAMAGED/DETERIORATED/MISSING SECTIONS
Deficiency Location/Instance	Macon Street, Parking Lot
Deficiency Quantity	1,175
Quantity Uom	S.F.
Potential Action	REPLACE

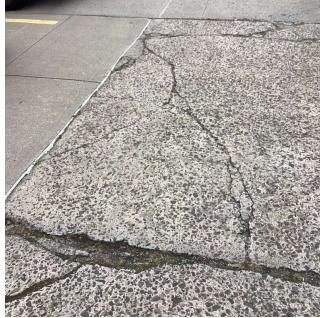
Parking Lot
Violations	No violations recorded.
<b>Pavers</b>	Does not Exist
<b>Student Use</b>	Does not Exist
<b>Site Sidewalks &amp; Walkways</b>	Inspected
<b>Asphalt</b>	Does not Exist
<b>Concrete</b>	Inspected
Condition	2 - Between Good and Fair
Deficiency	DAMAGED/DETERIORATED/MISSING SECTIONS
Deficiency Location/Instance	Nostrand Avenue
Deficiency Quantity	25
Quantity Uom	S.F.
Potential Action	REPLACE
Urgency of Action	PRIORITY 3
Purpose of Action	LEVEL 2
Deficiency Photo1

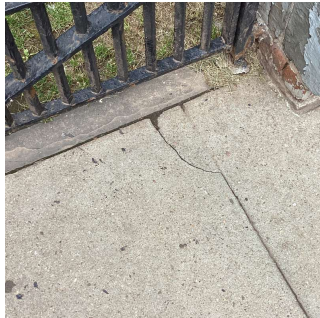
Nostrand Avenue
Violations	No violations recorded.
<b>Pavers</b>	Does not Exist
<b>DOT Sidewalk</b>	Inspected
<b>Asphalt</b>	Does not Exist
<b>Concrete</b>	Inspected
Condition	4 - Between Fair and Poor
Deficiency	HEAVING
Deficiency Location/Instance	Macon Street, Nostrand Avenue
Deficiency Quantity	100
Quantity Uom	S.F.
