NYC Department of Education
Building Condition Assessment Survey 2023 - 2024

Architectural Inspection

K748

Asset: P.S. @ 424 ALBEE SQUARE WEST - BROOKLYN, 424 ALBEE SQUARE WEST, 11201

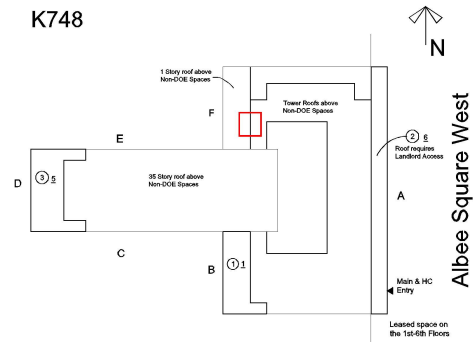
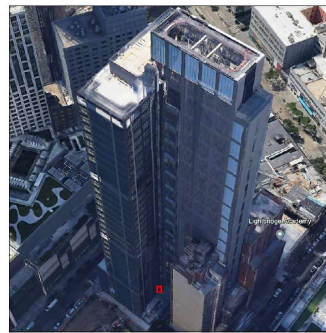
METAL/GLASS CURT WALL: BROKEN GLASS

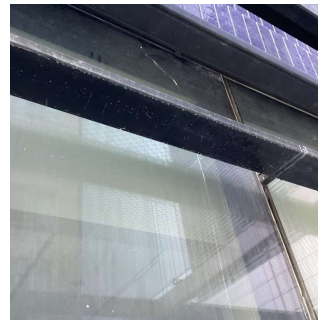
Facade F

Deficiency Quantity

50

Quantity Uom

S.F.

Potential Action

REPLACE

Urgency of Action

PRIORITY 3
