**NYC Department of Education**  
**Building Condition Assessment Survey 2023 - 2024**

Architectural Inspection

**K749**

**Asset:**        **PRE-K CENTER @ 173 25TH STREET - BROOKLYN, 173 25TH STREET, New York, 11232**

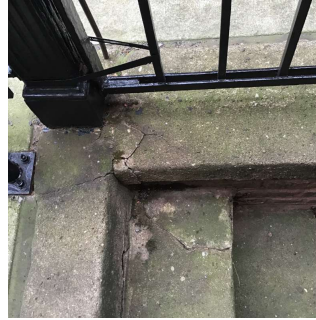
AW2

Question	Response
<b>Architectural</b>	
<b>EXTERIOR</b>	Inspected
<b>AREAWAY</b>	Inspected
Instance on AW1-AW-3	Inspected
Instance Condition	3 - Fair
Instance Quantity	3
Instance Quantity Uom	EACH
Deficiency	AREAWAY WALLS: DETERIORATED COPING STONE
Roof Plan reference

Deficiency Quantity	15
Quantity Uom	S.F.
Potential Action	REPAIR
Urgency of Action	PRIORITY 3
Purpose of Action	LEVEL 2

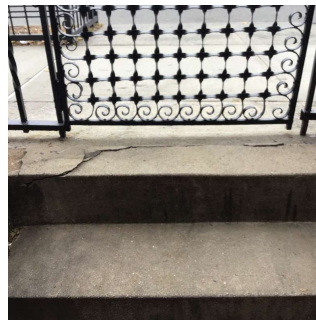
AW1

AREAWAY STAIRS: DETERIORATED TREADS/RISERS/NOSINGS

Deficiency Quantity

80

Potential Action

REPAIR

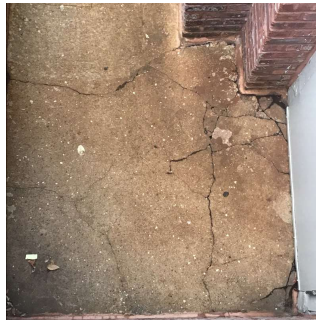
AW3

AREAWAY SLAB: CRACKS AND SPALLING

Deficiency Quantity

100

Potential Action

REPAIR

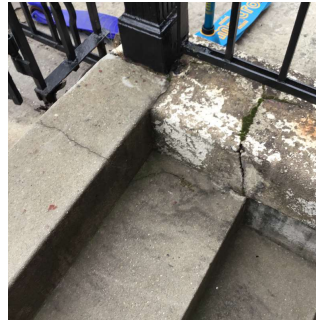
AW1  
No violations recorded.

AREAWAY WALLS: CRACKS AND SPALLING

Deficiency Quantity

15

Potential Action

REPAIR

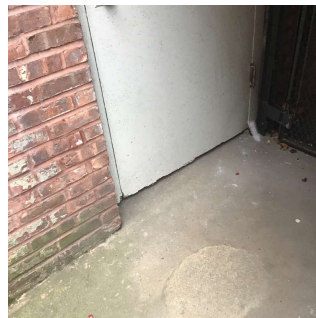
METAL: DETERIORATED DOOR AND FRAME - MAJOR DETERIORATION

REPLACE

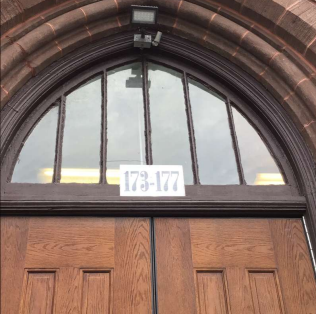
Question	Response
<b>EXTERIOR</b>	
<b>DOORS</b>	
<b>DOORS AND FRAMES</b>	Inspected
	AW2-Exit 7, Exit 2
Violations	No violations recorded.
<b>DOOR HARDWARE</b>	Inspected
Condition	2 - Between Good and Fair
Deficiency	No deficiencies recorded
<b>LINTELS</b>	Inspected
Condition	2 - Between Good and Fair
Deficiency	No deficiencies recorded
<b>TRANSOM/SIDE LIGHT</b>	Inspected
Condition	3 - Fair
Deficiency	WOOD: EXCESSIVELY WEATHERED
Roof Plan reference	<div style="text-align: right;">

</div>
Deficiency Quantity	30
Quantity Uom	S.F.
Potential Action	REPAIR
Urgency of Action	PRIORITY 3
Purpose of Action	LEVEL 2
Deficiency Photo1

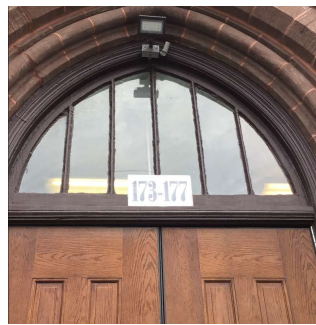
Main Entrance
Violations	No violations recorded.
Deficiency	WOOD: BROKEN GLASS

10  
 S.F.  
 MAINTENANCE  
 PRIORITY 3  
 LEVEL 2

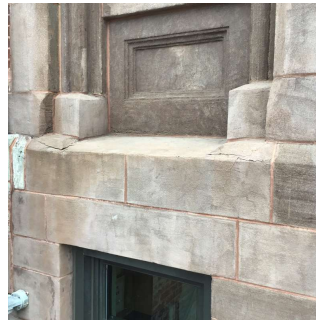
Facade A  
No violations recorded.

STONE: CHIPPED/SPALLED/BROKEN PIECES - MINOR

70  
S.F.  
REPAIR  
PRIORITY 3  
LEVEL 2

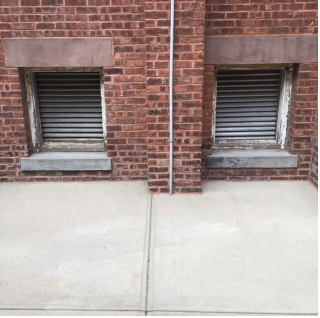
BROKEN/ DENTED BLADES

Violations	Facade D No violations recorded.
<b>PARAPETS</b>	Inspected
Material Type(s)	Masonry
Replacement Quantity	700
Replacement Uom	C.F.
Instance on Roof 2	Inspected
Instance Condition	2 - Between Good and Fair
Instance Quantity	700
Instance Quantity Uom	C.F.
Deficiency	No deficiencies recorded
<b>PLAZA DECK</b>	Does not Exist
<b>ROOF</b>	Inspected
<b>Roofing</b>	Inspected
Replacement Quantity	10,000
Replacement Uom	S.F.
<b>ROOF HATCH/SMOKE HATCH</b>	Does not Exist
<b>LEADERS, GUTTERS, DOWNSPOUTS, SCUPPERS</b>	Inspected
Condition	2 - Between Good and Fair
Deficiency	No deficiencies recorded
<b>ROOF BARRIER/FENCE</b>	Does not Exist
<b>ROOF CAGE</b>	Does not Exist
<b>ROOFING</b>	Inspected
Instance on Asphalt Shingle: Roof 1	Inspected

Deficiency Quantity	20
Quantity Uom	S.F.
Potential Action	REPLACE
Urgency of Action	PRIORITY 4
Purpose of Action	LEVEL 2
Deficiency Photo1

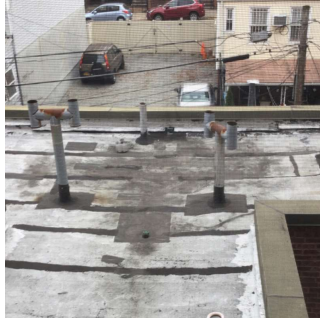
Is/Are the roof(s) suitable for Solar Panel installation?	No
Installation Year	1980
Source of Installation	Custodial Staff
Deficiency	MODIFIED BITUMEN: ROOFING: DELAMINATION
Roof Plan reference

Violations	Roof 2 No violations recorded.
Deficiency	MODIFIED BITUMEN: FLASHING: DETERIORATED JOINTS
Roof Plan reference

Question	Response
<b>EXTERIOR</b>	
<b>ROOF</b>	
<b>Roofing</b>	
<b>ROOFING</b>	
Deficiency Quantity	10
Quantity Uom	S.F.
Potential Action	REPLACE ROOFING WITHOUT MAJOR EQUIPMENT REMOVAL
Urgency of Action	PRIORITY 4
Purpose of Action	LEVEL 2
Deficiency Photo1

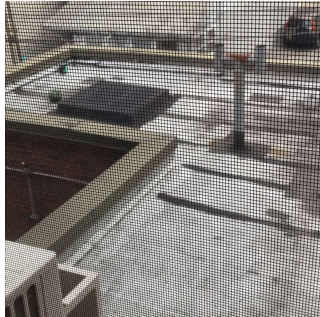
Violations	Roof 2 No violations recorded.
<b>ROOFING DRAINS</b>	
Condition	Inspected
Deficiency	2 - Between Good and Fair No deficiencies recorded

Deficiency Quantity	60
Quantity Uom	L.F.
Potential Action	MAINTENANCE
Urgency of Action	PRIORITY 3
Purpose of Action	LEVEL 2
Deficiency Photo1

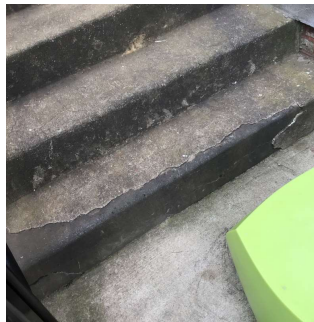
Exit 5  
No violations recorded.

Question	Response
<b>EXTERIOR</b>	
<b>ROOF</b>	Inspected
Specialties	Does not Exist
<b>STAIRS/RAMPS: EXTERIOR</b>	Inspected
<b>BUILDING CHEEK/FLANK WALLS</b>	Inspected
Condition	2 - Between Good and Fair
Deficiency	No deficiencies recorded
<b>RAILINGS</b>	Inspected
Condition	2 - Between Good and Fair
Deficiency	No deficiencies recorded
<b>STAIRS/RAMPS</b>	Inspected
Condition	5 - Poor
Deficiency	CONCRETE: CRACKS/SPALLING - MINOR
Roof Plan reference

20  
S.F.  
REPAIR  
PRIORITY 3  
LEVEL 2

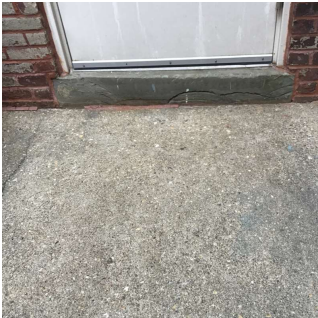
Violations	Exit 4 No violations recorded.
Deficiency	CONCRETE: CRACKS/SPALLING - MAJOR
Roof Plan reference

Question	Response
<b>EXTERIOR</b>	
<b>STAIRS/RAMPS: EXTERIOR</b>	Inspected
<b>STAIRS/RAMPS</b>	
Deficiency Quantity	10
Quantity Uom	S.F.
Potential Action	REPLACE
Urgency of Action	PRIORITY 4
Purpose of Action	LEVEL 2
Deficiency Photo1

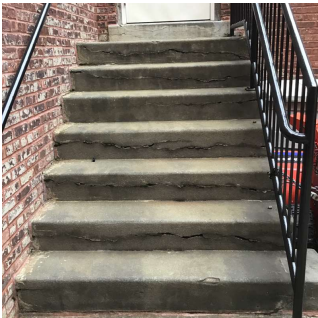
Violations	Exit 3, Main Entrance No violations recorded.
<b>WINDOWS</b>	Inspected
Replacement Quantity	1,800
Replacement Uom	S.F.
<b>EXTERIOR GUARDS</b>	Inspected

Deficiency Quantity	150
Quantity Uom	S.F.
Potential Action	REPLACE
Urgency of Action	PRIORITY 4
Purpose of Action	LEVEL 2
Deficiency Photo1

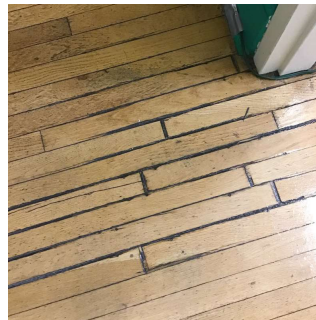
Corridor near Room 102

WOOD: DAMAGED/DETERIORATED

REPLACE

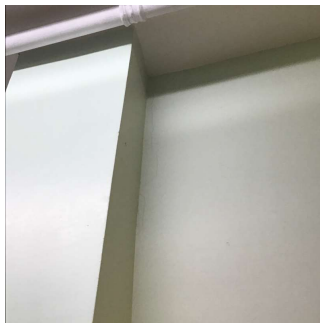
PLASTER: CRACKS/SPALLING

Violations	Corridor near Room 106 No violations recorded.
<b>Specialties</b>	Does not Exist
<b>GYMNASIUM</b>	Does not Exist
<b>INTERIOR DOOR HARDWARE</b>	Inspected
Condition	2 - Between Good and Fair
Deficiency	No deficiencies recorded
<b>INTERIOR GUARDS</b>	Inspected
Condition	2 - Between Good and Fair
Deficiency	No deficiencies recorded
<b>KITCHEN</b>	Inspected
Instance on Basement	Inspected
<b>Ceiling</b>	
Instance on Basement	Inspected
Condition	2 - Between Good and Fair
Deficiency	No deficiencies recorded
<b>Door(s)</b>	
Instance on Basement	Inspected
Condition	2 - Between Good and Fair
Deficiency	No deficiencies recorded
<b>Floor Finish</b>	
Instance on Basement	Inspected
Condition	2 - Between Good and Fair
Deficiency	No deficiencies recorded
<b>Walls</b>	
Instance on Basement	Inspected
Condition	2 - Between Good and Fair

REPLACE

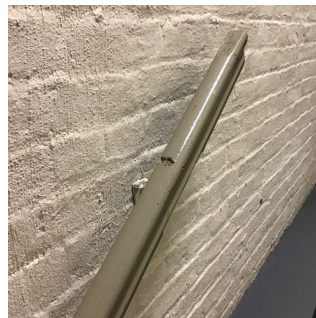
Condition	4 - Between Fair and Poor
-----------	---------------------------

Deficiency	METAL: DAMAGED
------------	----------------

Deficiency Location/Instance	Stairs C/1, D/1
------------------------------	-----------------

Potential Action	REPLACE
------------------	---------

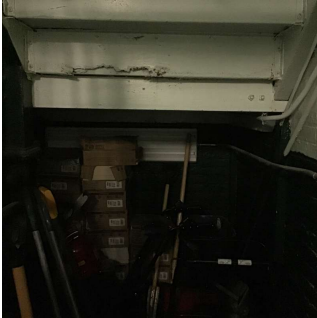
Violations	No violations recorded.
Deficiency	METAL: RUST - MAJOR
Deficiency Location/Instance	Stair B/Basement
Deficiency Quantity	10
Quantity Uom	S.F.
Potential Action	REPLACE
Urgency of Action	PRIORITY 3
Purpose of Action	LEVEL 2
Deficiency Photo1

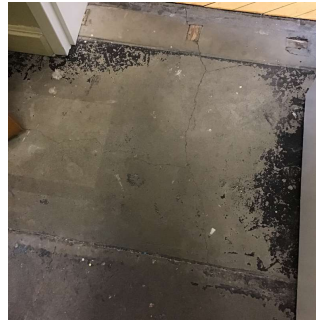
Stair B/3

Violations	No violations recorded.
Deficiency	CONCRETE: CRACKS/SPALLING - MAJOR
Deficiency Location/Instance	Stair B/Basement, 3
Deficiency Quantity	20
Quantity Uom	S.F.
Potential Action	REPLACE
Urgency of Action	PRIORITY 3

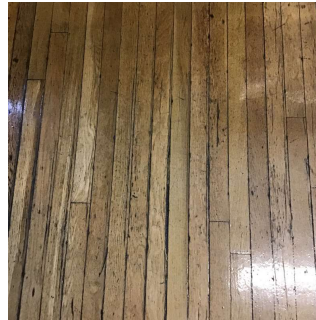
Stair A/1

**WOOD: BROKEN/DETERIORATED**

REPLACE

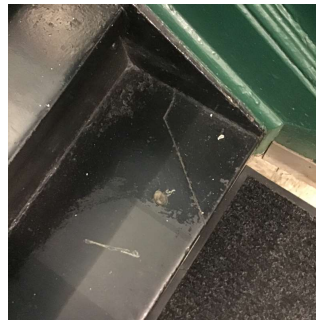
Stair A/Basement

**STONE: BROKEN/MISSING**

REPLACE

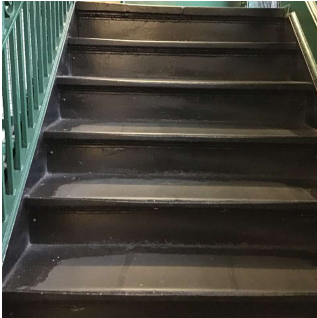
Question	Response
<b>INTERIOR</b>	
<b>STAIRS/RAMPS: INTERIOR</b>	
<b>Stairs and Landings</b>	
Deficiency	STONE: WORN-OUT TREAD/NOSINGS
Deficiency Location/Instance	Stairs A/Basement,1,2, B/2
Deficiency Quantity	70
Quantity Uom	S.F.
Potential Action	REPLACE
Urgency of Action	PRIORITY 3
Purpose of Action	LEVEL 2
Deficiency Photo1

Violations	Stair A/Basement No violations recorded.
<b>Walls</b>	Inspected
Condition	2 - Between Good and Fair
Deficiency	PLASTER: CRACKS/SPALLING
Deficiency Location/Instance	Stair A/1
Deficiency Quantity	10
Quantity Uom	S.F.
Potential Action	REPLACE
Urgency of Action	PRIORITY 3
Purpose of Action	LEVEL 2
Deficiency Photo1

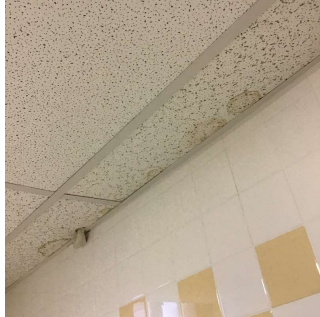
Violations	Stair A/1 No violations recorded.
<b>TOILET ROOMS - STAFF</b>	
Inspected	
<b>Ceiling</b>	
Inspected	
Condition	3 - Fair
Deficiency	ACOUSTIC TILES: DAMAGED/MISSING
Deficiency Location/Instance	Room 008
Deficiency Quantity	10
Quantity Uom	S.F.
Potential Action	REPLACE

Room 008
Violations	No violations recorded.
<b>Door(s)</b>	Inspected
Condition	5 - Poor
Deficiency	WOOD: DETERIORATED DOOR
Deficiency Location/Instance	Rooms 008, 301
Deficiency Quantity	2
Quantity Uom	EACH
Potential Action	MAINTENANCE
Urgency of Action	PRIORITY 3
Purpose of Action	LEVEL 2
Deficiency Photo1

Urgency of Action	PRIORITY 3
