**NYC Department of Education**  
**Building Condition Assessment Survey 2023 - 2024**

Architectural Inspection

K751

Asset: **PRE-K CENTER @ 131 UNION STREET - BROOKLYN, 131 UNION STREET, New York, 11231**

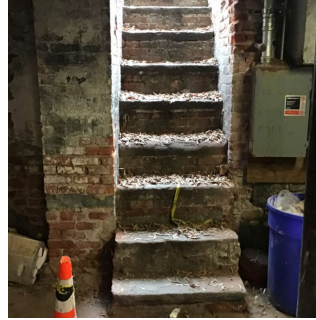
Question	Response
<b>Architectural</b>	
<b>EXTERIOR</b>	Inspected
<b>AREAWAY</b>	Inspected
Instance on AW1	Inspected
Instance Condition	3 - Fair
Instance Quantity	1
Instance Quantity Uom	EACH
Deficiency	AREAWAY STAIRS: DETERIORATED TREADS/RISERS/NOSINGS
Roof Plan reference	
Deficiency Quantity	50
Quantity Uom	S.F.
Potential Action	REPAIR
Urgency of Action	PRIORITY 3
Purpose of Action	LEVEL 2

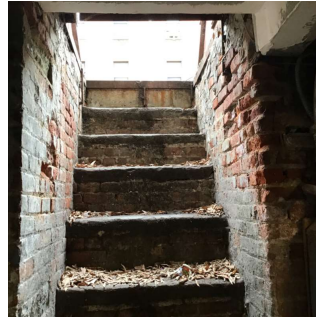
AW1

AREAWAY WALLS: CRACKS AND SPALLING

Potential Action

REPAIR

Urgency of Action

PRIORITY 3

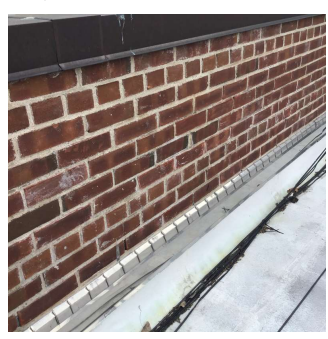
Question	Response
<b>EXTERIOR</b>	
<b>EXTERIOR WALLS</b>	Inspected
Deficiency	No deficiencies recorded
<b>EXTERIOR SOFFITS</b>	Does not Exist
<b>LOADING DOCK</b>	Does not Exist
<b>LOUVER</b>	Does not Exist
<b>PARAPETS</b>	Inspected
Material Type(s)	Masonry
Replacement Quantity	650
Replacement Uom	C.F.
Instance on Roof 1	Inspected
Instance Condition	3 - Fair
Instance Quantity	650
Instance Quantity Uom	C.F.
Deficiency	BRICK: DETERIORATED JOINTS
Roof Plan reference

Deficiency Quantity	20
Quantity Uom	S.F.
Potential Action	REPOINT
Urgency of Action	PRIORITY 3
Purpose of Action	LEVEL 2
Deficiency Photo1

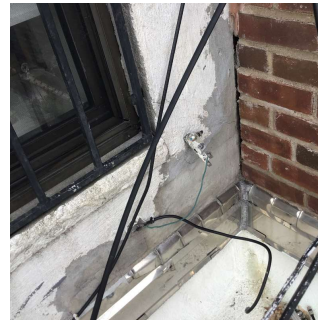
Roof 1  
No violations recorded.

Violations	Roof No violations recorded.
Deficiency	BRICK: DETERIORATED CONTROL/EXPANSION JOINT

10  
L.F.  
MAINTENANCE  
PRIORITY 3  
LEVEL 2

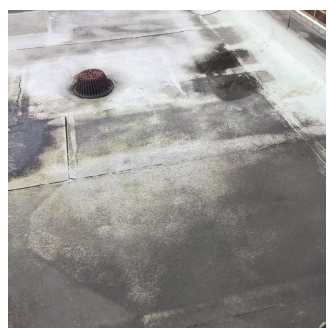
Question	Response
<b>EXTERIOR</b>	
<b>ROOF</b>	
<b>Roofing</b>	
<b>ROOFING</b>	
Instance Quantity	2,000
Instance Quantity Uom	S.F.
Does the roof have major mechanical equipment sitting on Dunnage Steel less than 18" above the Roofing?	No
Does this roof instance have a Sustainable Roof System?	Yes
Sustainable Roof Type	White Roof
Sustainable Roof Location (Roof Number)	Roof 1
Do solar panels exist on these roofs?	No
Is/Are the roof(s) suitable for Solar Panel installation?	No
Installation Year	2016
Source of Installation	Custodial Staff
Deficiency	MODIFIED BITUMEN: ROOFING: DELAMINATION
Roof Plan reference

Deficiency Quantity	250
Quantity Uom	S.F.
Potential Action	REPLACE ROOFING WITHOUT MAJOR EQUIPMENT REMOVAL
Urgency of Action	PRIORITY 4
Purpose of Action	LEVEL 2
Deficiency Photo1
