NYC Department of Education
Building Condition Assessment Survey 2023 - 2024

Architectural Inspection

Asset: **PRE-K CENTER @ 1355 84TH STREET - BROOKLYN, 1355 84TH STREET, New York, 11228**

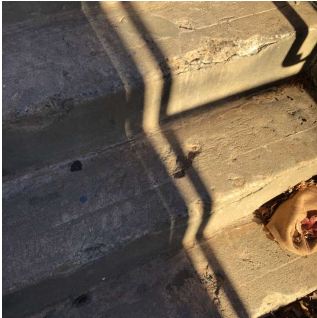
Question	Response
Architectural	
EXTERIOR	Inspected
AREAWAY	Inspected
Instance on AW1	Inspected
Instance Condition	4 - Between Fair and Poor
Instance Quantity	1
Instance Quantity Uom	EACH
Deficiency	AREAWAY STAIRS: DETERIORATED TREADS/RISERS/NOSINGS
Roof Plan reference	
Deficiency Quantity	20
Quantity Uom	S.F.
Potential Action	REPLACE
Urgency of Action	PRIORITY 4
Purpose of Action	LEVEL 2

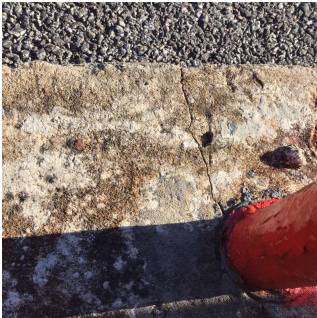
Violations	AW1 No violations recorded.
Deficiency	AREAWAY WALLS: CRACKS AND SPALLING
Roof Plan reference

Deficiency Quantity	10
Quantity Uom	S.F.
Potential Action	REPLACE
Urgency of Action	PRIORITY 4
Purpose of Action	LEVEL 2
Deficiency Photo1

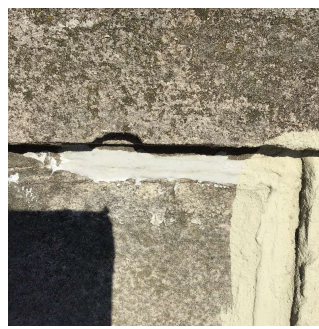
Violations	AW1 No violations recorded.
AWNINGS AND CANOPIES	Does not Exist
CHIMNEY	Inspected
Material Type(s)	Masonry
Condition	2 - Between Good and Fair
Deficiency	No deficiencies recorded
COPING	Inspected
Condition	3 - Fair
Deficiency	CAST STONE: CRACKED/BROKEN PIECES

84th Street
Deficiency Quantity	10
Quantity Uom	L.F.
Potential Action	REPLACE-IN-KIND
Urgency of Action	PRIORITY 4
Purpose of Action	LEVEL 2
Deficiency Photo1

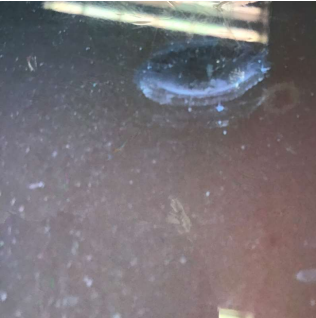
Violations	Roof 1 No violations recorded.
CORNICE	Inspected
Condition	2 - Between Good and Fair
Deficiency	No deficiencies recorded
DOORS	Inspected
DOORS AND FRAMES	Inspected
Condition	2 - Between Good and Fair
Deficiency	No deficiencies recorded
DOOR HARDWARE	Inspected
Condition	2 - Between Good and Fair
Deficiency	No deficiencies recorded
LINTELS	Inspected
Condition	2 - Between Good and Fair
Deficiency	No deficiencies recorded
TRANSOM/SIDE LIGHT	Inspected
Condition	3 - Fair
Deficiency	METAL: BROKEN GLASS

84th Street
Deficiency Quantity	30
Quantity Uom	S.F.
Potential Action	MAINTENANCE
Urgency of Action	PRIORITY 3
Purpose of Action	LEVEL 2
Deficiency Photo1

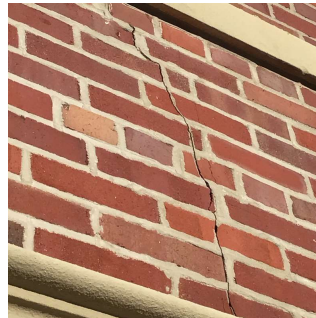
Facade A
Violations	No violations recorded.
EXTERIOR WALLS	Inspected
Material Type(s)	Masonry
Replacement Quantity	10,000
Replacement Uom	S.F.
Instance on All Facades	Inspected
Instance Condition	4 - Between Fair and Poor
Instance Quantity	10,000
Instance Quantity Uom	S.F.
Deficiency	BRICK: MAJOR / THRU CRACKS
Roof Plan reference

Deficiency Quantity

30

REMOVE AND REBUILD

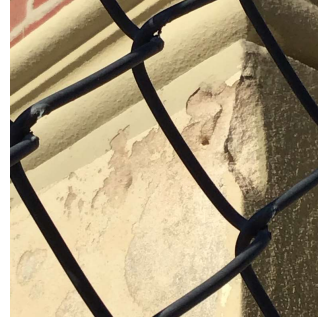
Facade A

STONE: CHIPPED/SPALLED/BROKEN PIECES - MAJOR

REPLACE

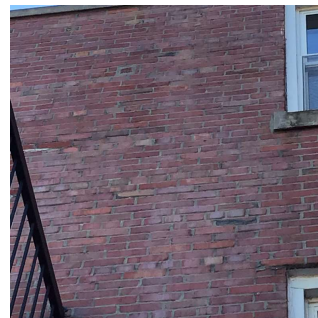
Facade C

BRICK: DETERIORATED JOINTS

REPOINT

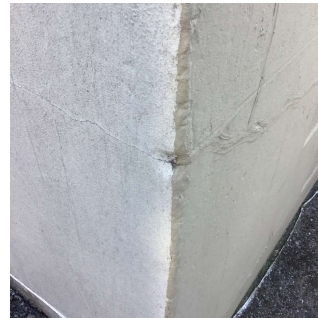
Facade B

STONE: CRACKS AT BUILDING CORNERS

REPLACE

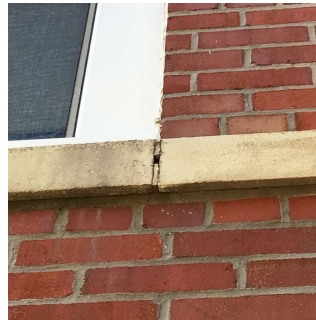
Facade B

STONE: DETERIORATED JOINTS

REPOINT

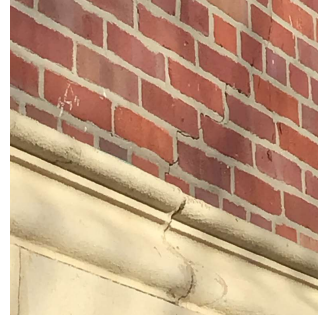
Facade A

BRICK: MINOR CRACKS AND SPALLING

RESTITCH

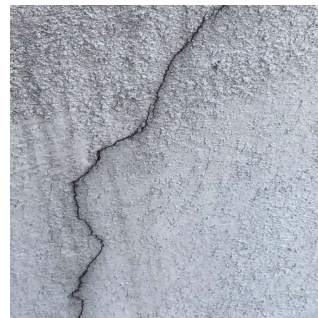
Facade C

STONE: CHIPPED/SPALLED/BROKEN PIECES - MINOR

REPAIR

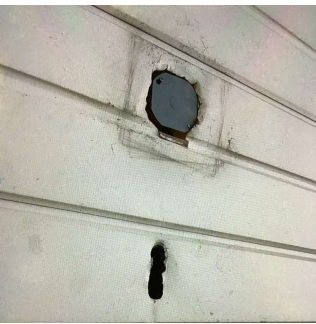
Question	Response
EXTERIOR	
EXTERIOR WALLS	Inspected
Violations	No violations recorded.
EXTERIOR SOFFITS	Inspected
Condition	3 - Fair
Deficiency	METAL: DETERIORATION/DAMAGED/MISSING PIECES
Roof Plan reference

Deficiency Quantity	20
Quantity Uom	S.F.
Potential Action	REPLACE
Urgency of Action	PRIORITY 4
Purpose of Action	LEVEL 2
Deficiency Photo1

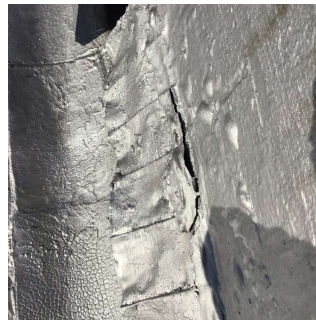
Roof 1
No violations recorded.

Deficiency Quantity	60
Quantity Uom	S.F.
Potential Action	REPLACE ROOFING WITHOUT MAJOR EQUIPMENT REMOVAL
Urgency of Action	PRIORITY 4
Purpose of Action	LEVEL 2
Deficiency Photo1	 
	Roof 1
Violations	No violations recorded.
Deficiency	MODIFIED BITUMEN: FLASHING: BASE FLASHING DETERIORATED

10
S.F.
REPLACE
PRIORITY 4
LEVEL 2

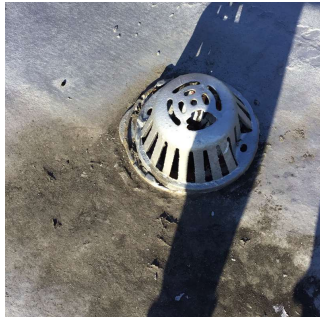
3 - Fair
DETERIORATED

1
EACH
REPLACE
PRIORITY 4
LEVEL 2

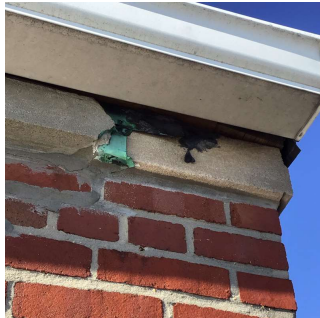
Violations	Roof 1 No violations recorded.
Specialties	Inspected
BULKHEAD/PENTHOUSE	Inspected
Condition	3 - Fair
Deficiency	BULKHEAD/PENTHOUSE WALLS/EXTERIOR: CRACKS/SPALLING - MAJOR
Roof Plan reference

Deficiency Quantity	20
Quantity Uom	S.F.
Potential Action	REPLACE
Urgency of Action	PRIORITY 4
Purpose of Action	LEVEL 2
Deficiency Photo1

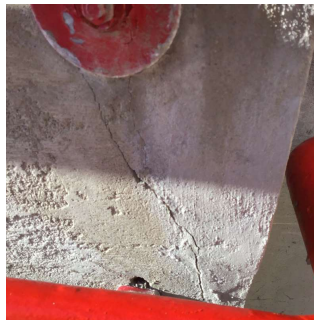
Facade A

Deficiency	CAST IN PLACE CONCRETE: CRACKS/SPALLING - MAJOR
------------	---

REPLACE

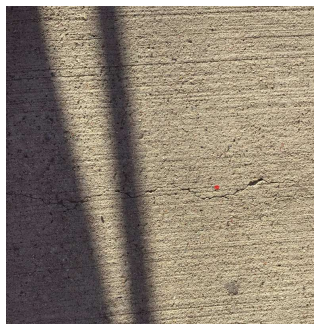
Facade A

Question	Response
EXTERIOR	
STAIRS/RAMPS: EXTERIOR	Inspected
STAIRS/RAMPS	
Deficiency Quantity	10
Quantity Uom	S.F.
Potential Action	REPLACE
Urgency of Action	PRIORITY 4
Purpose of Action	LEVEL 2
Deficiency Photo1	 
	Facade C
Violations	No violations recorded.
Deficiency	STONE: WATER INFILTRATION IN INSTRUCTIONAL SPACE BELOW
Roof Plan reference	  <p>K762</p> <p>83rd Street</p> <p>84th Street</p>
Deficiency Quantity	100
Quantity Uom	S.F.
Potential Action	INSTALL NEW
Urgency of Action	PRIORITY 5
Purpose of Action	LEVEL 2
Deficiency Photo1	 
	Facade C - Exit 3 Exterior Stairs - Room 113
Violations	No violations recorded.
Deficiency	CONCRETE: CRACKS/SPALLING - MINOR

15
S.F.
REPAIR
PRIORITY 3
LEVEL 2

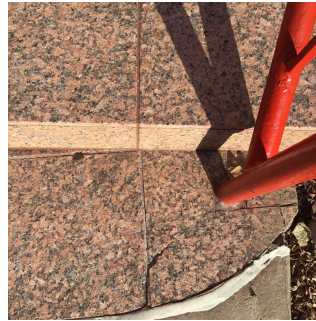
Facade A

STONE: CRACKS/SPALLING - MAJOR

10
S.F.
REPLACE
PRIORITY 4
LEVEL 2

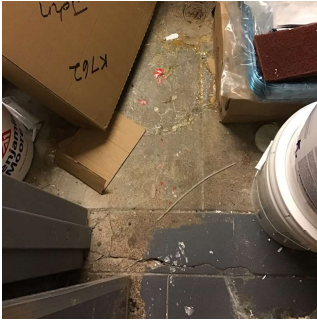
Question	Response
INTERIOR	
STRUCTURAL	
COLUMNS/BEAMS/BEARING WALLS	Inspected
Violations	No violations recorded.
FLOOR STRUCTURE	Inspected
Condition	3 - Fair
Deficiency	CONCRETE SLAB ON GRADE: THRU CRACKS
Deficiency Location/Instance	Room 119
Deficiency Quantity	10
Quantity Uom	S.F.
Potential Action	REPLACE
Urgency of Action	PRIORITY 4
Purpose of Action	LEVEL 5
Deficiency Photo1

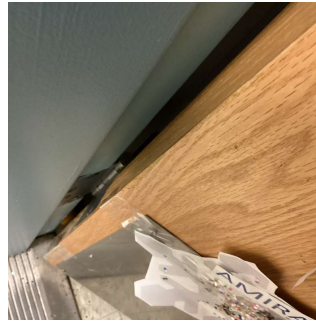
Violations	Room 119 No violations recorded.
FOUNDATION WALLS	Inspected
Material Type(s)	Concrete
Condition	2 - Between Good and Fair
Deficiency	No deficiencies recorded
ROOF STRUCTURE	Inspected
Condition	2 - Between Good and Fair
Deficiency	No deficiencies recorded
VAULTS-BUNKERS	Does not Exist
AUDITORIUM	Does not Exist
CAFETERIA	Does not Exist
CLASSROOMS/CORRIDORS/ADMIN SPACES	Inspected
Ceiling	Inspected
Condition	2 - Between Good and Fair
Deficiency	No deficiencies recorded
Door(s)	Inspected
Condition	4 - Between Fair and Poor
Deficiency	WOOD: DETERIORATED DOOR

Deficiency Location/Instance	Room 112
Deficiency Quantity	1
Quantity Uom	EACH
Potential Action	MAINTENANCE
Urgency of Action	PRIORITY 3
Purpose of Action	LEVEL 2

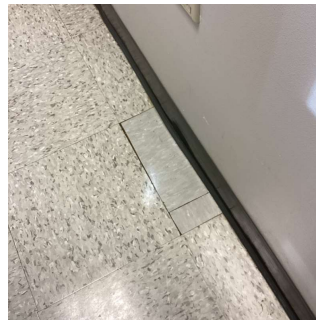
Room 125

VINYL TILES: BROKEN/DETERIORATED/MISSING TILES

REPLACE

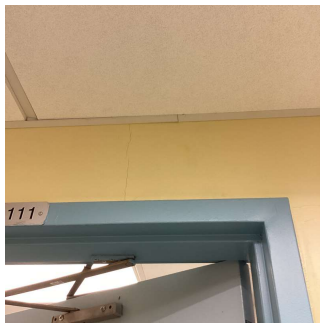
GYPSUM BOARD: DETERIORATED

REPLACE

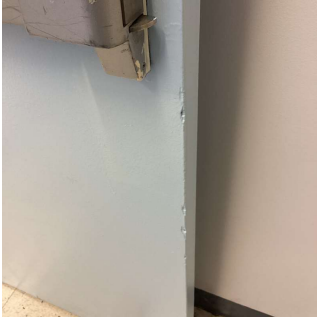
Question	Response
INTERIOR	
MULTI-PURPOSE ROOM	
Fixed Equipment	
Instance on Room 310	Does not Exist
Floor Finish	
Instance on Room 310	Inspected
Condition	2 - Between Good and Fair
Deficiency	No deficiencies recorded
Sliding-folding Partition	
Instance on Room 310	Does not Exist
Stage	
Instance on Room 310	Does not Exist
Walls	
Instance on Room 310	Inspected
Condition	2 - Between Good and Fair
Deficiency	No deficiencies recorded
Window Curtains/Shades/Blinds	
Instance on Room 310	Does not Exist
SCIENCE DEMO ROOM	Does not Exist
SCIENCE LAB	Does not Exist
SCIENCE PREP ROOM	Does not Exist
SHOWER ROOM	Does not Exist
STAIRS/RAMPS: INTERIOR	Inspected
Do Letter Stair Signs Exist?	Yes
Ceiling	
Condition	2 - Between Good and Fair
Deficiency	No deficiencies recorded
Door(s)	
Condition	4 - Between Fair and Poor
Deficiency	WOOD: DETERIORATED DOOR
Deficiency Location/Instance	Stair B/2
Deficiency Quantity	1
Quantity Uom	EACH
Potential Action	MAINTENANCE

Urgency of Action	PRIORITY 3
Purpose of Action	LEVEL 2
Deficiency Photo1

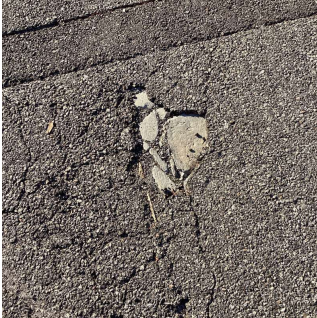
Near Exit 5
Violations	No violations recorded.
Deficiency	CRACKS - MAJOR
Deficiency Location/Instance	Near Exits 3,4,5
Deficiency Quantity	400
Quantity Uom	S.F.
Potential Action	REPLACE
Urgency of Action	PRIORITY 3
Purpose of Action	LEVEL 2
Deficiency Photo1

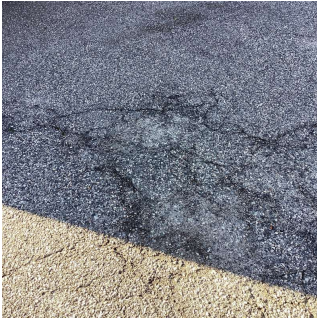
Near Exit 4
Violations	No violations recorded.
Concrete	Inspected
Condition	2 - Between Good and Fair
Deficiency	No deficiencies recorded
Pavers	Does not Exist
Student Use	Does not Exist
Site Sidewalks & Walkways	Inspected
Asphalt	Does not Exist
Concrete	Inspected
Condition	3 - Fair
Deficiency	DAMAGED/DETERIORATED/MISSING SECTIONS
Deficiency Location/Instance	West walkway
Deficiency Quantity	150
Quantity Uom	S.F.
Potential Action	REPLACE
Urgency of Action	PRIORITY 3
Purpose of Action	LEVEL 2

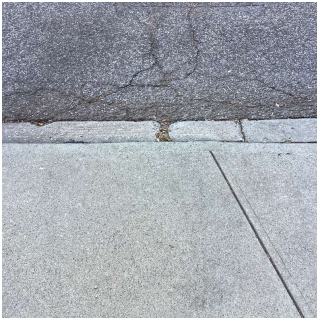
Question	Response
SITE	
PAVING	
Site Sidewalks & Walkways	
Concrete	
Deficiency Photo1	 
Violations	West walkway No violations recorded.
Pavers	Does not Exist
DOT Sidewalk	Inspected
Asphalt	Does not Exist
Concrete	Inspected
Condition	3 - Fair
Deficiency	DAMAGED CURBS
Deficiency Location/Instance	84th Street
Deficiency Quantity	40
Quantity Uom	L.F.
Potential Action	REPLACE
Urgency of Action	PRIORITY 3
Purpose of Action	LEVEL 2
Deficiency Photo1

Violations	84th Street No violations recorded.
Deficiency	DAMAGED/DETERIORATED/MISSING SECTIONS
Deficiency Location/Instance	84th Street
Deficiency Quantity	100
Quantity Uom	S.F.
Potential Action	REPLACE
Urgency of Action	PRIORITY 3
Purpose of Action	LEVEL 2

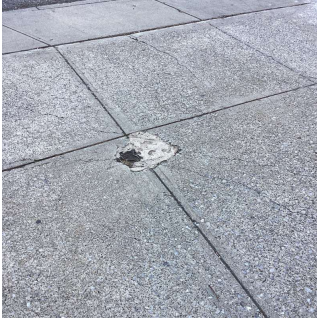
84th Street
Violations	No violations recorded.
Pavers	Does not Exist
PLAYGROUNDS	Inspected
Instance on 84th Street - East	Inspected
Instance on 84th Street - West	Inspected
Benches	
Instance on 84th Street - West	Does not Exist
Instance on 84th Street - East	Does not Exist
Fence	
Instance on 84th Street - West	Inspected
Condition	2 - Between Good and Fair
Deficiency	No deficiencies recorded
Instance on 84th Street - East	Inspected
Condition	2 - Between Good and Fair
Deficiency	No deficiencies recorded
Pavement	
Instance on 84th Street - West	Does not Exist
Instance on 84th Street - East	Does not Exist
Play Equipment	
Instance on 84th Street - West	Inspected
Condition	2 - Between Good and Fair
Deficiency	No deficiencies recorded
Instance on 84th Street - East	Does not Exist
Safety Surfacing	
Instance on 84th Street - East	Inspected
Condition	2 - Between Good and Fair
