NYC Department of Education
Building Condition Assessment Survey 2023 - 2024

Architectural Inspection

Asset: **P.S. 118 MAURICE SENDAK COMMUNITY SCHOOL - BROOKLYN, 211 8TH STREET,
New York, 11215**

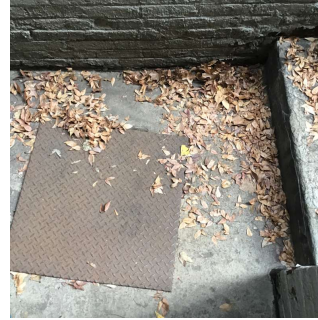
AW1

AREAWAY WALLS: CRACKS AND SPALLING

REPAIR

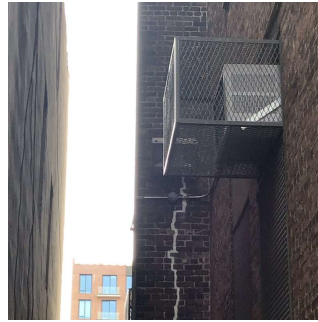
Chimney - Facade M

Violations	No violations recorded.
AWNINGS AND CANOPIES	Does not Exist
CHIMNEY	Inspected
Material Type(s)	Masonry
Condition	3 - Fair
Deficiency	BRICK: MINOR CRACKS AND SPALLING
Roof Plan reference

Deficiency Quantity	35
Quantity Uom	S.F.
Potential Action	RESTITCH
Urgency of Action	PRIORITY 3
Purpose of Action	LEVEL 2

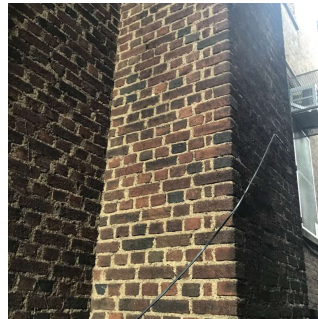
Chimney

BRICK: DETERIORATED JOINTS

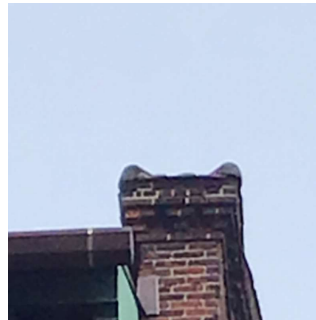
Facade H
 No violations recorded.

TERRA COTTA: DETERIORATED BED JOINT

10
 L.F.
 REPOINT
 PRIORITY 3
 LEVEL 2

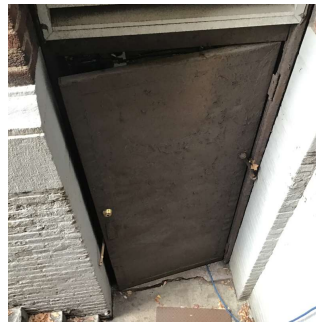
AW1-Door

DOORS AND FRAMES	Inspected
Condition	5 - Poor
Deficiency	METAL CLAD: DETERIORATED DOOR - MAJOR DETERIORATION

3
 EACH
 REPLACE
 PRIORITY 4
 LEVEL 2

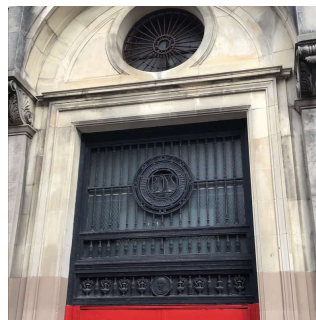
Main Entrance

METAL: DENTED, MAJOR RUSTING

REPLACE

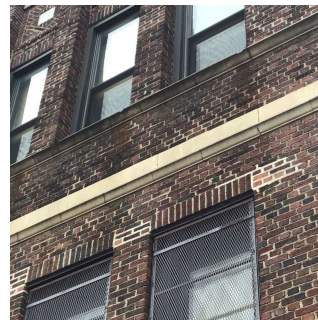
Violations	Facade D - Room 209 shown, Facade G - Room 218 similar No violations recorded.
Deficiency	STONE: CHIPPED/SPALLED/BROKEN PIECES - MINOR

REPAIR

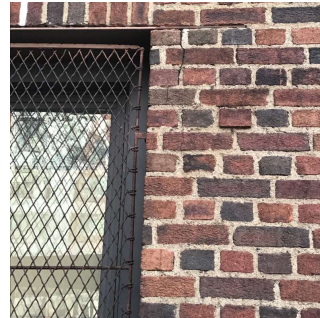
Facade B

BRICK: MINOR CRACKS AND SPALLING

PRIORITY 3
LEVEL 2

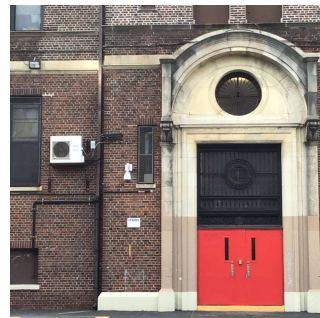
Facade G

BRICK: DETERIORATED JOINTS

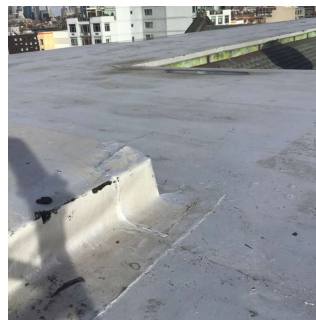
Roof 1
No violations recorded.

Instance Condition	3 - Fair
Instance Photo	 
	Roof 1
Instance Quantity	4,000
Instance Quantity Uom	S.F.
Does the roof have major mechanical equipment sitting on Dunnage Steel less than 18" above the Roofing?	No
Does this roof instance have a Sustainable Roof System?	No
Do solar panels exist on these roofs?	No
Is/Are the roof(s) suitable for Solar Panel installation?	No
Installation Year	2005
Source of Installation	Custodial Staff
Deficiency	SINGLE PLY, FULLY ADHERED ROOF: ROOFING: OPEN SEAMS

10
L.F.
REPAIR
PRIORITY 4
LEVEL 2

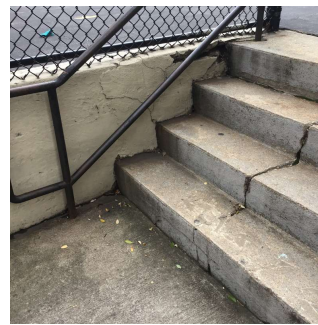
Facade G

ROOFING DRAINS	Does not Exist
Specialties	Inspected
BULKHEAD/PENTHOUSE	Does not Exist
CUPOLA/ SPIRES/ TOWERS	Does not Exist
DORMER	Inspected
Condition	2 - Between Good and Fair
Deficiency	No deficiencies recorded
DUNNAGE STEEL	Does not Exist
SKYLIGHT/ROOF VENT	Does not Exist
ROOF/GRAVITY TANK	Does not Exist
STAIRS/RAMPS: EXTERIOR	Inspected
BUILDING CHEEK/FLANK WALLS	Inspected
Condition	4 - Between Fair and Poor
Deficiency	CAST IN PLACE CONCRETE: CRACKS/SPALLING - MAJOR

20
S.F.
REPLACE
PRIORITY 4
LEVEL 2

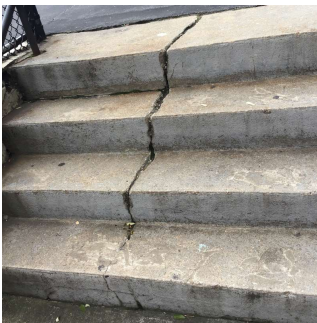
CONCRETE: CRACKS/SPALLING - MAJOR

50
S.F.
REPLACE
PRIORITY 4
LEVEL 2

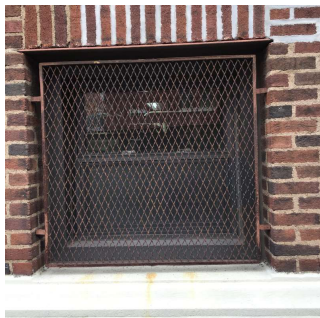
Violations	Facade G No violations recorded.
WINDOWS	
Replacement Quantity	Inspected 4,000
Replacement Uom	S.F.
EXTERIOR GUARDS	
Condition	Inspected 5 - Poor
Deficiency	RUST - MAJOR
Roof Plan reference	K763

Deficiency Quantity	600
Quantity Uom	S.F.
Potential Action	REPLACE
Urgency of Action	PRIORITY 4
Purpose of Action	LEVEL 2

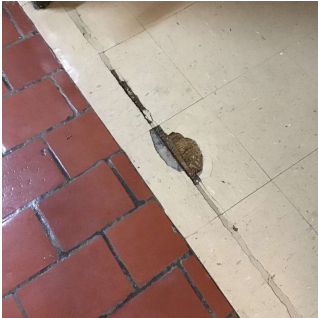
No	Tripping Hazard	Severely damaged floor and substrate is a potential tripping hazard.	INTERIOR CLASSROOMS /CORRIDORS/ ADMIN SPACES Floor Finish	Corridor near Toilet Room 208, Room 209	Jorge Rodriguez	Fireman

Question	Response
INTERIOR	
CLASSROOMS/CORRIDORS/ADMIN SPACES	
Door(s)	Inspected
	Room 309
Violations	No violations recorded.
Floor Finish	Inspected
Condition	2 - Between Good and Fair
Deficiency	VINYL TILES: DETERIORATED SUBSTRATE
Deficiency Location/Instance	Corridor near Toilet Room 208, Room 209
Deficiency Quantity	40
Quantity Uom	S.F.
Potential Action	REPLACE
Urgency of Action	PRIORITY 5
Purpose of Action	LEVEL 6
Deficiency Photo1

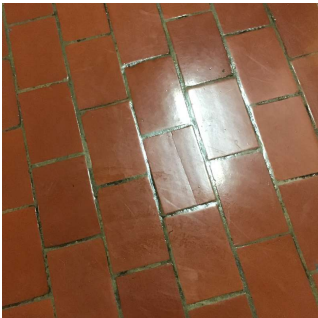
Corridor near Toilet Room 208
Violations	No violations recorded.
Deficiency	QUARRY TILE: BROKEN/MISSING TILES
Deficiency Location/Instance	Corridor near Rooms 109, 309
Deficiency Quantity	20
Quantity Uom	S.F.
Potential Action	REPLACE
Urgency of Action	PRIORITY 3
Purpose of Action	LEVEL 2
Deficiency Photo1

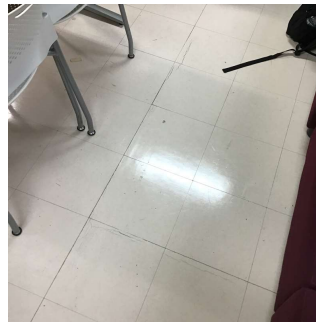
Room 109

Corridor near Room 309
Violations	No violations recorded.
Deficiency	VINYL TILES: DETERIORATED SUBSTRATE
Deficiency Location/Instance	Rooms 109, 117, 202, 301, 302, and others

Deficiency Quantity	250
Quantity Uom	S.F.
Potential Action	REPLACE
Urgency of Action	PRIORITY 3
Purpose of Action	LEVEL 2

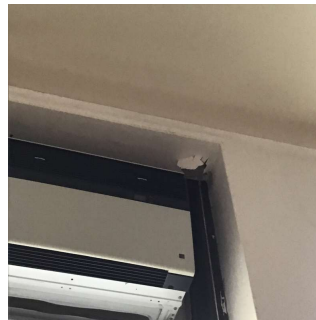
Room 209

PLASTER: CRACKS/SPALLING - ACTIVE LEAK

REPLACE

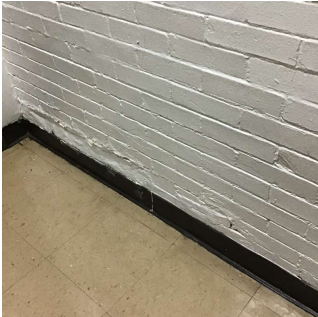
Question	Response
INTERIOR	
CLASSROOMS/CORRIDORS/ADMIN SPACES	
Walls	
Violations	Corridor near Room 109 No violations recorded.
Deficiency	BRICK: CRACKS/SPALLING
Deficiency Location/Instance	Room B01
Deficiency Quantity	15
Quantity Uom	S.F.
Potential Action	REPLACE
Urgency of Action	PRIORITY 3
Purpose of Action	LEVEL 2
Deficiency Photo1

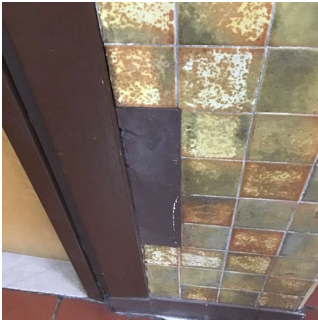
Violations	Room B01 No violations recorded.
Deficiency	CERAMIC TILE: BROKEN/ MISSING
Deficiency Location/Instance	Corridor near Rooms 104, 208, 213, 309
Deficiency Quantity	40
Quantity Uom	S.F.
Potential Action	REPLACE
Urgency of Action	PRIORITY 3
Purpose of Action	LEVEL 2
Deficiency Photo1

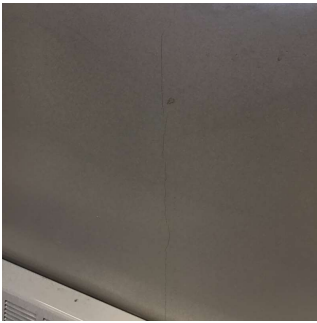
Violations	Corridor near Room 309 No violations recorded.
Deficiency	GYPSUM BOARD: DETERIORATED
Deficiency Location/Instance	Room 401
Deficiency Quantity	10
Quantity Uom	S.F.
Potential Action	REPLACE
Urgency of Action	PRIORITY 3
Purpose of Action	LEVEL 2

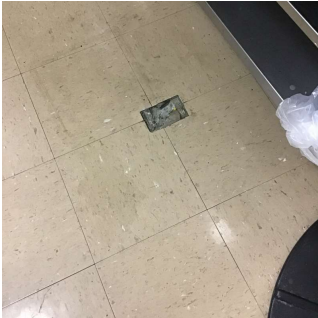
Question	Response
INTERIOR	
KITCHEN	
Floor Finish	
Deficiency	VINYL TILES: DETERIORATED SUBSTRATE
Deficiency Location/Instance	Serving Area
Deficiency Quantity	20
Quantity Uom	S.F.
Potential Action	REPLACE
Urgency of Action	PRIORITY 3
Purpose of Action	LEVEL 2
Deficiency Photo1

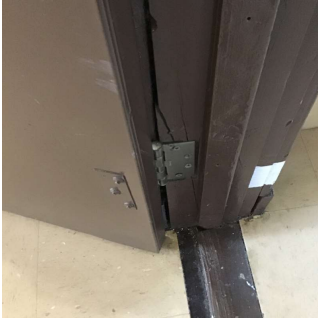
Question	Response
INTERIOR	
STAIRS/RAMPS: INTERIOR	
Door(s)	
Condition	5 - Poor
Deficiency	WOOD: DETERIORATED DOOR AND FRAME
Deficiency Location/Instance	Stair B/4 (Multi-Purpose Room)
Deficiency Quantity	2
Quantity Uom	EACH
Potential Action	MAINTENANCE
Urgency of Action	PRIORITY 3
Purpose of Action	LEVEL 2
Deficiency Photo1

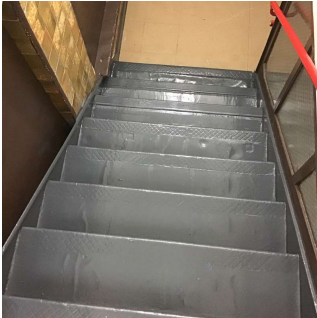
Question	Response
INTERIOR	
STAIRS/RAMPS: INTERIOR	
Stairs and Landings	
Deficiency	ROLLED ASPHALT: CRACKS
Deficiency Location/Instance	Stairs A/1,4, B/Basement,2,4, and others
Deficiency Quantity	480
Quantity Uom	S.F.
Potential Action	REPLACE
Urgency of Action	PRIORITY 3
Purpose of Action	LEVEL 2
Deficiency Photo1

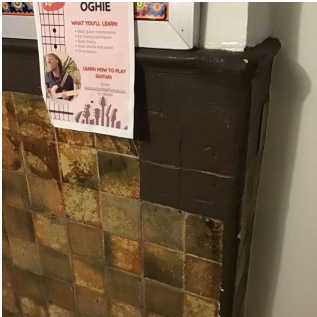
Violations	Stair A/4 No violations recorded.
Walls	Inspected
Condition	2 - Between Good and Fair
Deficiency	CERAMIC TILE: BROKEN/ MISSING
Deficiency Location/Instance	Stairs A/2, B/1,3
Deficiency Quantity	25
Quantity Uom	S.F.
Potential Action	REPLACE
Urgency of Action	PRIORITY 3
Purpose of Action	LEVEL 2
Deficiency Photo1

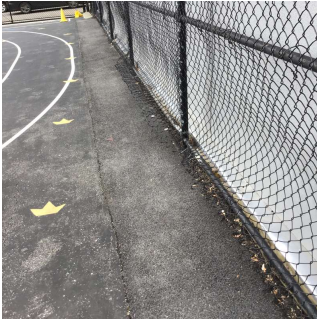
Violations	4th Avenue No violations recorded.
Deficiency	CHAIN LINK: DAMAGED/DETERIORATED
Deficiency Location/Instance	Schoolyard, 8th Street
Deficiency Quantity	350
Quantity Uom	S.F.
Potential Action	REPLACE
Urgency of Action	PRIORITY 3
Purpose of Action	LEVEL 2
Deficiency Photo1

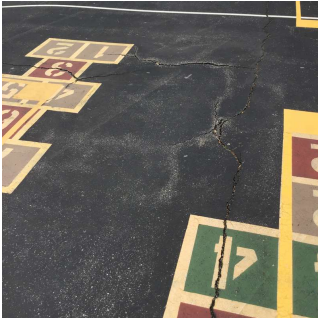
Violations	4th Avenue No violations recorded.
Pavers	Does not Exist
Student Use	Inspected
Gravel Exists?	No
Asphalt	Inspected
Condition	3 - Fair
Deficiency	CRACKS - MAJOR
Deficiency Location/Instance	Schoolyard
Deficiency Quantity	450
Quantity Uom	S.F.
Potential Action	REPLACE
Urgency of Action	PRIORITY 3
Purpose of Action	LEVEL 2
Deficiency Photo1

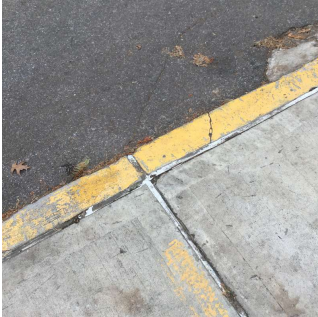
4th Avenue
Violations	No violations recorded.
Deficiency	DAMAGED CURBS
Deficiency Location/Instance	7th Street, 8th Street
Deficiency Quantity	75
Quantity Uom	L.F.
Potential Action	REPLACE
Urgency of Action	PRIORITY 3
Purpose of Action	LEVEL 2
Deficiency Photo1
