NYC Department of Education
Building Condition Assessment Survey 2023 - 2024

Architectural Inspection

K765

Asset: **PRE-K CENTER @ 1139 CONEY ISLAND AVENUE - BROOKLYN, 1139 CONEY ISLAND AVENUE, New York, 11230**

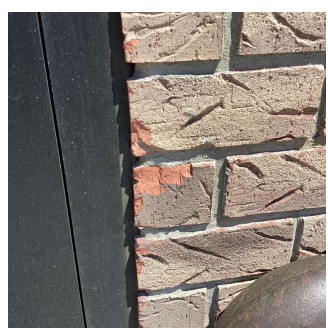
Question	Response
EXTERIOR	
EXTERIOR WALLS	
Material Type(s)	Masonry
Replacement Quantity	6,000
Replacement Uom	S.F.
Instance on All Facades	Inspected
Instance Condition	3 - Fair
Instance Quantity	6,000
Instance Quantity Uom	S.F.
Deficiency	BRICK: MINOR CRACKS AND SPALLING
Roof Plan reference	  <p>K765</p> <p>A Playground Main Entrance BH1 ① 2 B C Avenue H Coney Island Avenue</p>
Elevation

Deficiency Quantity	10
Quantity Uom	S.F.
Potential Action	RESTITCH
Urgency of Action	PRIORITY 3
Purpose of Action	LEVEL 2
Deficiency Photo1

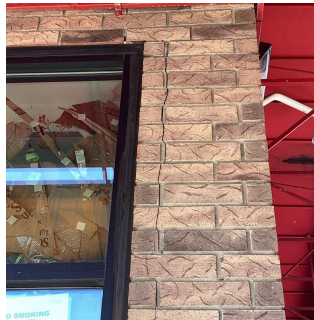
Facade B

Violations	Facade C No violations recorded.
Deficiency	BRICK: CRACKS/DISPLACED/SPALLED BRICK AT BUILDING CORNERS

Deficiency Quantity

10

REMOVE AND REBUILD

PRIORITY 4

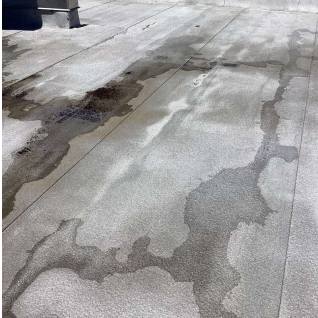
Installation Year	2015
Source of Installation	Custodial Staff
Deficiency	MODIFIED BITUMEN: ROOFING: DELAMINATION
Roof Plan reference

Deficiency Quantity	100
Quantity Uom	S.F.
Potential Action	REPLACE ROOFING WITHOUT MAJOR EQUIPMENT REMOVAL
Urgency of Action	PRIORITY 4

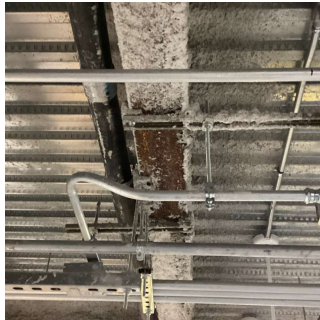
Question	Response
EXTERIOR	Inspected
WINDOWS	Inspected
WINDOWS	
Source of Installation	Custodial Staff
Deficiency	No deficiencies recorded
INTERIOR	Inspected
POOLS	Does not Exist
STRUCTURAL	Inspected
COLUMNS/BEAMS/BEARING WALLS	Inspected
Condition	2 - Between Good and Fair
Deficiency	STEEL COLUMNS/BEAMS: DETERIORATED/MISSING SPRAY-ON FIREPROOFING
Deficiency Location/Instance	Basement - Room 2
Deficiency Quantity	20
Quantity Uom	S.F.
Potential Action	REPLACE
Urgency of Action	PRIORITY 3
Purpose of Action	LEVEL 5
Deficiency Photo1

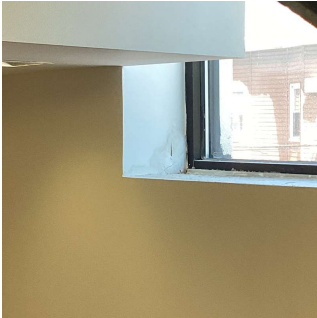
Question	Response
INTERIOR	
STAIRS/RAMPS: INTERIOR	
Stairs and Landings	
Deficiency Location/Instance	Stair A/Bulkhead
Deficiency Quantity	10
Quantity Uom	S.F.
Potential Action	REPLACE
Urgency of Action	PRIORITY 3
Purpose of Action	LEVEL 2
Deficiency Photo1	 
Violations	Stair A/Bulkhead No violations recorded.
Walls	Inspected
Condition	2 - Between Good and Fair
Deficiency	GYPSUM BOARD: DETERIORATED
Deficiency Location/Instance	Stair A/2
Deficiency Quantity	10
Quantity Uom	S.F.
Potential Action	REPLACE
Urgency of Action	PRIORITY 3
Purpose of Action	LEVEL 2
Deficiency Photo1

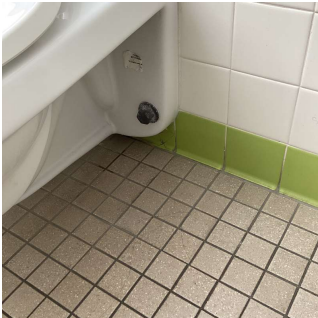
Question	Response
INTERIOR	
TOILET ROOMS - STAFF	
Stalls	Does not Exist
Walls	Inspected
Condition	2 - Between Good and Fair
Deficiency	CERAMIC TILE: BROKEN/ MISSING
Deficiency Location/Instance	Room 205
Deficiency Quantity	10
Quantity Uom	S.F.
Potential Action	REPLACE
Urgency of Action	PRIORITY 3
Purpose of Action	LEVEL 2
Deficiency Photo1

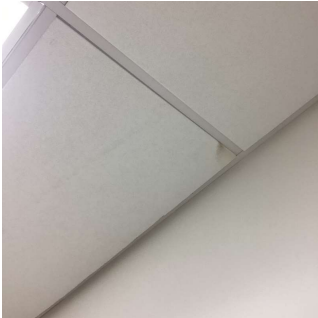
Violations	Room 205 No violations recorded.
TOILET ROOMS - STUDENTS	
Ceiling	Inspected
Condition	2 - Between Good and Fair
Deficiency	ACOUSTIC TILES: DAMAGED/MISSING
Deficiency Location/Instance	Room 210A
Deficiency Quantity	10
Quantity Uom	S.F.
Potential Action	REPLACE
Urgency of Action	PRIORITY 3
Purpose of Action	LEVEL 2
Deficiency Photo1

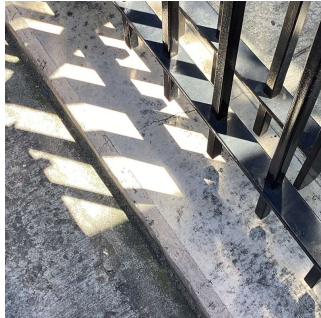
Violations	Avenue H No violations recorded.

Question	Response
INTERIOR	
TOILET ROOMS - STUDENTS	
Stalls	Does not Exist
Walls	Inspected
Condition	2 - Between Good and Fair
Deficiency	No deficiencies recorded
LIFE SAFETY	Inspected
F.D. HOLDING AREA	Does not Exist
STEEL STAIRS	Does not Exist
SITE	Inspected
CONTAINERIZATION	Does not Exist
Drainage System for Asphalt	Does not Exist
Drainage System for Concrete	Inspected
Catch Basins/Manhole - Surrounded by concrete	Inspected
Condition	2 - Between Good and Fair
Deficiency	No deficiencies recorded
Culverts - Concrete Covering	Does not Exist
Drainage System for Soil	Does not Exist
DRINKING FOUNTAINS	Does not Exist
FENCES	Inspected
Condition	2 - Between Good and Fair
Deficiency	CONCRETE CURB: DAMAGED/DETERIORATED
Deficiency Location/Instance	Avenue H
Deficiency Quantity	10
Quantity Uom	S.F.
Potential Action	REPLACE
Urgency of Action	PRIORITY 3
Purpose of Action	LEVEL 2
Deficiency Photo1

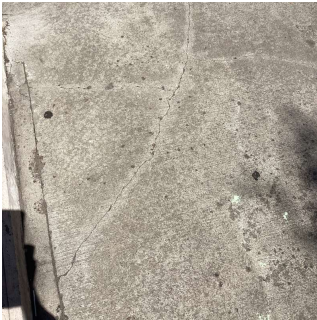
Question	Response
SITE	
PAVING	
DOT Sidewalk	
Concrete	
Deficiency	DAMAGED/DETERIORATED/MISSING SECTIONS
Deficiency Location/Instance	Avenue H
Deficiency Quantity	75
Quantity Uom	S.F.
Potential Action	REPLACE
Urgency of Action	PRIORITY 3
Purpose of Action	LEVEL 2
Deficiency Photo1

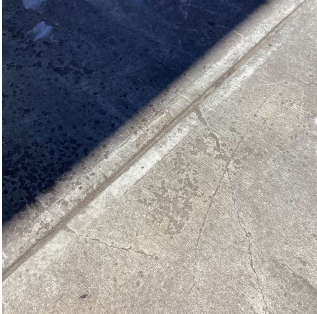
Violations	Avenue H No violations recorded.
Pavers	Does not Exist
PLAYGROUNDS	Inspected
Instance on Avenue H	Inspected
Benches	
Instance on Avenue H	Inspected
Condition	2 - Between Good and Fair
Deficiency	No deficiencies recorded
Fence	
Instance on Avenue H	Does not Exist
Pavement	
Instance on Avenue H	Inspected
Condition	3 - Fair
Deficiency	CONCRETE: CRACKS - MAJOR
Deficiency Location/Instance	Near Main Entrance
Deficiency Quantity	100
Quantity Uom	S.F.
Potential Action	REPLACE
Urgency of Action	PRIORITY 3
Purpose of Action	LEVEL 2
Deficiency Photo1
