NYC Department of Education
Building Condition Assessment Survey 2023 - 2024

Architectural Inspection

K767

Asset: **PRE-K CENTER @ 1668 46TH STREET - BROOKLYN, 1668 46TH STREET, New York, 11204**

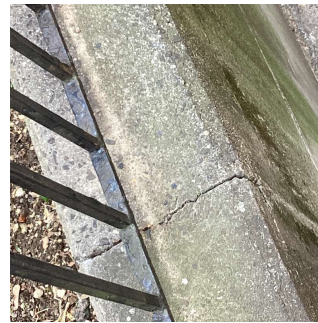
AW1

AREAWAY SLAB: CRACKS AND SPALLING

40

REPAIR

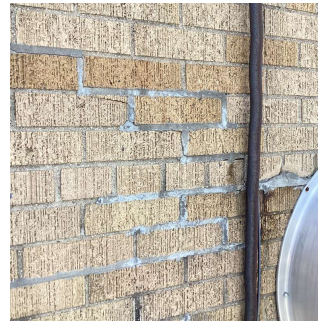
CH
No violations recorded.

BRICK: DETERIORATED JOINTS

20
S.F.
REPOINT
PRIORITY 4
LEVEL 2

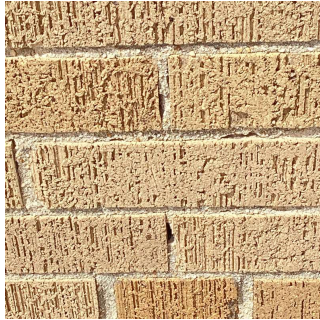
Violations	CH No violations recorded.
Deficiency	BRICK: DETERIORATED JOINTS
Roof Plan reference

Deficiency Quantity	120
Quantity Uom	S.F.
Potential Action	REPOINT
Urgency of Action	PRIORITY 3
Purpose of Action	LEVEL 2
Deficiency Photo1

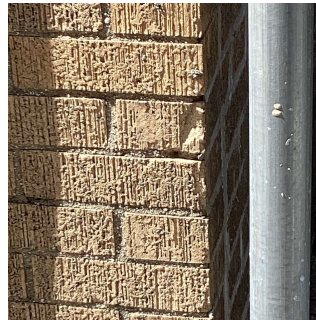
Facade B

BRICK: DETERIORATED JOINTS

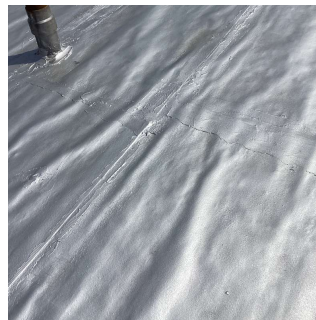
Roof 1

Deficiency	MODIFIED BITUMEN: ROOFING: DELAMINATION
------------	---

Potential Action	REPLACE ROOFING WITHOUT MAJOR EQUIPMENT REMOVAL
------------------	---

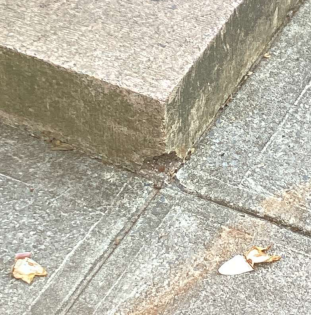
Question	Response
EXTERIOR	
STAIRS/RAMPS: EXTERIOR	
RAILINGS	Does not Exist
STAIRS/RAMPS	Inspected
Condition	4 - Between Fair and Poor
Deficiency	STONE: CRACKS/SPALLING - MINOR
Roof Plan reference

<p>K767 46th Street 17th Avenue</p>
Deficiency Quantity	10
Quantity Uom	S.F.
Potential Action	REPAIR
Urgency of Action	PRIORITY 3
Purpose of Action	LEVEL 2
Deficiency Photo1

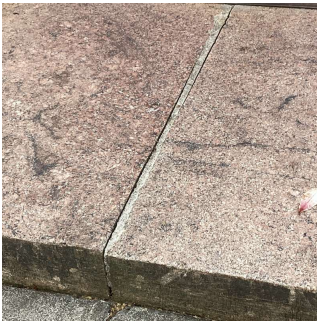
Violations	Facade A No violations recorded.
Deficiency	STONE: DETERIORATED SUBSTRATE
Roof Plan reference

Deficiency Quantity	20
Quantity Uom	S.F.
Potential Action	REPLACE SUBSTRATE AND RESET
Urgency of Action	PRIORITY 4
Purpose of Action	LEVEL 2
Deficiency Photo1

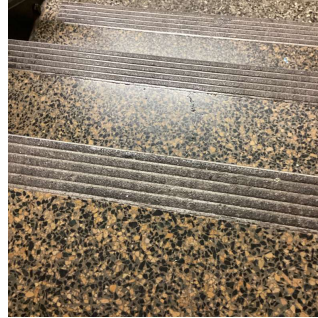
Stair B/Basement

Condition	3 - Fair
Deficiency	TERRAZZO: CRACKS
Deficiency Location/Instance	Multi-Purpose Room Exit, Stairs A/1, B/Basement
Deficiency Quantity	30
Quantity Uom	S.F.
Potential Action	REPLACE

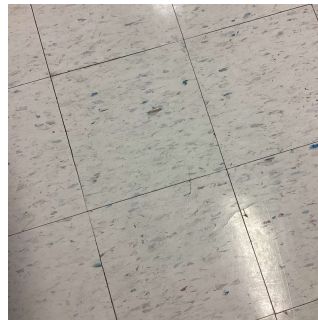
VINYL TILES: BROKEN/DETERIORATED/MISSING TILES
Stair A/2
10
S.F.
REPLACE
PRIORITY 3
LEVEL 2

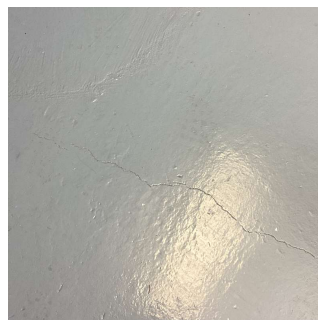
CONCRETE: CRACKS/SPALLING - MAJOR
Stair A/Bulkhead
20
S.F.
REPLACE
PRIORITY 3
LEVEL 2

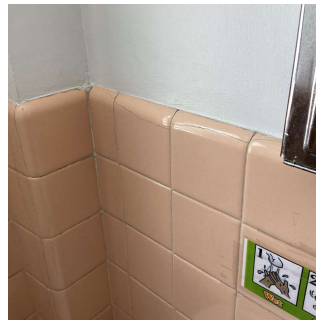
2nd Floor Staff

MASONRY: CRACKS/SPALLING

REPLACE
